**CHANNEL GEOMORPHOLOGY ASSESSMENT:
A COMPONENT OF THE WATERSHED
MANAGEMENT PLAN FOR THE SULPHUR
CREEK WATERSHED, NAPA COUNTY,
CALIFORNIA:**

**PREPARED FOR
STEWARDSHIP SUPPORT AND WATERSHED ASSESSMENT IN
THE NAPA RIVER WATERSHED: A CALFED PROJECT**

**CALFED CONTRACT NO. 4600001703
NAPA COUNTY RESOURCE CONSERVATION DISTRICT**

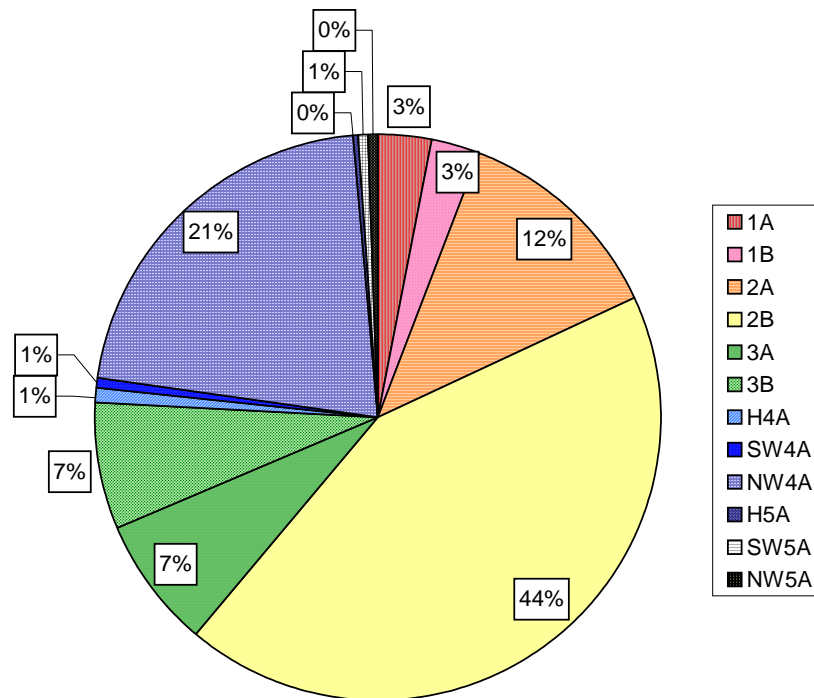
Figure 22. Total volume of bar material measured in each sample reach.

contain much larger, and highly active deposits (Figure 25). Combined, these two reaches are storing over half of the total amount of sediment measured in the entire channel network (Figure 22). Since gravel mining ceased in 1999, local residents believe that the channel is aggrading, or “filling up” with sediment (Historical Ecology). If this is true, the increased volume of sediment storage in the current channel will decrease the volume available for floodwater, possibly causing an increased flood hazard for the alluvial fan and town of St. Helena. Also, any modification of the channel in this reach should consider the possible increased deposition of sediment, and the implications it will have for the channel modification design and lifespan. But the most important factor limiting the habitat available in these reaches is the lack of perennial flow during the summer and fall. As Sulphur Creek exits its canyon, and begins to flow over the alluvial fan, discharge is lost as the water infiltrates into the fan gravels. During the dry season (approximately May/June to October/November) the stream is completely dry soon after exiting the canyon, and does not transmit surface discharge again until near Main Street. The lack of flow completely eliminates all available salmonid habitat during the summer and fall, and limits both upstream migration of adults and downstream migration of spawned out adults and juveniles to times when these reaches contain discharge. Because these reaches have a relatively low number of pools, low channel complexity, poor cover elements, high sediment storage, and a lack of perennial flow, reaches 2A and 2B act only as a migration corridor for salmonids.

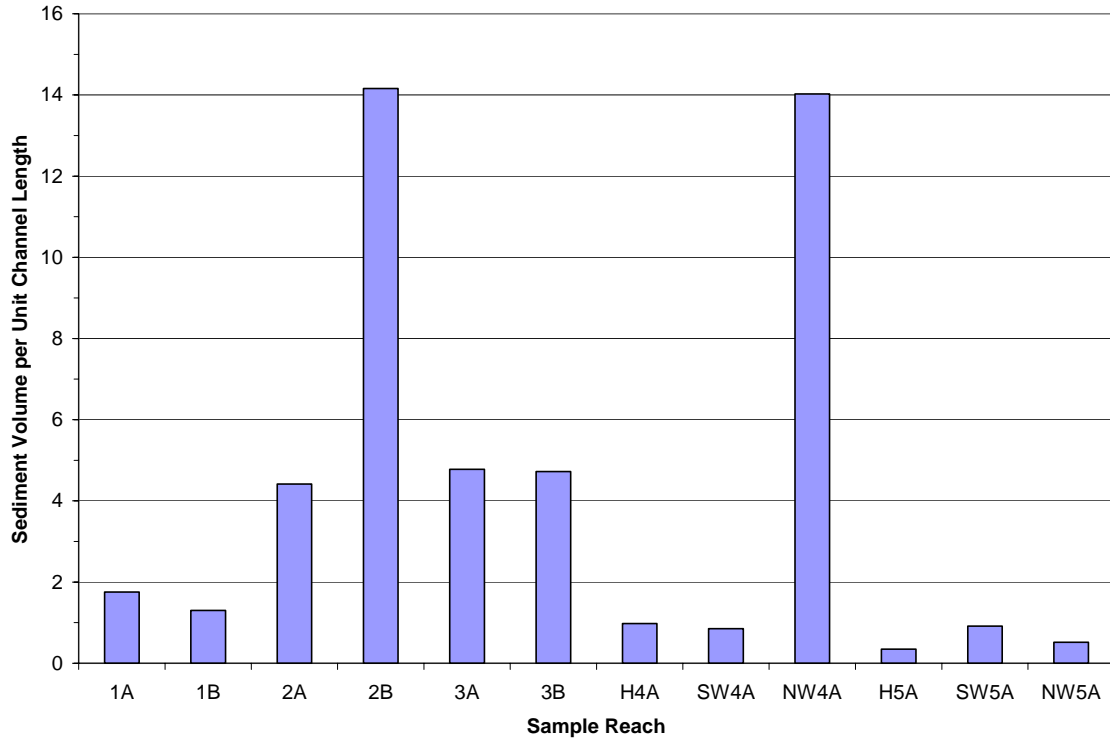
Figure 23. Calculated bar volume per unit channel length in each sample reach.

The total volume of material stored in each sample reach is dependant upon the length of the sample reach. To account for the various sample reach lengths, total sediment storage is normalized, giving sediment volume per unit channel length (in m^3/m) allowing the comparison of total storage between reaches (Figure 23). Reaches 2B and NW4A have the largest amount of storage per unit channel length, however, other reaches including 2A, 3A and 3B also have relatively high storage. Large bars account for the high sediment storage volume in Reach 2A, a braided reach on the downstream part of the alluvial fan surface. Reach 3B is significantly affected by a landslide that previously blocked the channel, causing a large bar to form upstream of the blockage. Since the time of the landslide, the channel has incised through a portion of the blockage, returning to its original gradient, and leaving a majority of the bar intact. In addition, this reach has a nearly continuous active channel deposit, indicating a large bedload supply from upstream in this particular setting. Reach 3A is storing a majority of its sediment in many types of bars, some being up to 1 m thick. It also has a large active channel deposit, suggesting a large sediment supply from upstream.

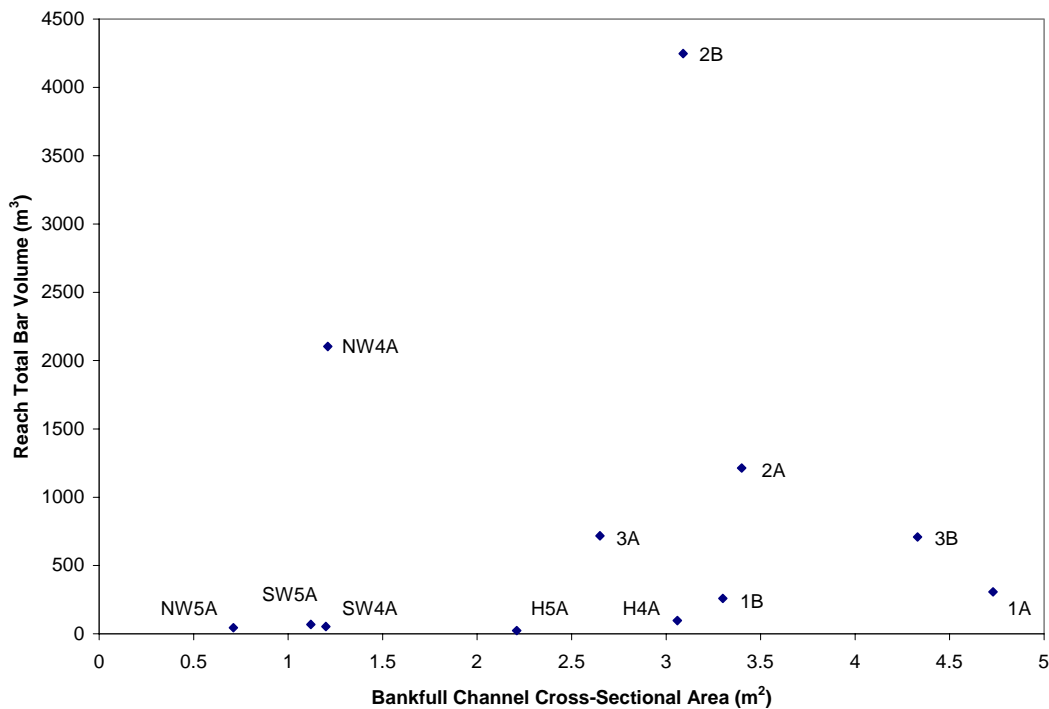
Figure 24. Bankfull channel cross-sectional area versus reach total bar volume.

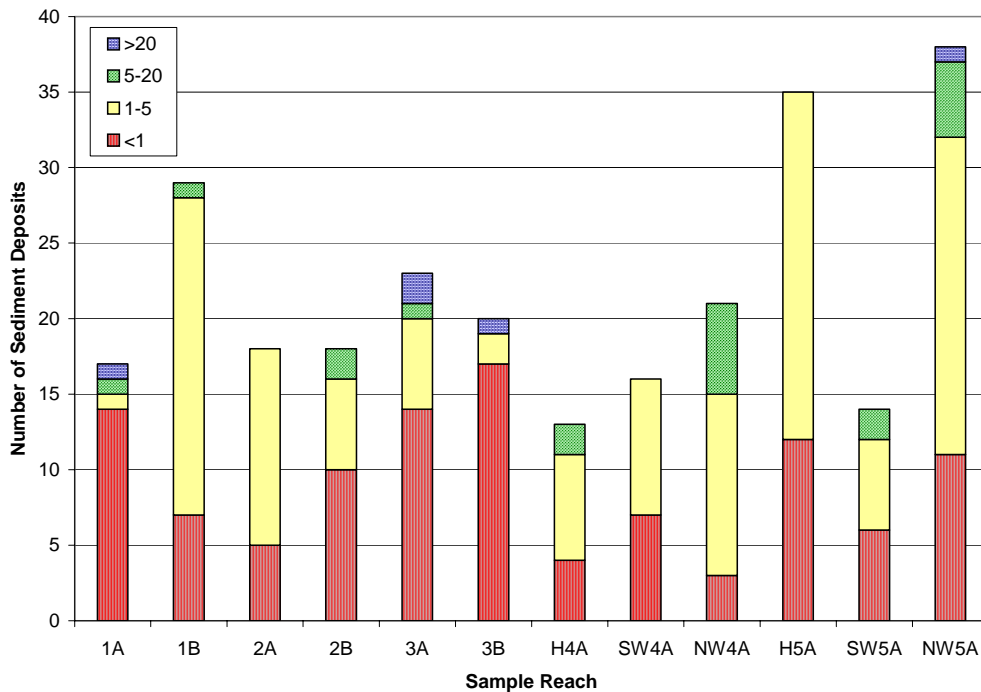
Figure 25. Distribution of estimated age (years) of bars measured in each sample reach.

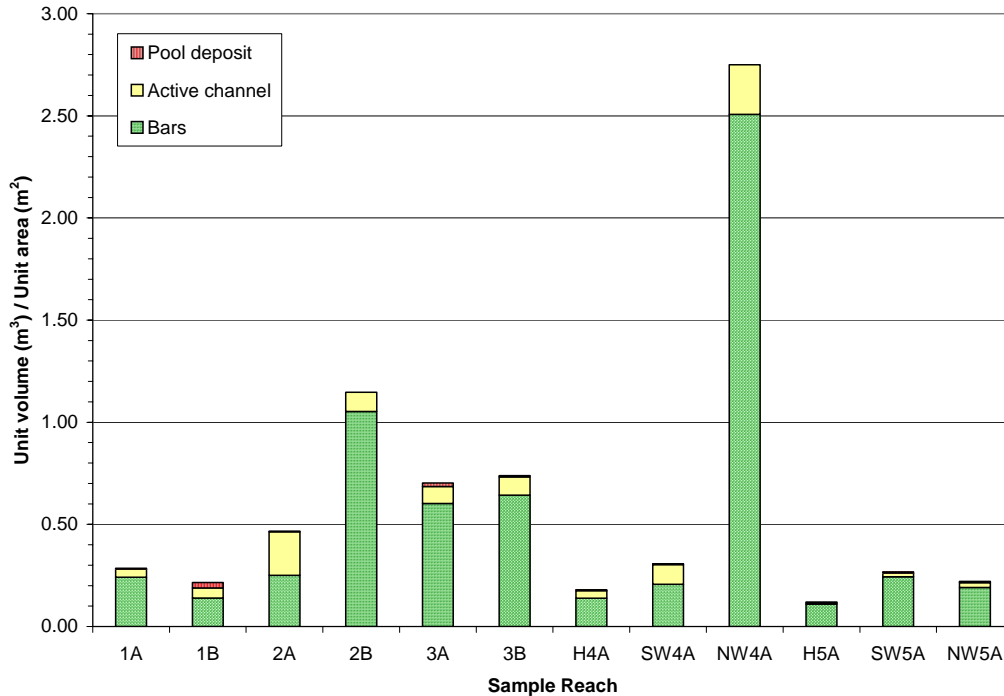
Figure 26. Volumetric percentage of pool deposits, active channel deposits, and all types of bars measured in each sample reach.

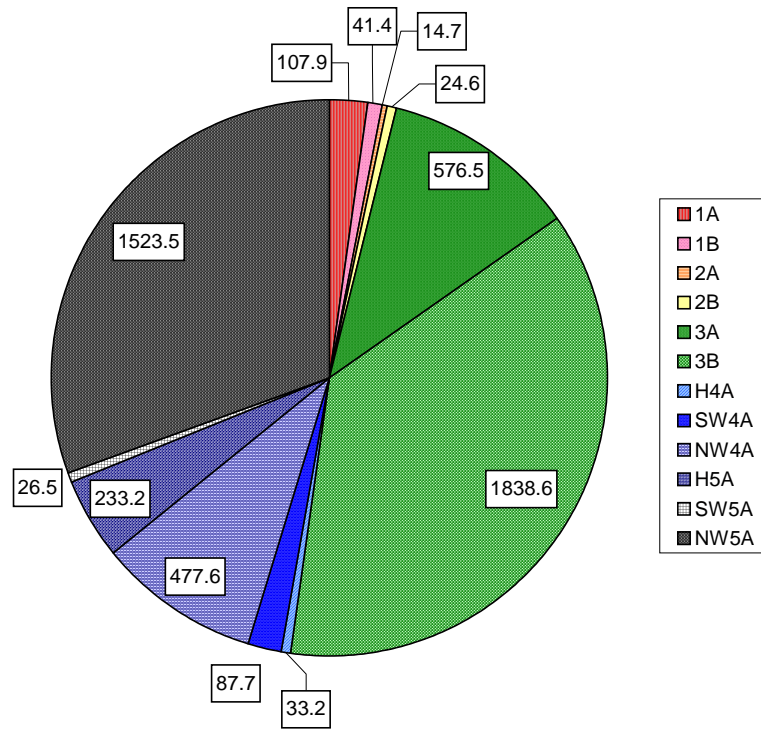
Figure 27. Total volume of measured bank erosion in each sample reach (m³).

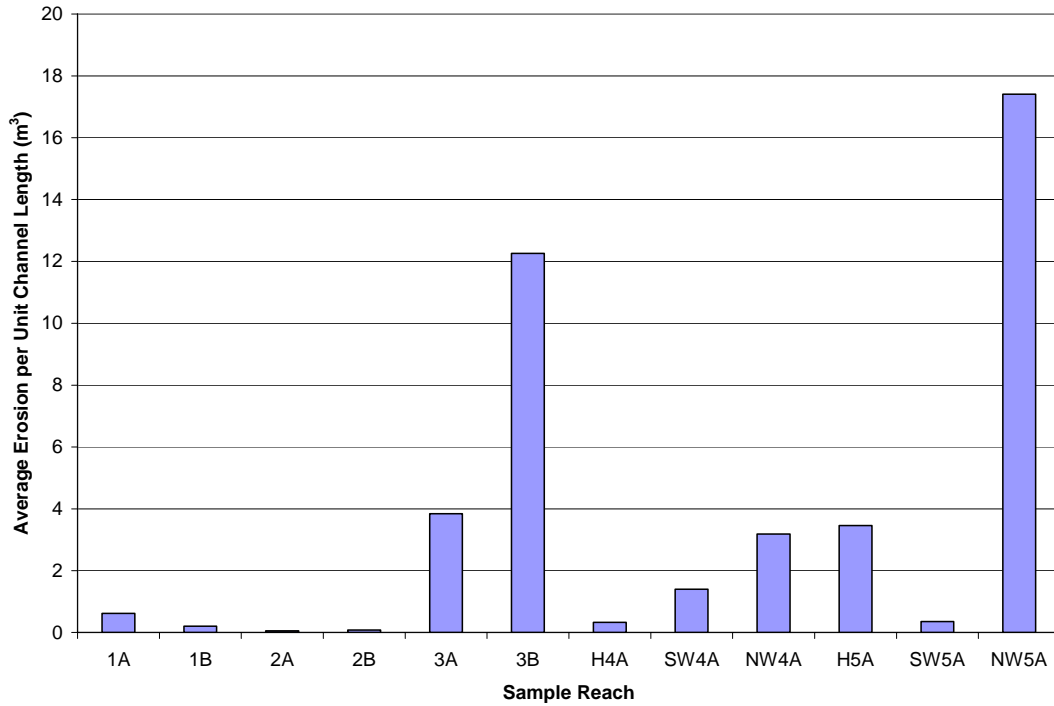
Figure 28. Average bank erosion per unit channel length in each sample reach.

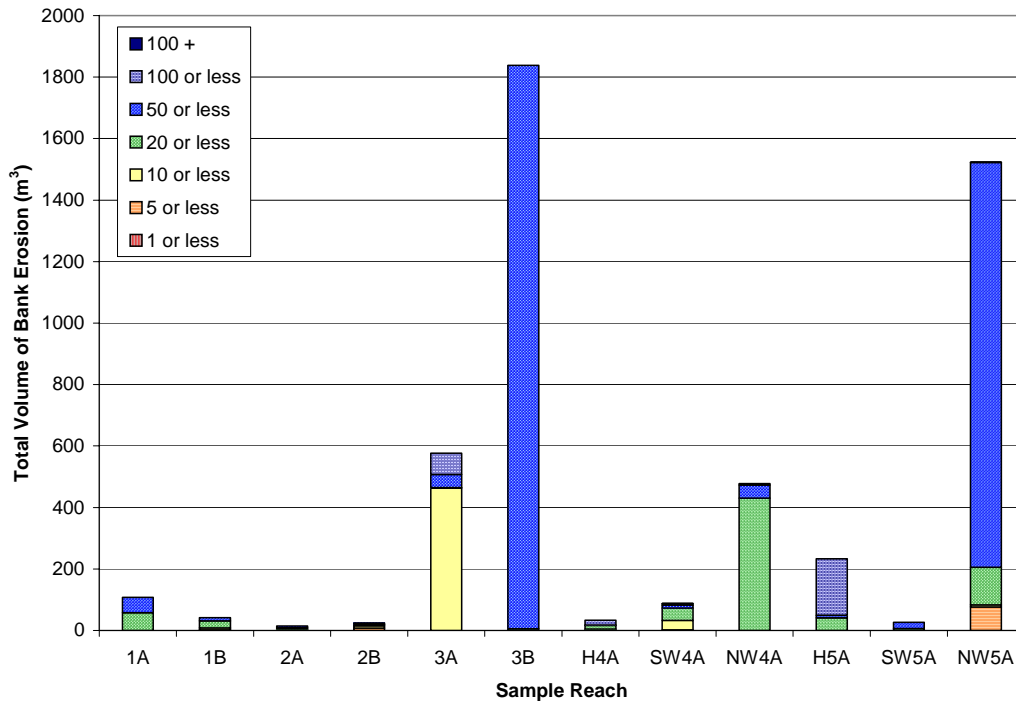
Figure 29. Age estimates associated with measured erosion in each sample reach (years).

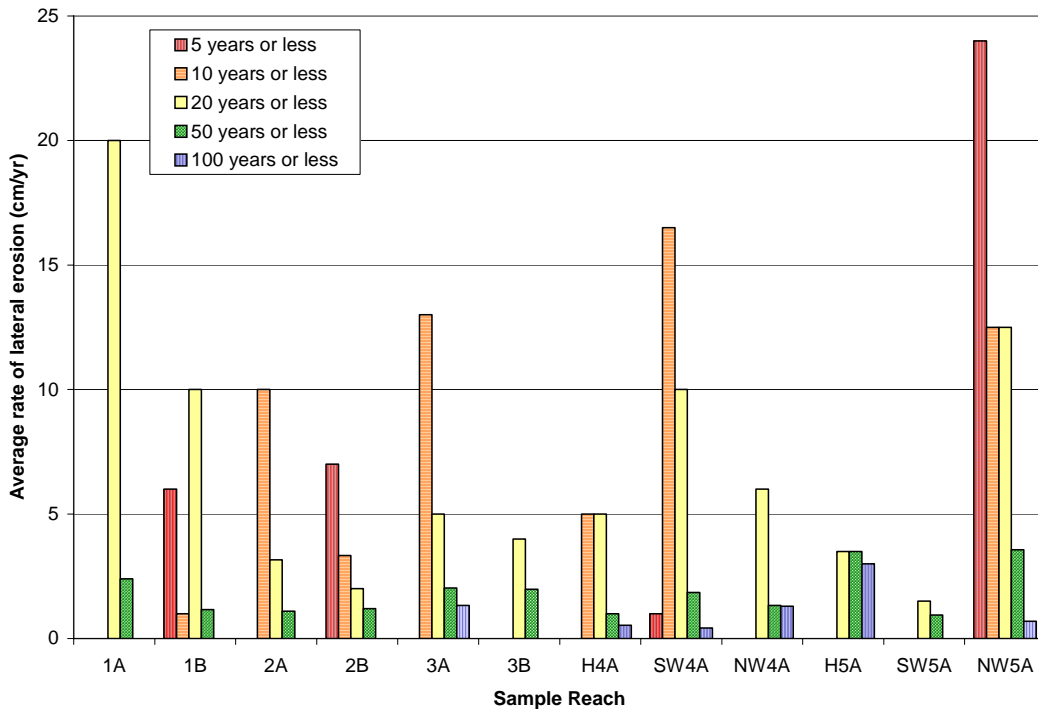
Figure 30. Average rate of lateral bank erosion (cm/yr) in each sample reach.

Using the amount of lateral bank erosion measured, and associated age class estimates made in the field, an average rate of lateral erosion for each erosion age class in

each sample reach can be calculated (Figure 30). These rates of retreat are for portions of the sample reach that are actively retreating, and thus, represent the highest rates of erosion in each sample reach. In all sample reaches, erosion that is in the 5-year, 10-year and 20-year categories have the highest rates. For example, in seven of the 12 sample reaches, erosion in the 20 years or less age class is equal to, or has the highest average rate. In the reaches where the 20-year age class is not the highest, either the 5-year or 10-year age class has the highest rate. Although a majority of erosion measured was based upon indicators in the 50-year age class, in all reaches, the 100-year and 50-year age class has the lowest and second lowest rates of erosion, respectively. Some reaches have higher rates of erosion, representing bank erosion from active landslides that directly impinge on the creek, as in reaches NW5A, SW4A and 3A. However, the high rate of erosion measured in reach 1A is primarily from localized scour around rootwads that entered the channel during a single bank collapse event. It appears that erosion within the past 10 years has been at a greater rate compared to erosion occurring over longer time periods. This is likely due to the erosion that occurred in the high flow events of 1995 and 1997. The real or perceived higher rates of recent erosion are likely due to the presence of more indicators of erosion that are likely to still exist from erosion that occurred 10 years ago, compared to 100 years ago. For example, exposed tree roots will rot and snap off after a certain length of time, preventing the older erosion from being measured. Also, any recent erosion could completely remove the older indicators, essentially “resetting the clock”. All of these caveats aside, bank erosion is occurring in Sulphur Creek, and irregardless of the rates, a majority of the volume of erosion observed is based upon indicators younger than 50 years.

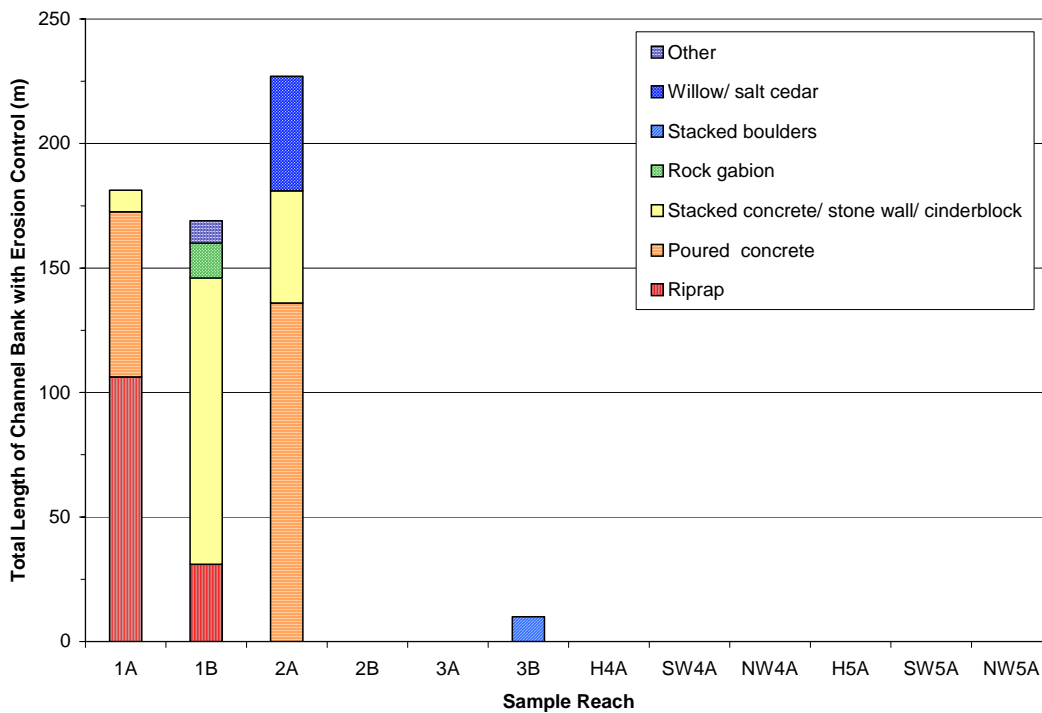
Figure 31. Type and total length of measured channel banks with erosion control revetments.

Modifications made to the banks of the channels, including erosion control measures primarily occur in the lower reaches of the watershed (Figure 31). These bank revetments include riprap, poured concrete slabs, stacked concrete or stone walls, rock gabions, willow wattles, and other styles of revetment. Reaches 1A, 1B and 2A clearly have the longest length of bank with revetments. Reaches 1A and 1B are confined by the entrenchment and revetments in the residential areas of the city of St. Helena; many of the bank revetments in these reaches are efforts by local landowners to prevent the channel from threatening their property or houses. The lower reaches are also the areas that experience the highest levels of flood flow, collecting the drainage from the entire watershed, resulting in the greatest potential for bank erosion. Reach 2A has been modified by historic gravel mining operations, however the bank revetments are set back from the active thalweg to allow some natural modification by the channel. It is important to remember that measurements of erosion in reaches with erosion control devices are minimum measures, because the devices limit the amount of erosion occurring.

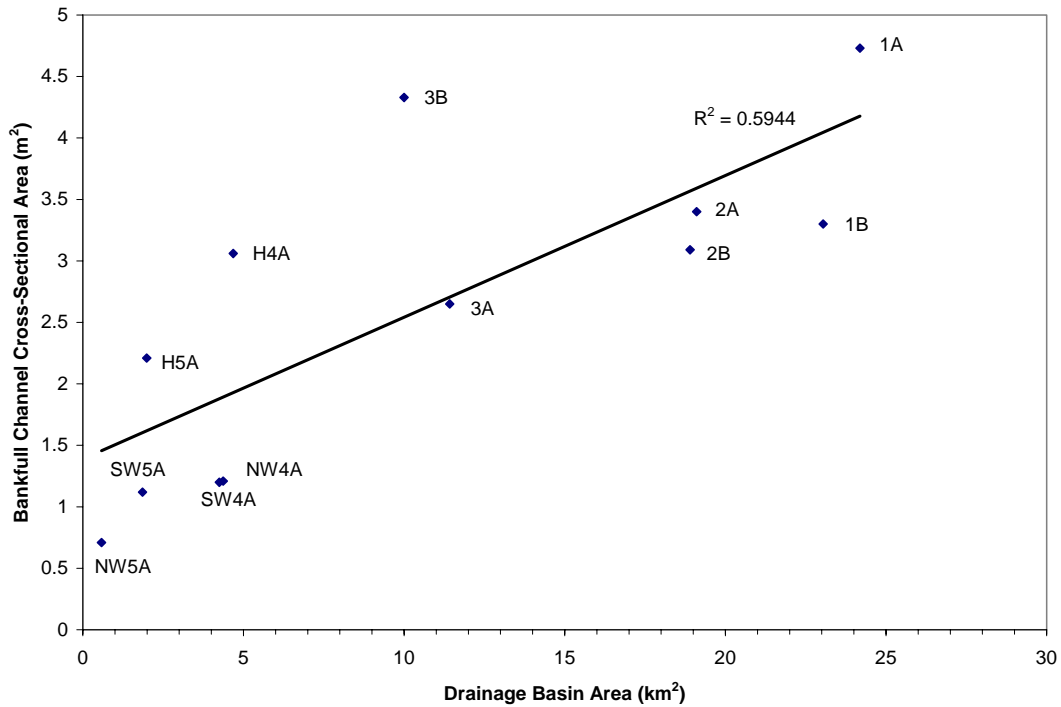
Figure 32. Drainage basin area versus bankfull channel cross-sectional area.

exists between watershed area and channel cross-sectional area (Figure 32). The D84 of the grain size distribution is strongly correlated with bed shear stress as is usually observed in channel networks. The median grain size, D50, is also correlated with shear stress, reflecting the relatively high degree of mobility of D50 sediment sizes in general and relatively high sediment supply throughout the channel network.

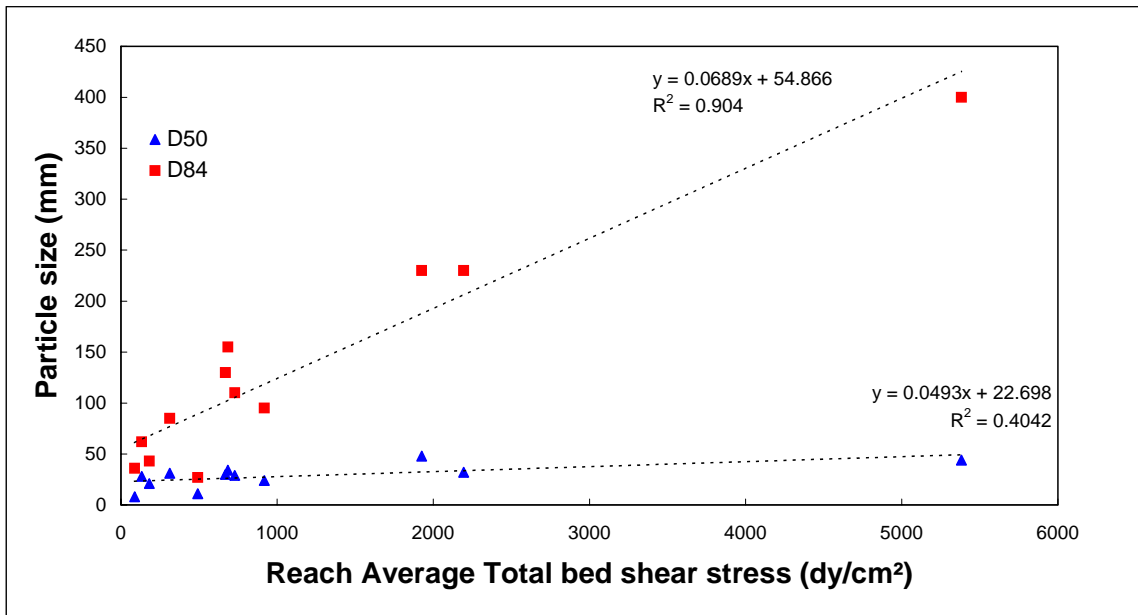
Figure 33. Reach average total bed shear stress versus particle size for each sample reach.
