Napa River Rutherford Reach Restoration Project
Final Memorandum Report for Annual Maintenance Activities
2011 Field Season

Prepared by: Napa County Flood Control and Water Conservation District

December 2011

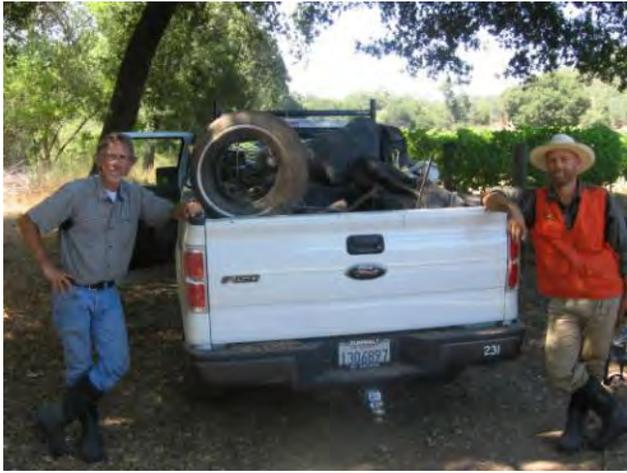
Figure 1: Trash and debris removal

A total of 48 occurrences of trash and debris were initially documented in the Report, but 54 items were actually removed from the river channel. A total of 28 tires and 26 other items, including two large washing machines that were not documented in the June survey, were removed. All trash and debris items were removed over two days in September 2011 (Figure 1). Table 1 depicts the types and number of occurrences of trash detected and removed since the surveys began in 2009. Landowners who were identified during the June survey as having significant amounts of debris stored on the top of their river bank that is susceptible to washing into the channel during high flows were contacted by the District. These landowners have agreed to remove this material from the top of bank and report back to District staff once the debris has been removed.

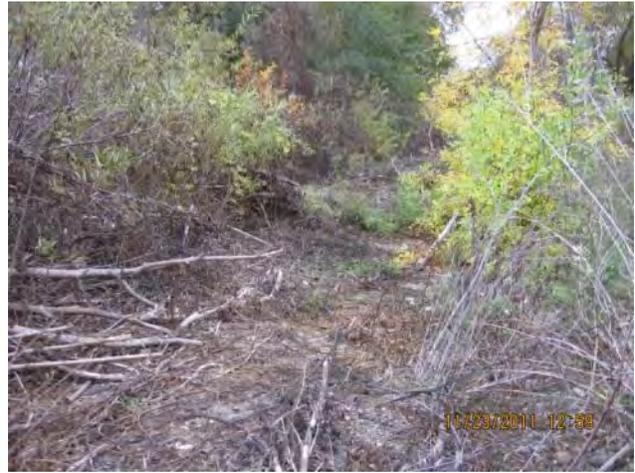
Figure 2: Invasive blackberry removal site (Pre-re-vegetation)

Seventy-nine (79) combined occurrences of giant reed, periwinkle, grape, Himalayan blackberry, poison hemlock and sesbania were actually treated during late summer/fall 2011 covering a total area of approximately 134,771 square feet or 3.09 acres (Figure 2). Table 2 depicts the area by species and cumulative

area of invasive and Pierce host plants treated and/or removed since the inception of the maintenance surveys in 2009. Approximately half of the Himalayan blackberry and periwinkle, as well as the 2,461 square feet of poison hemlock that were treated in Reaches 1-3, was paid for with funds from the Restoration Project re-vegetation contract for this area; thus labor and materials for this work was not charged to the Rutherford Maintenance Assessment District (MAD) fund. Of particular interest this year was the discovery and treatment of a large population of highly invasive red sesbania on a tributary that is thought to be the main source for occurrences of this species found in the Rutherford Reach of the Napa River. Select populations of invasive species that were treated during the 2011 field season and have the potential to cause streambank erosion have been, or will be, replanted with willow and/or cotton wood stakes and/or broad cast seeded with appropriate native species throughout the winter and spring of 2011 and 2012 respectively.

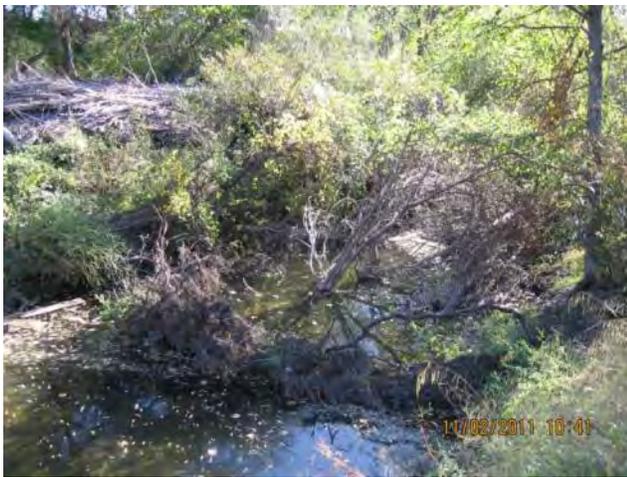
Figure 3: LWD thinning (before)

A total of 7 large woody debris (LWD) accumulations were documented during the 2011 survey that ranked as potential maintenance issues in the river channel. The Report recommended thinning out and/or realigning 3 of these 7 LWD occurrences. However, after several additional site inspections under low flow conditions, District staff concluded that only two LWD accumulations required treatment. The two occurrences of LWD that presented a maintenance issue were treated between October 1st and October 15th, 2011 respectively (Figures 3 and 4). Table 3 represents the number of LWD accumulations treated over the life of the Project thus far.

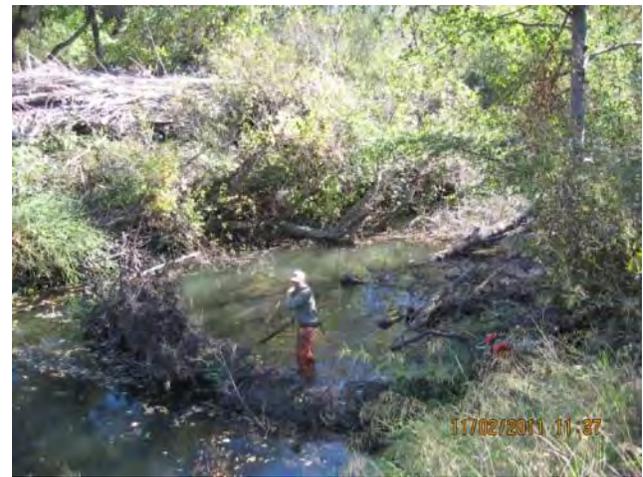
Figure 4: LWD thinning (after)

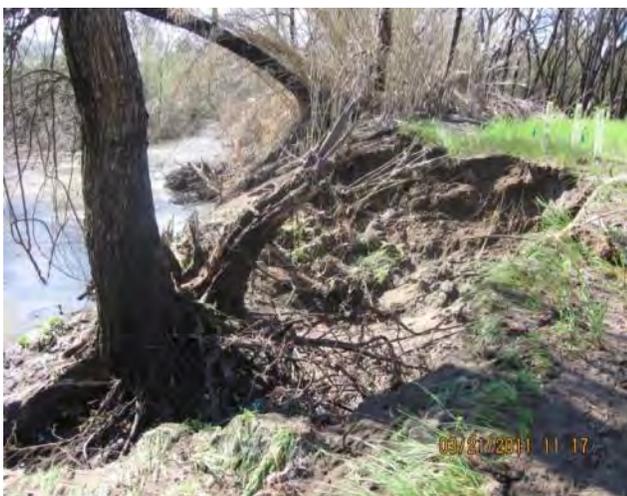
Figure 5: Erosion at constructed bench (before)

At the time of the June 2011 survey, construction had been completed through Reach 3 resulting in the creation of 9 in-stream benches and 1 backwater alcove, installation of 27 bench logs, 10 root wad structures, 1 boulder cluster and the setting back of over 8500 linear feet (1.6 miles) of agricultural berms. The Report recommended repairing the scoured stream bank at the downstream end of the instream bench constructed on the Caymus Vineyard property around a large willow tree (river station 181+50). The stream bank in this area was re-graded to a 3:1 slope, broad cast seeded and secured with bio-degradable erosion control fabric during November 2011 (Figure 5 and 6). Additional work will take place at this site in December and will consist of planting with willow and cotton wood stakes. Reach 3 construction funds will pay for this work and not maintenance assessment funds. Additional work including removal of various patches of dead giant reed rhizomes and re-planting of these areas with willow and cotton wood stakes is scheduled to take place in during winter/spring 2011/2012. No other work is currently proposed or required for built Project features.

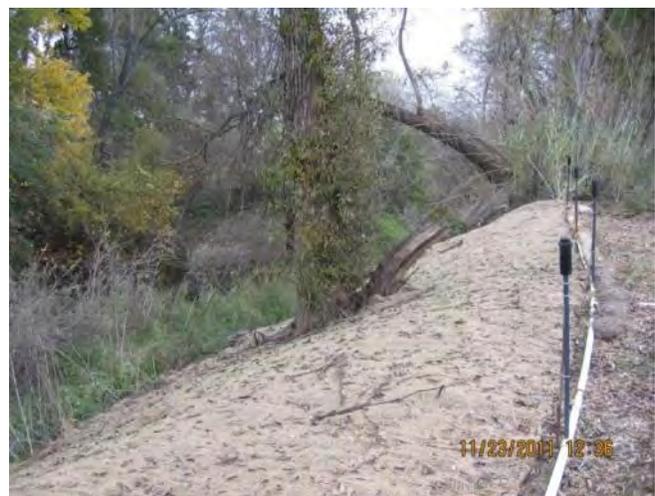
Figure 6: Erosion repair at constructed bench (after)
