FINAL TECHNICAL MEMORANDUM • SEPTEMBER 2013

# Napa River Sediment TMDL Monitoring Program: Summary Report of Pilot Implementation

# Monitoring Plan for the Napa River Sediment TMDL & Habitat Enhancement Monitoring Program

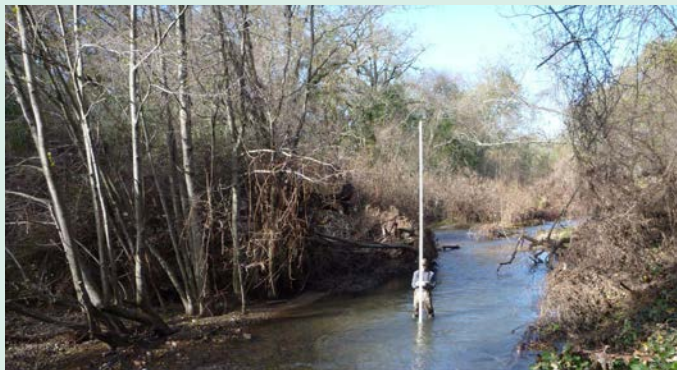
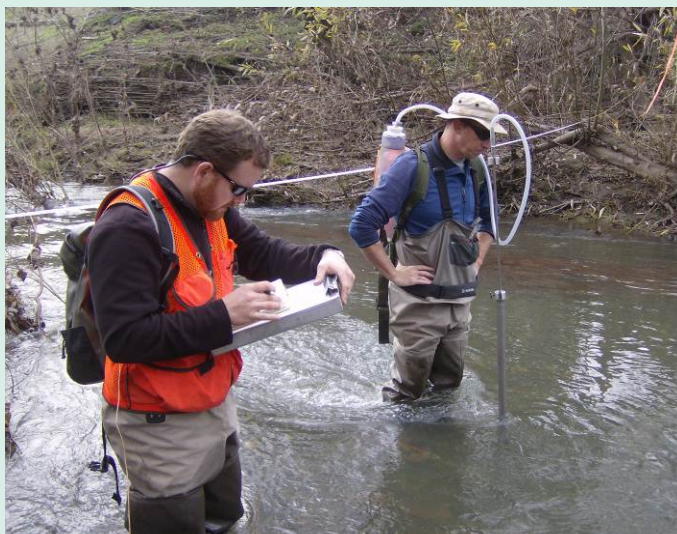
**Cover photos:**

*Upper left:* Photographic view of gravel substrates at scour-chain site M5-2 on the middle Napa River (photo taken on May 7, 2013 by Stillwater Sciences)

*Upper right:* Photographic view of high-water survey in reach M2 on the upper Napa River (photo taken December 14, 2012 by Napa County RCD)

*Bottom left:* Underwater photographic view of exposed scour chain at site M2-1 on the middle Napa River (photo taken on May 14, 2013 by Napa County RCD)

*Bottom right:* Photographic view of permeability measurements at site M5-1 on the middle Napa River (photo taken on December 12, 2012 by Stillwater Sciences)

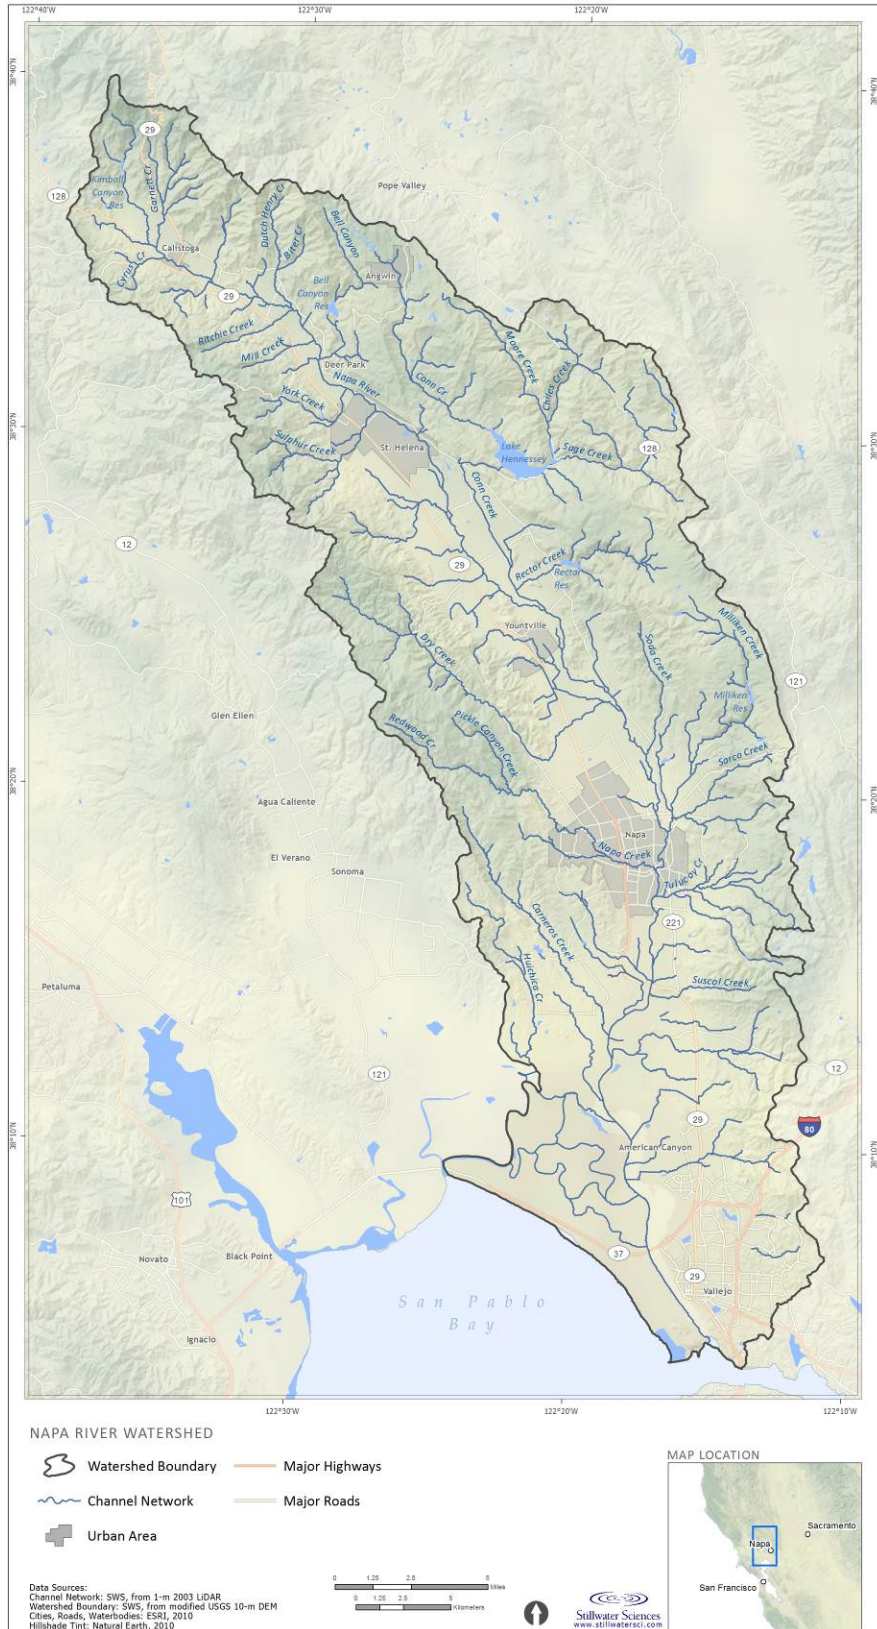
Figure 1. Hydrography map of the Napa River watershed.

The Napa River drains a 1,100-km<sup>2</sup> (420-mi<sup>2</sup>) watershed and flows through the cities of Calistoga, St. Helena, Yountville, Napa, American Canyon, and Vallejo before discharging into San Pablo Bay near the mouth of the Sacramento-San Joaquin estuary (Figure 1). The 90-km (60-mi) long river originates in steep, forested headwaters exceeding 1,300 m (4,300 ft) at Mount Saint Helena and then enters the depositional Napa Valley, whose floodplain is dominated presently by agriculture and developed areas. Historically, an array of both “connected” tributaries (i.e., tributaries with a discrete channel mouth that delivered water and sediment to the mainstem Napa River) and “disconnected” tributaries (i.e., tributaries without a discrete channel mouth that flowed directly onto the mainstem floodplain) flowed into the Napa Valley (Grossinger 2012). Over the past century, widespread channelization for urban and agricultural land uses has resulted in the direct connection of most tributaries to the Napa River. Currently,

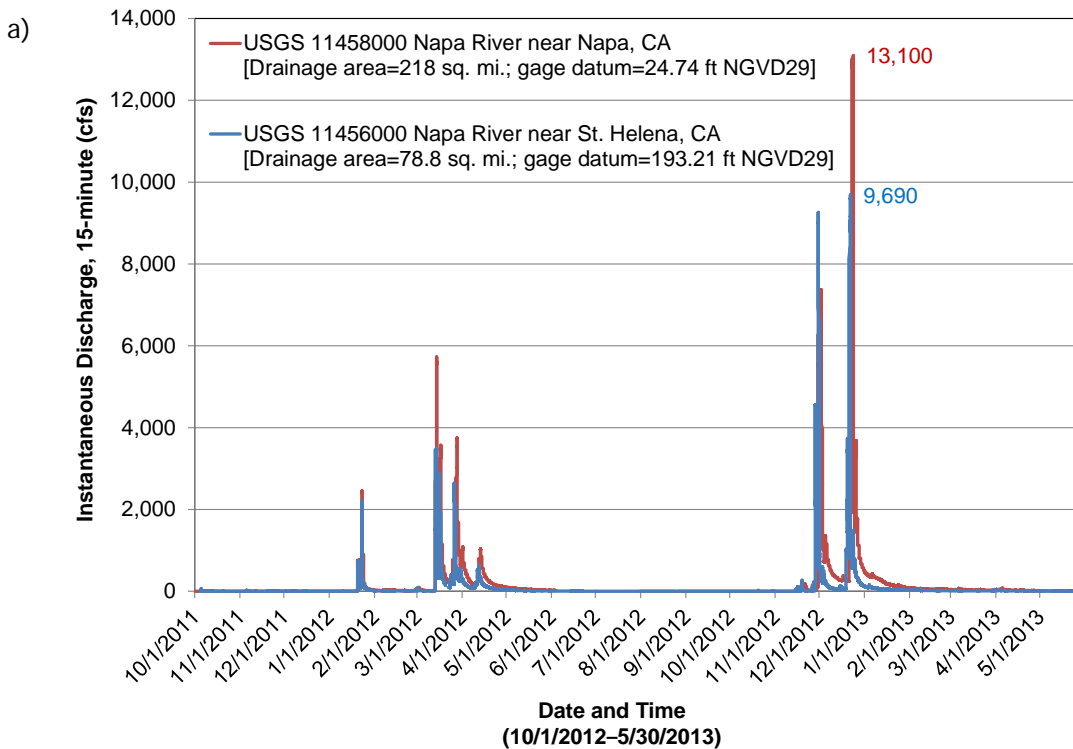
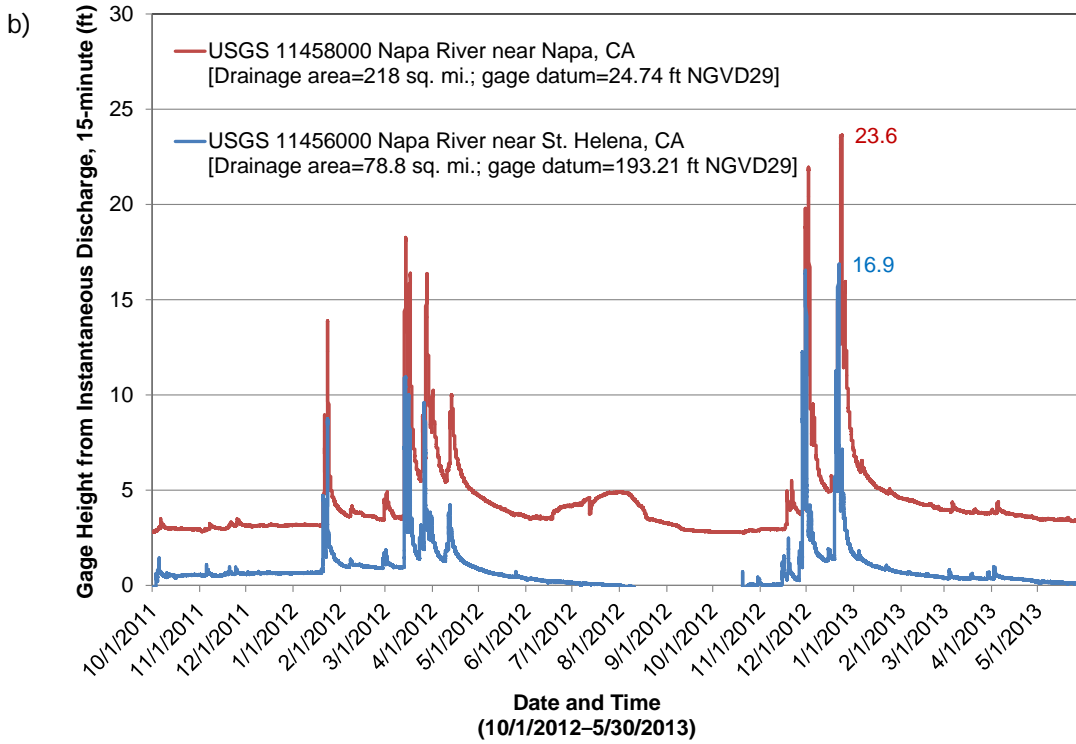
Figure 7. River discharge (a) and gage height (b) recorded continuously at the two active stream gages between October 1, 2011 and May 30, 2013. Peak flow during the pilot monitoring period occurred on December 23–24, 2012, and is indicated on the above graphs with data labels.

Streamflow in the Napa River during the pilot monitoring period peaked during late December, 2012. The peak flow recorded in Reach 2 near St. Helena (USGS gage 11456000<sup>4</sup>) and in Reach 4 near Napa (USGS gage 11458000<sup>5</sup>) during this period was 9,690 and 13,100 cfs, respectively, on December 23–24, 2012. These peak flows have approximate flood recurrence intervals of 4.8 and 3.5 years, respectively, over their contemporary periods of record. The flood frequencies for the two gages were analyzed using the Log-Pearson Type III statistical technique (USGS 1982) to estimate probabilities of various flood magnitudes. River discharge and stage data recorded continuously at the two active stream gages are presented in Figure 7. Peak flow data and flood frequency results computed for the gages are presented in Figure 8.

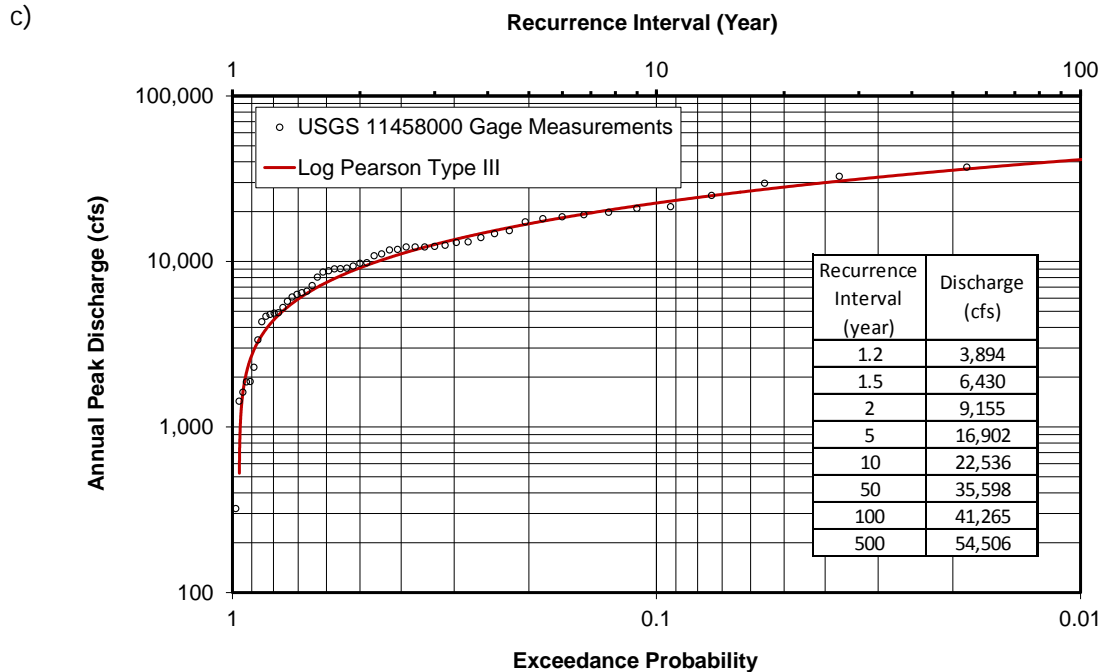
Figure 8. Annual peak discharge (a) and flood frequency (Log Pearson Type III) curves with tabularized recurrence intervals for the two active stream gages near St. Helena (b, USGS 11456000) and Napa (c, USGS 11458000) over their contemporary periods of record.

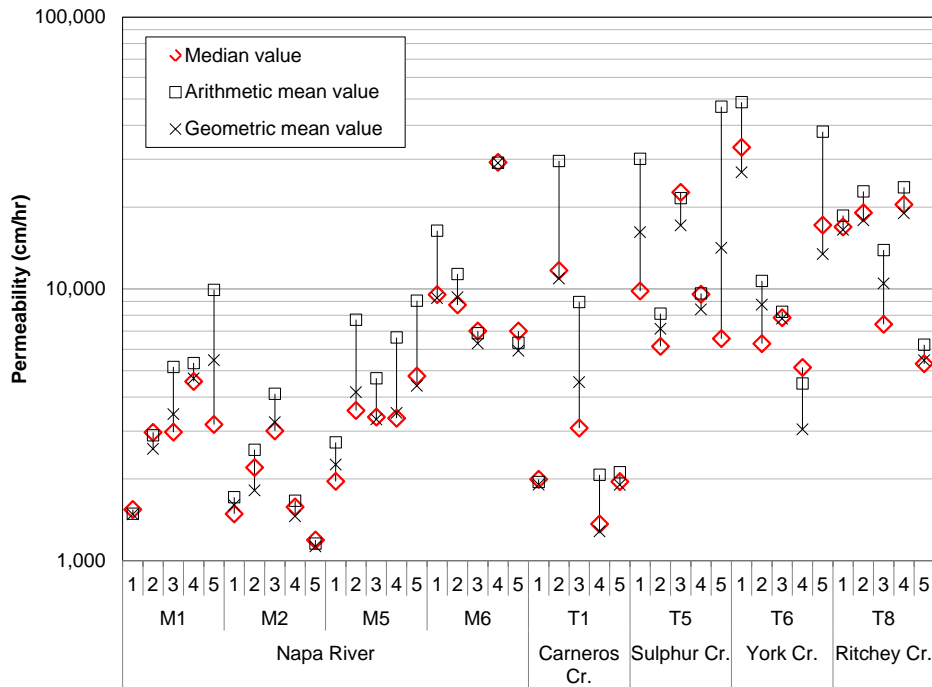
Figure 10. Three measures of the central tendency of permeability values at the monitoring sites.

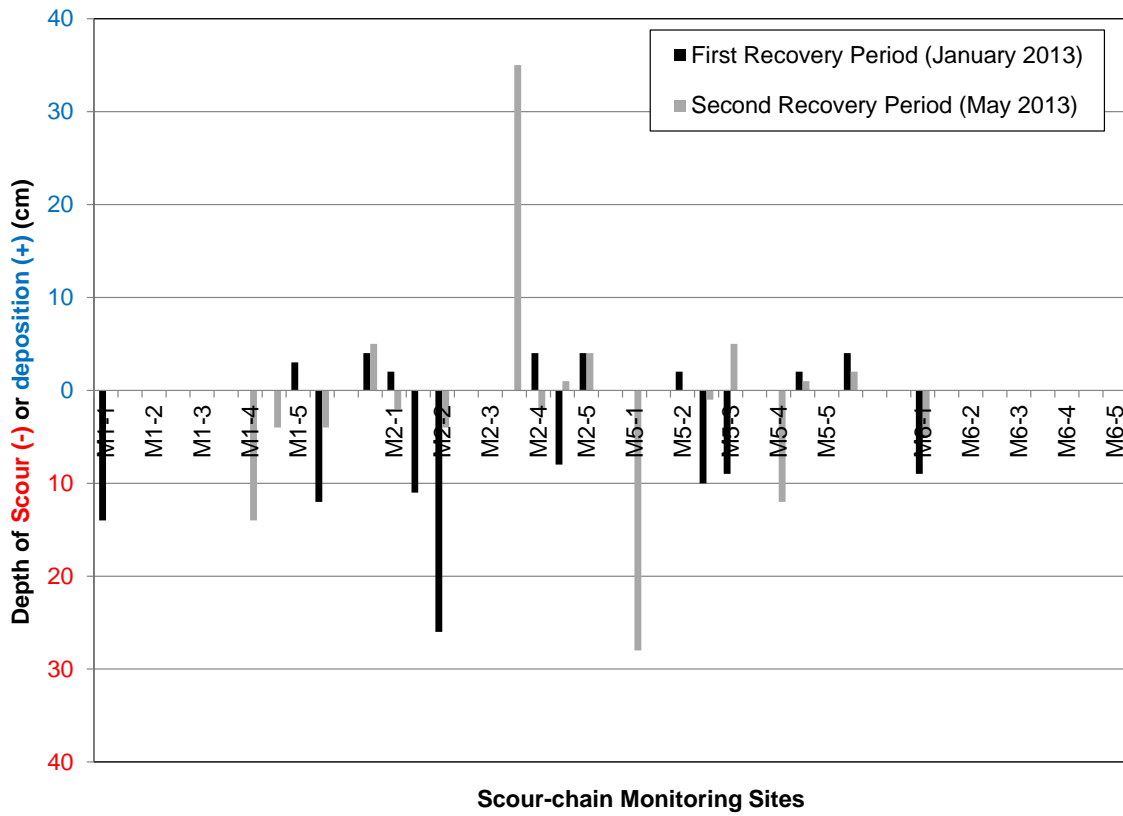
Figure 14. Measured streambed scour from the scour-chain data.

The scour-chain data from the streambed scour monitoring conducted at the mainstem sites are presented graphically in Figure 14 and summarized in Table 4. Overall, successful recovery of the scour-chains was poor for both recovery periods, as described above in Section 2.4. For reference, chain recovery for this type of effort should be much greater, although achieving 100% recovery is rarely possible (e.g., Nawa and Frissell 1993, Bigelow 2005). The poor recovery ultimately limits the ability to draw meaningful conclusions for scour activity throughout the monitoring reaches. Of the 40 scour-chains installed at the sites (two chains per site) only 17 were found during the first recovery period (January 10, 2013). Measurements made of these recovered chains reveal a variation of bed scour or deposition, with lengths ranging between -26 and +4 cm, where negative values represent greater chain exposure compared to initial installation (i.e., bed scour or lowering) and positive values represent less chain exposure through burial (i.e., bed aggradation). The TMDL target for mean bed scour following peak flows that equal or exceed bankfull discharge is 15 cm or less (Napolitano et al. 2009). The greater the scour depth the greater the potential for redd scour, which can cause mortality of incubating salmonid embryos. The maximum scour of 26 cm was documented at site M2-2B. There were four sites (M2-1A, M2-4B, M2-5B, M5-5B) that experienced the maximum depositional depth of 4 cm.

The second scour-chain recovery period (May 7, 14, 21, 2013) met equally poor recovery success, where only 20 chains were found, five of which were chains not found during the first recovery period (Figure 14 and Table 4). There were another five chains previously found and reset during the first recovery period, but not found during this second effort. Measurements reveal that both bed scour and deposition occurred between the first and second recovery periods. Measured lengths ranged from -28 and +35 cm, with the maximum scour documented at site M5-1A and maximum deposition documented at site M2-4A. See Section 3.4 below for discussion on potential for sediment transport at these sites.

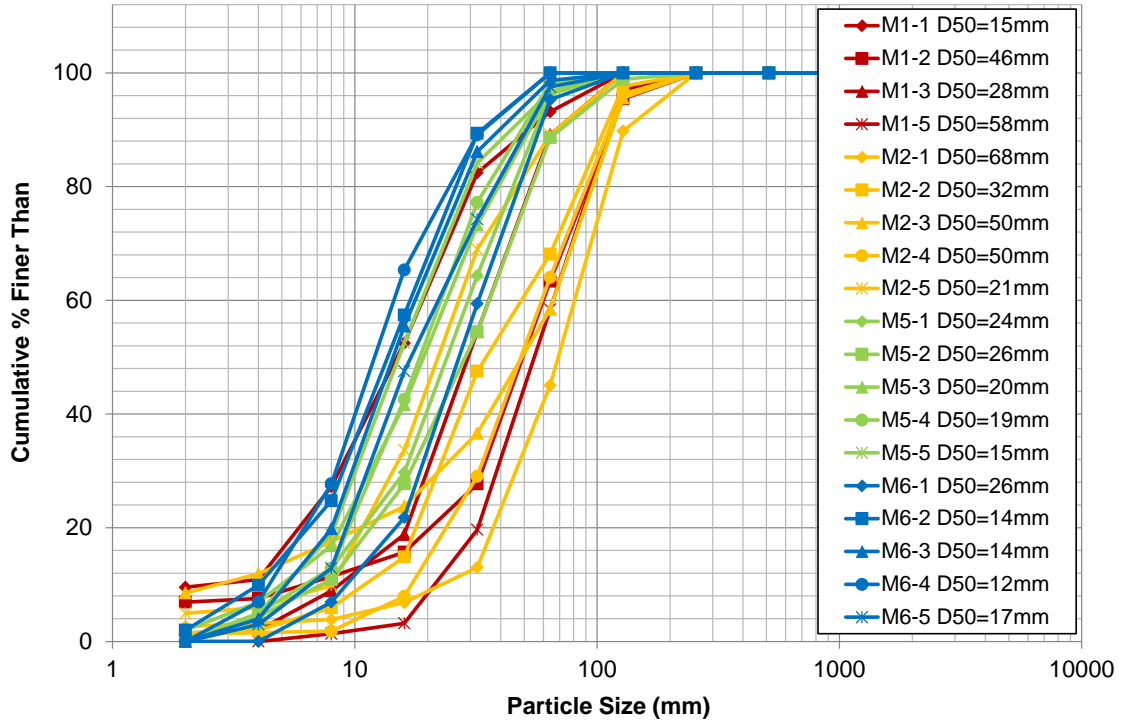
Figure 15. Particle size distributions from the pebble-count data.

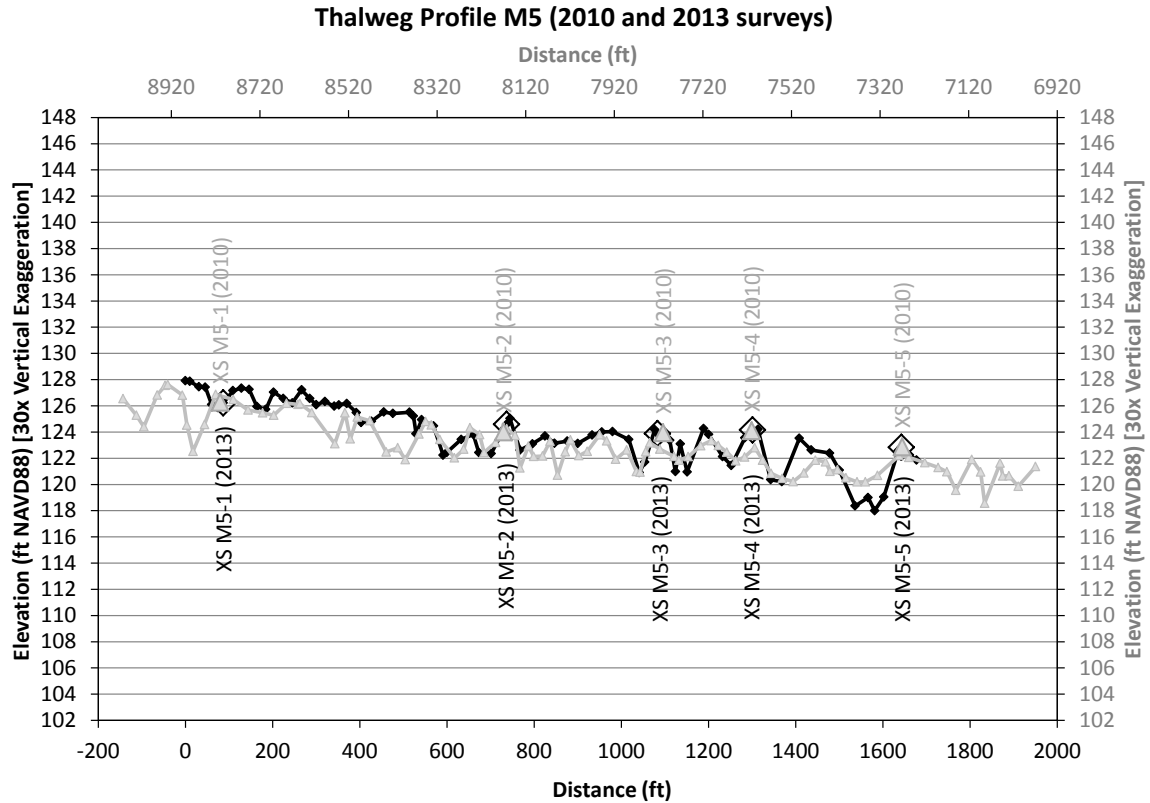
Figure 20. Cross-section (top five panels) and thalweg-profile (bottom panel) data plots for monitoring reach M5. Thalweg-profile from 2010 survey is displayed atop the 2013 data (bottom panel) for visual comparison. High water marks in cross-sectional view shown in dashed, grey-colored lines where data was available. Cross-section view is towards downstream and thalweg-profile view is generally eastward, with flow moving from left to right.

Bed slopes vary considerably from site to site indicating the topographic complexity present along the length of the surveyed reaches (M1, M2, and M5) (Figures 18 through 21; and Table 7). Mean bed-slope values were found to range between 0.003 and 0.005 at the sub-reach scale (i.e.,

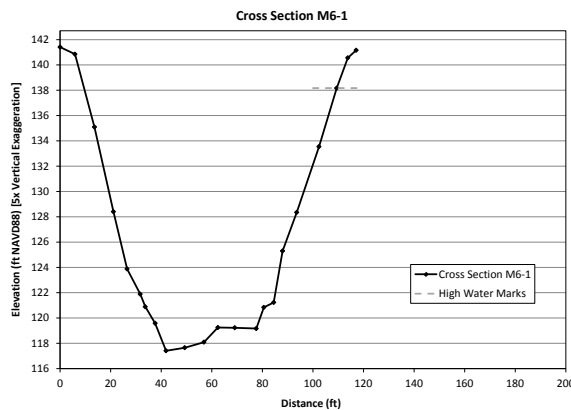
Figure 21. Cross-section data plot for monitoring reach M6. High water marks in cross-sectional view shown in dashed, grey-colored lines where data was available. Cross-section view is towards downstream.

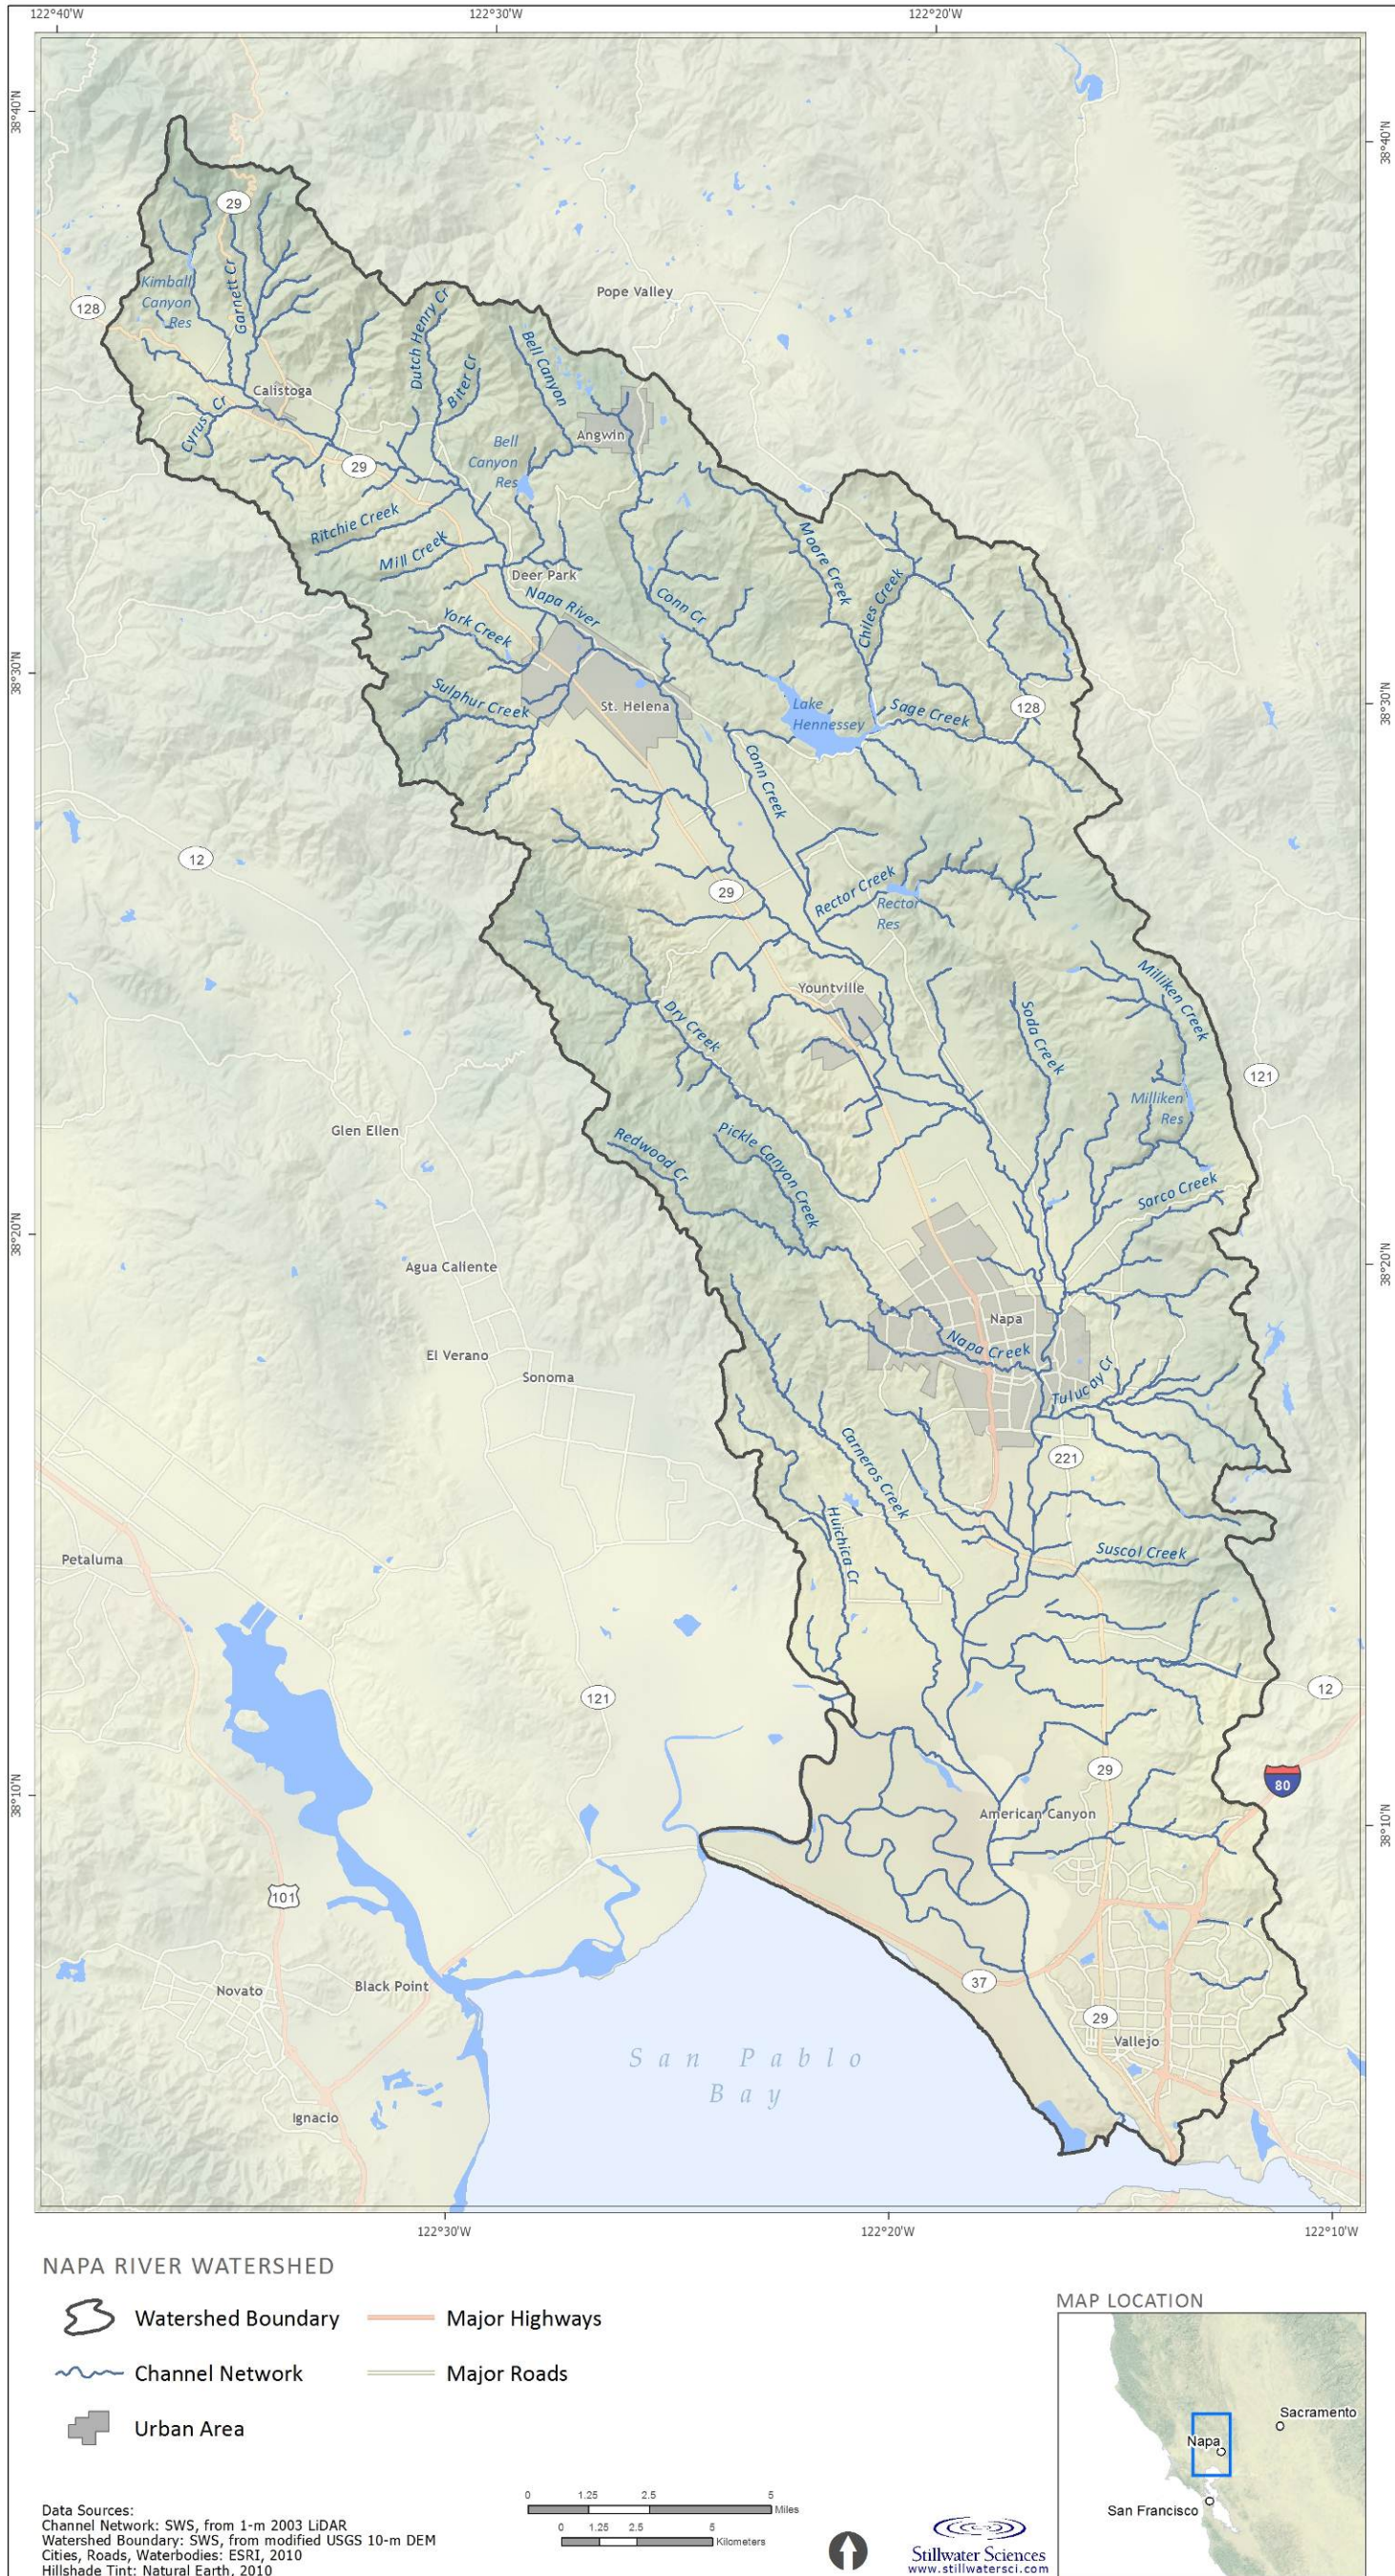
Figure 2-1. Napa River watershed.

The Napa River drains a 1,200 km<sup>2</sup> watershed and flows through the cities of Calistoga, St. Helena, Yountville, Napa, American Canyon, and Vallejo before discharging into San Pablo Bay near the mouth of the Sacramento-San Joaquin estuary (Figure 2-1). The river originates in steep, forested headwaters (elevation 1,200 m) and then enters the depositional Napa Valley, whose floodplain is dominated presently by agriculture and developed areas. Historically, an array of both ‘connected’ tributaries (i.e., tributaries with a discrete channel mouth that delivered water and sediment to the mainstem Napa River) and ‘disconnected’ tributaries (i.e., tributaries without a discrete channel mouth that flowed directly onto the mainstem floodplain) flowed into the Napa Valley (Grossinger 2012). Over the past century, widespread channelization for agricultural land establishment has resulted in the direct connection of most tributaries to the Napa River. Currently, delivery of both water and sediment from tributaries to the Napa River is regulated by the network of water supply dams installed over the past century. Most major dams (i.e., dams large enough to impound water and sediment) are located on the tributaries draining the eastern

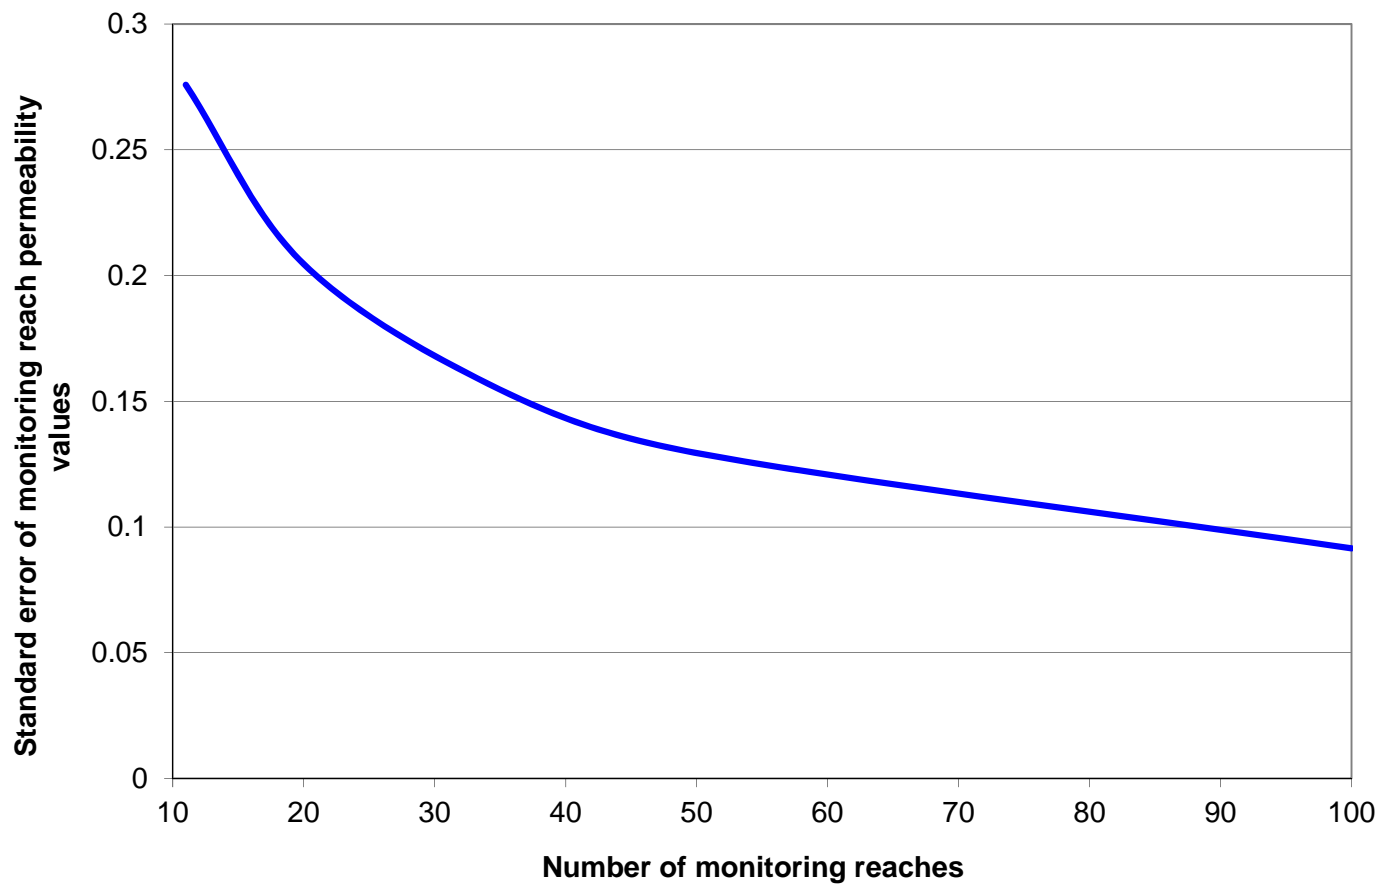
Figure 4-1. Relationship between permeability standard error and number of monitoring reaches (derived from data presented in Napolitano et al. 2009).

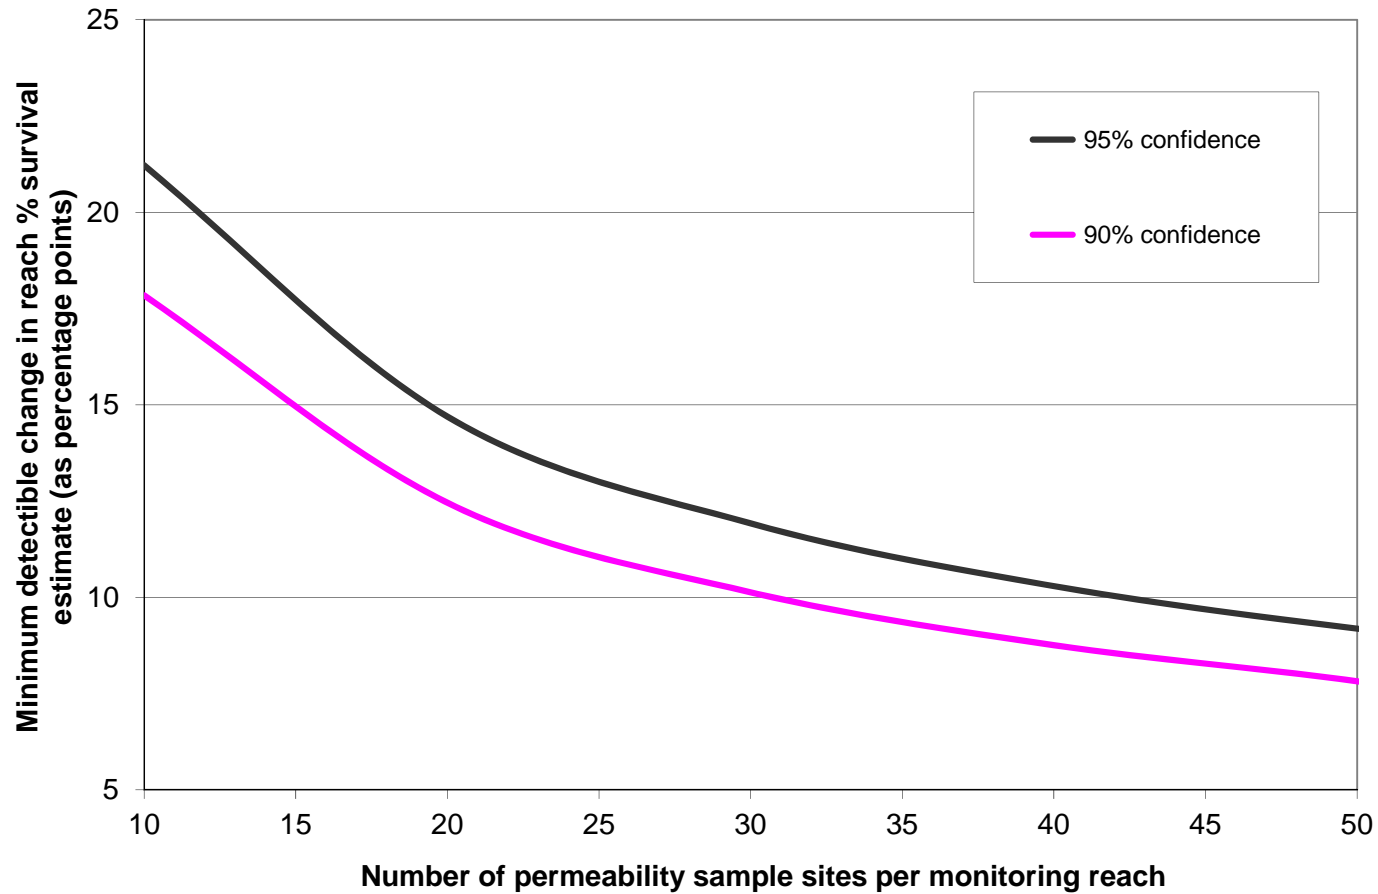
Figure 4-3. Relationship between minimum perceptible change in percent egg survival and number of permeability samples (derived from data presented in Napolitano et al. 2009).
