Napa River Spawning Gravel Study

Jonathan Koehler, Senior Biologist

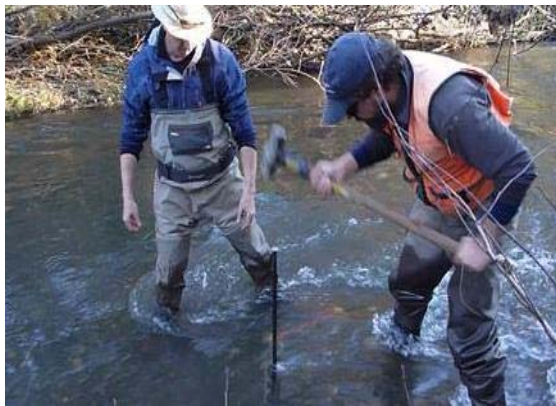
Installing a scour chain.

Streambed scour was measured at 20 sites in the mainstem Napa River during the 2012/13 water year. RCD and Stillwater staff buried 40 chains vertically in the streambed at potential spawning locations and carefully measured the exposed lengths of chain left on the surface. We then made a series of follow-up visits to recover the chains and re-measure the exposed lengths. By comparing the original exposed length to subsequent measurements, we were able to document the depth to which the bed had been scoured away or filled in. The average scour value for the entire monitoring effort was 5.2 cm (2 inches) with a standard error of 3.7 cm (1.5 inches). Assuming that the measurements from the recovered chains are representative of all sites, the mean depth of scour/deposition achieved the TMDL target.

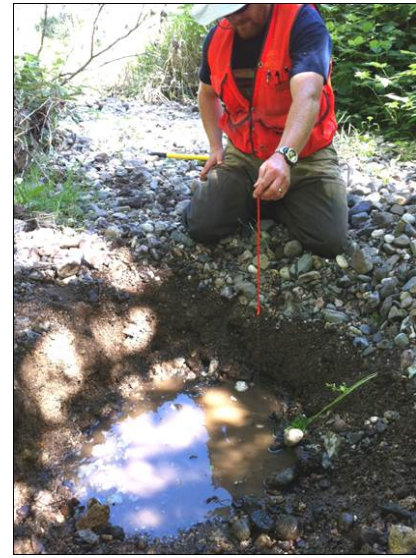
Recovering a buried scour chain from the river.

The primary challenge encountered during the pilot monitoring effort was the low number of recovered scour chains: only 21 of 40 chains were recovered, despite extensive searching. The low recovery rate was likely caused by high flow conditions during the study. A series of large storms occurred in fall 2012 with peak flows on November 30 and December 23 shortly after we installed the chains. These flows were similar in magnitude - both were approximately 5-year storm events. The TMDL, however, specifies that scour targets are applicable for 2-year storm events and less. Therefore, RCD is re-installing chains at the same sites in the river again this winter in hopes of measuring scour during a more "normal" flow year for comparison.
