NAPA RIVER RUTHERFORD REACH RESTORATION PROJECT ANNUAL MONITORING REPORT - 2019

Reach 8, May 2019

Napa County Flood Control and Water Conservation District
804 First Street
Napa, California, 94559
Contact: Jeremy Sarrow
(707) 259-8204

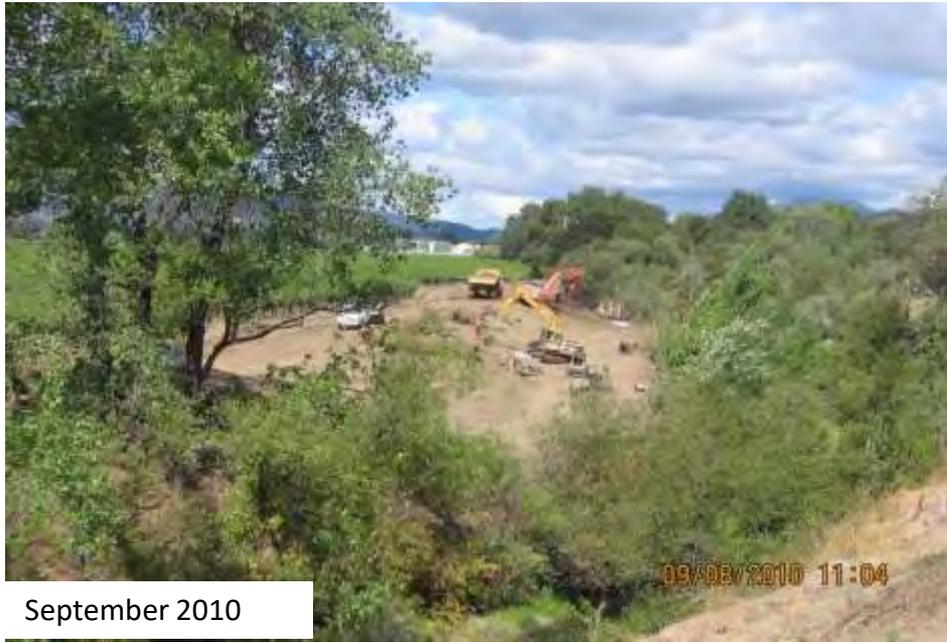
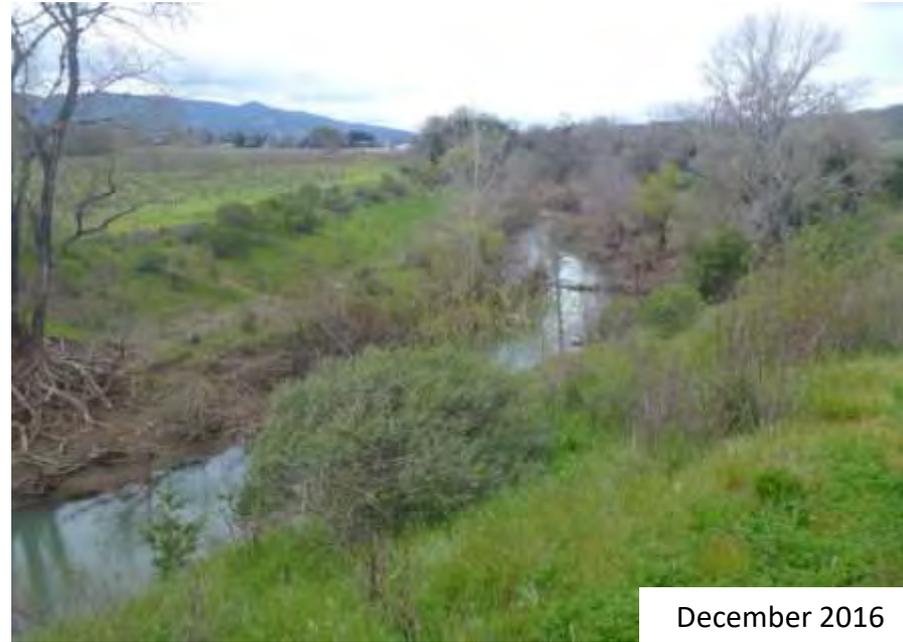
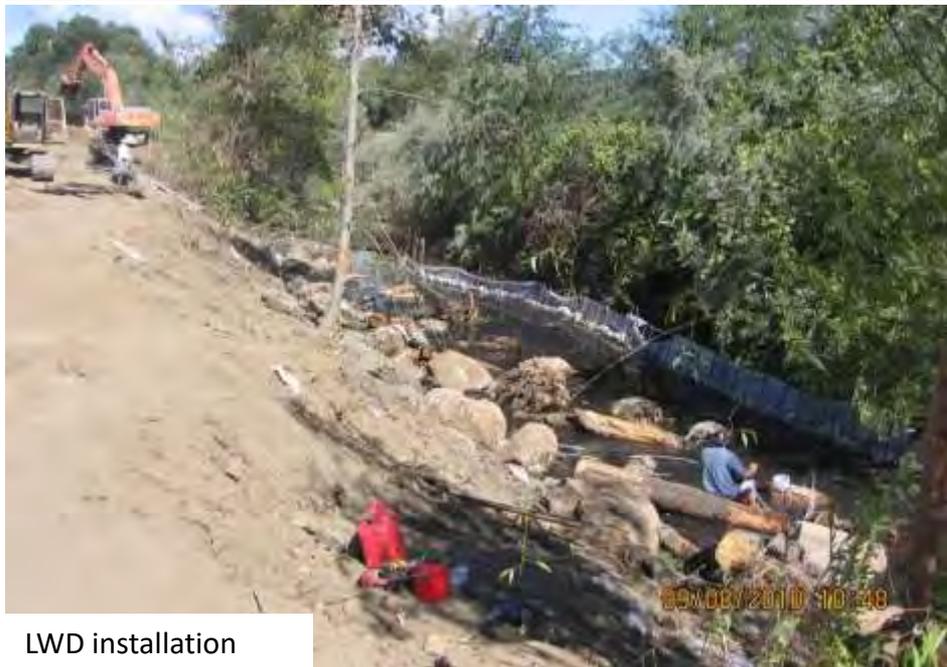
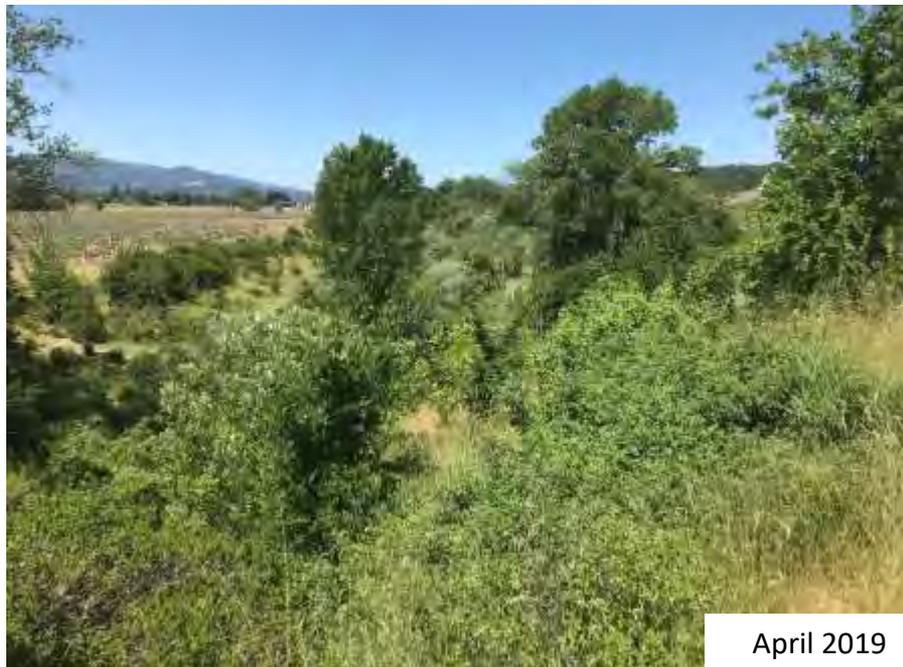
River Station 191+00
Frog's Leap Bench from Quintessa Road, East Bank

LWD installation
