Napa River Sediment Reduction and Habitat Enhancement Plan: Oakville to Oak Knoll

April 2011

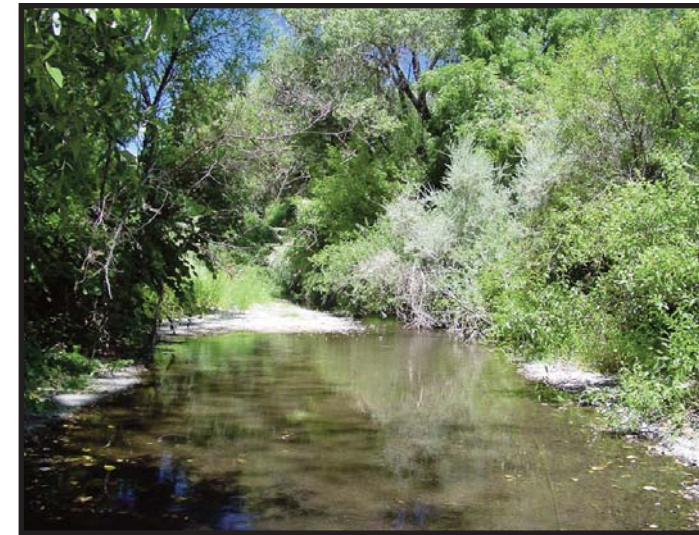
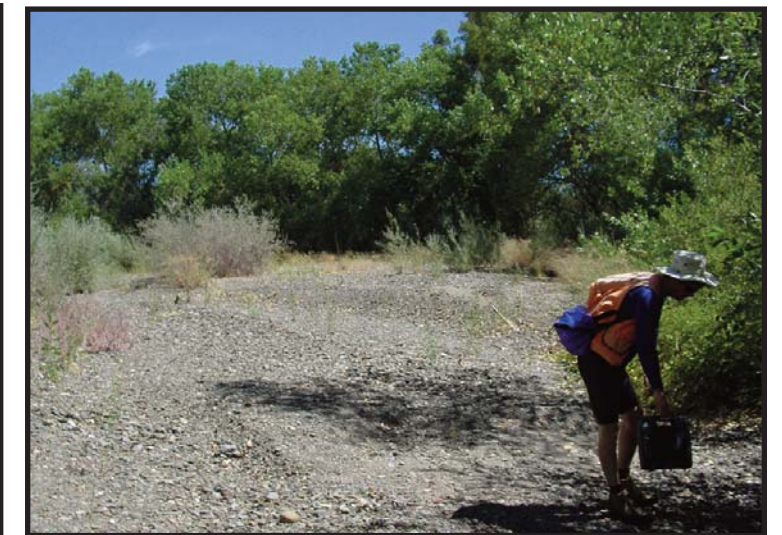
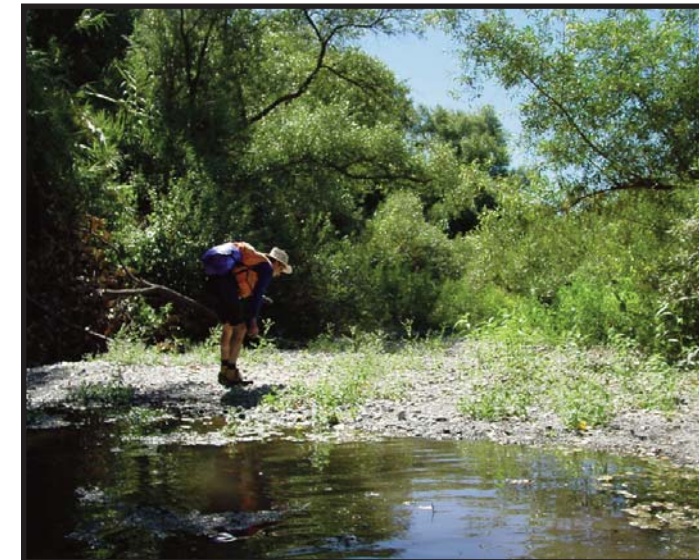
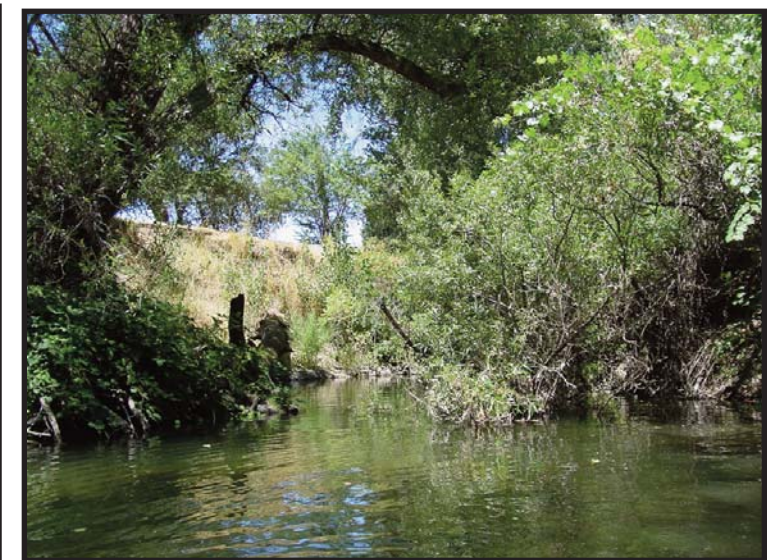
These images show the relatively abundant gravel bar and secondary channel features in Reach 10, alongside some of the steep banks typical of outside bends.

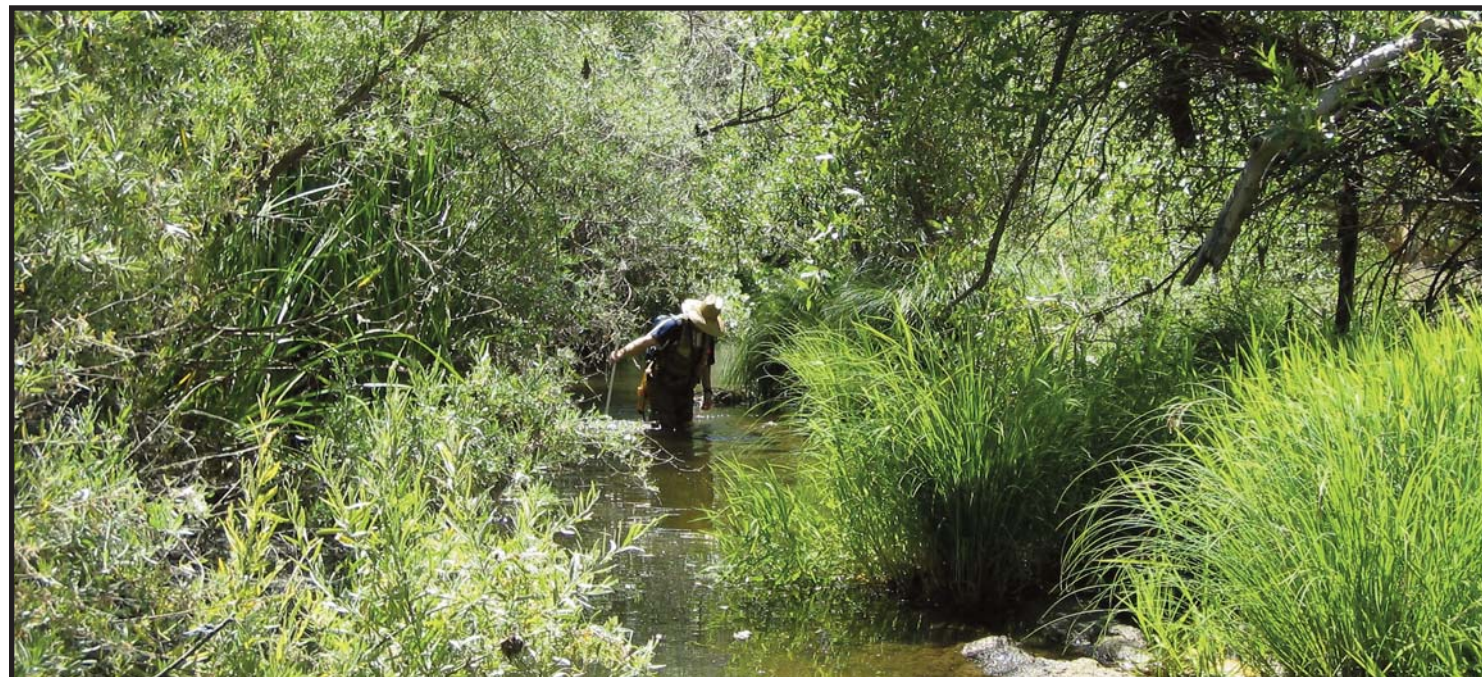
THIS PHOTO SHOWS A SIDE CHANNEL WITH AN ALCOVE OF HIGH HABITAT QUALITY FOR YOUNG SALMON.

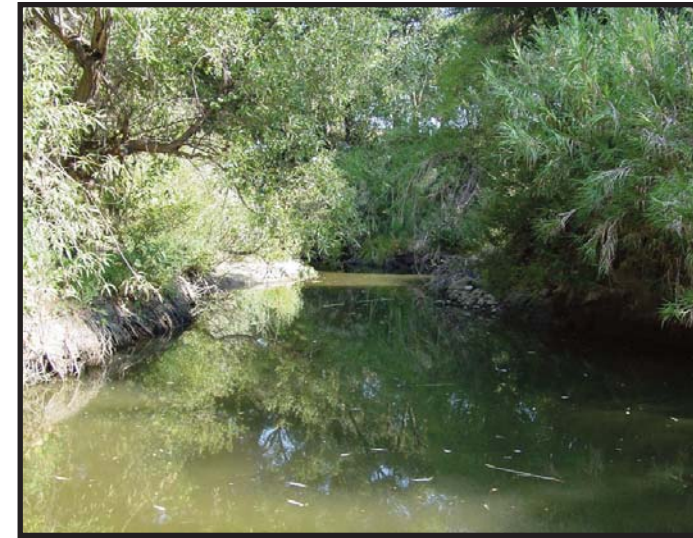
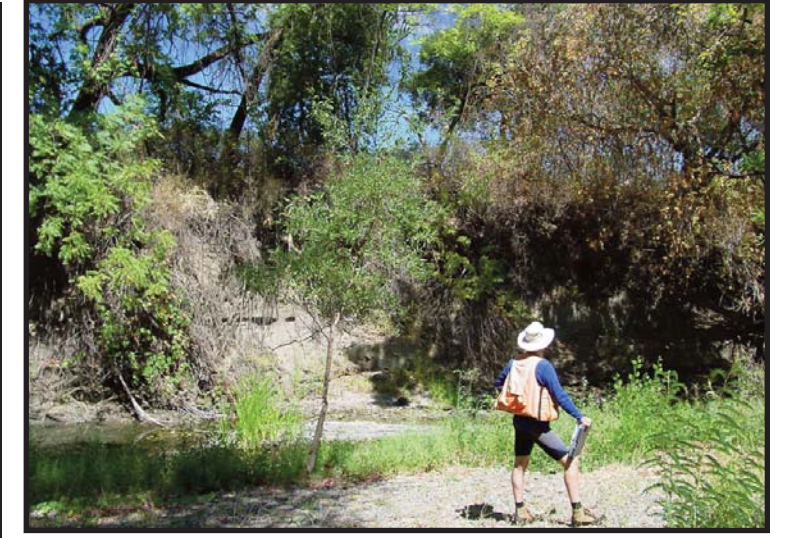
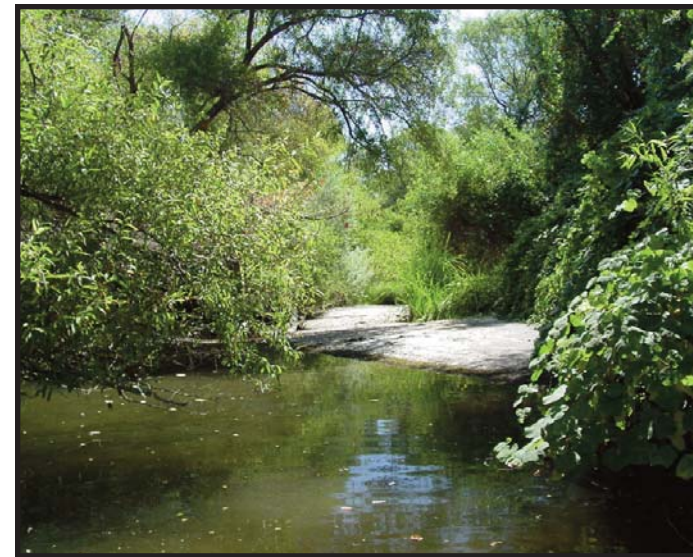
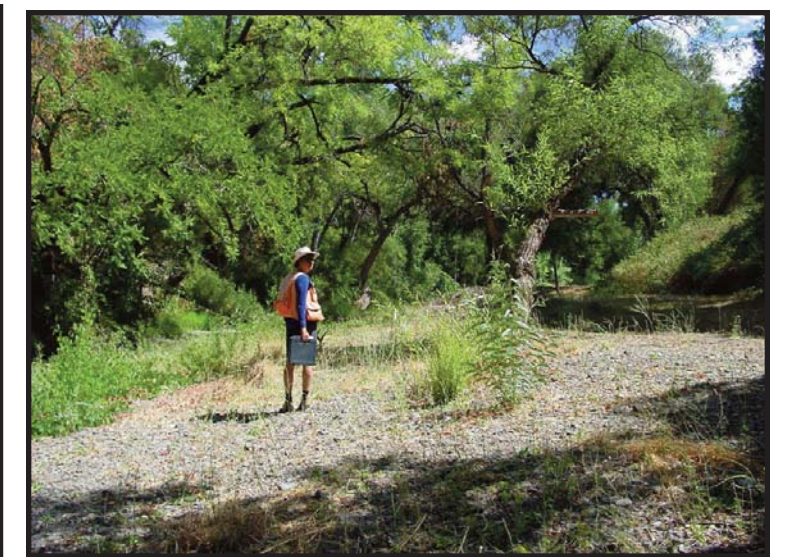
These images of Reach 9 capture the combination of deep, entrenched conditions with unstable banks (upper) interspersed with pockets that contain spawning gravel bars and small floodplains (lower).

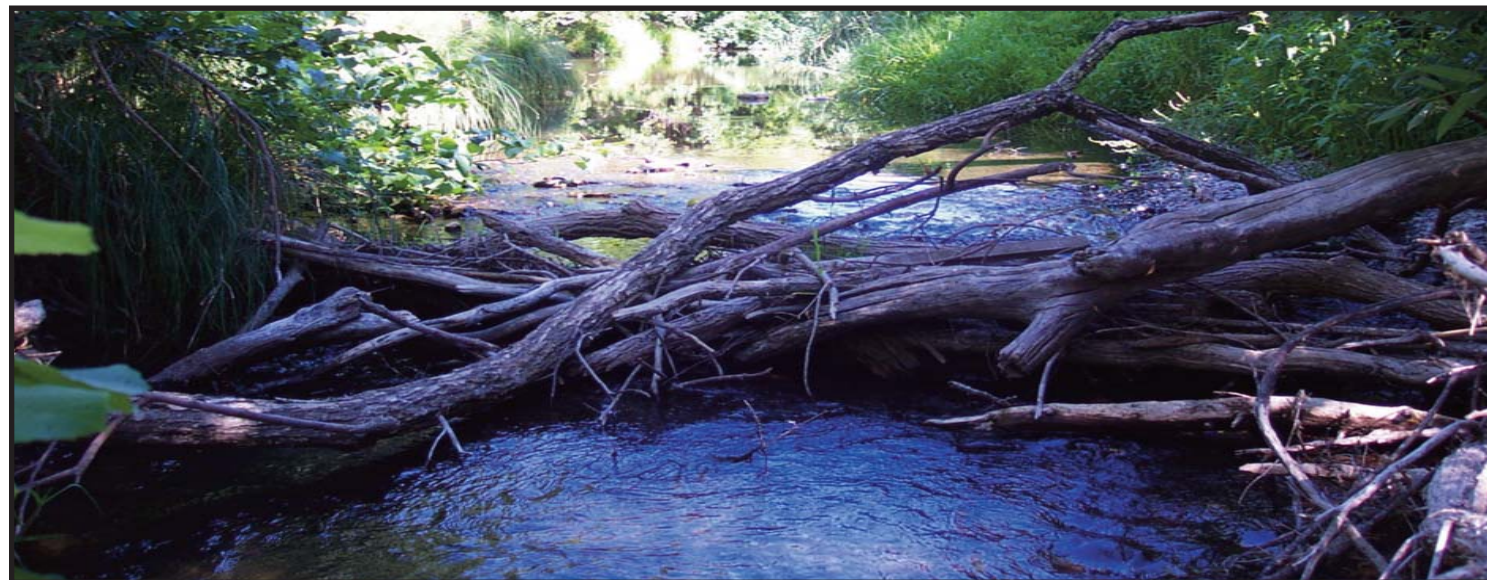
BURIED LARGE WOOD CREATES SCOUR AND UNDERCUT BANK - A HIGH QUALITY HABITAT.

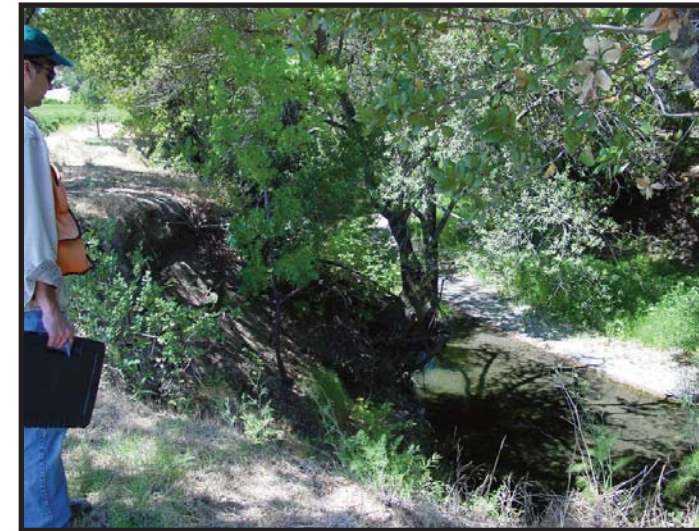
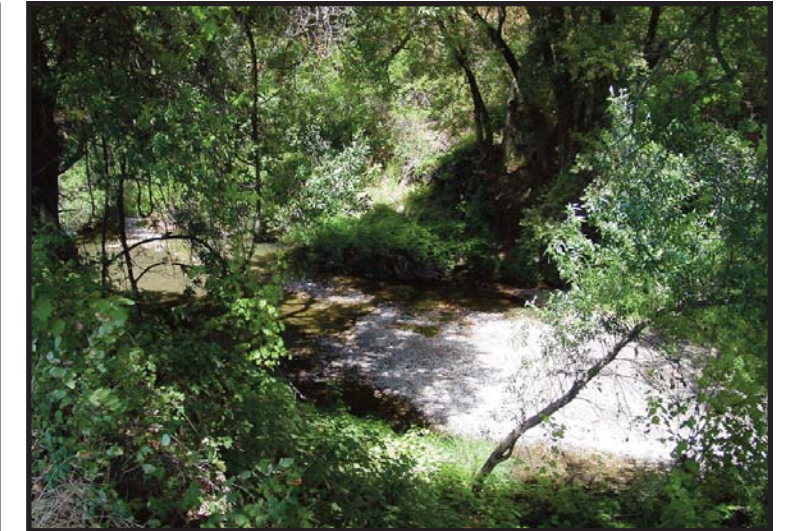
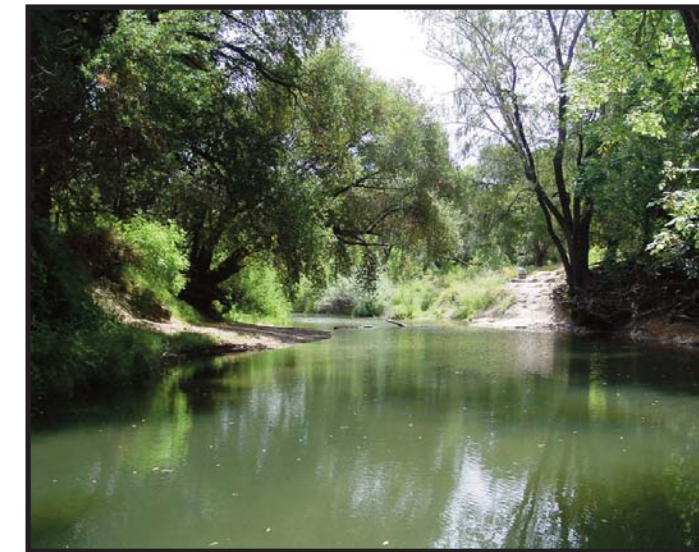
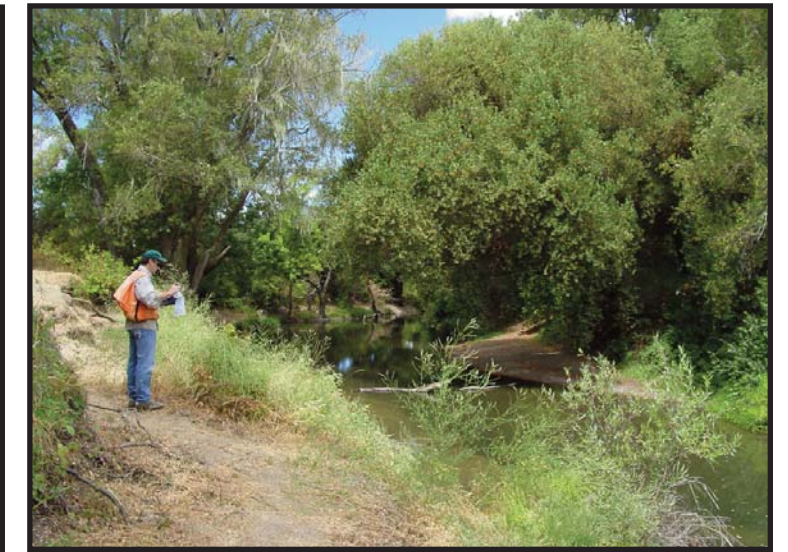
Shields stress analysis shows most of this reach has partial scour where the upper few inches of spawning gravel are eroded, and medium strength unvegetated bank material may start to erode. This level of erosion will cause some erosion of redds, and some loss of eggs. Several areas show full scour where the gravel beds will fully mobilize, destroying all redds. Moderate to resistant unvegetated banks will experience erosion. After these flows gravel may reform bed features.

Upstream Reach 8 is deeply entrenched with failing banks and long, continuous pools (upper images and lower left image). Downstream the channel widens and the banks become lower in the Napa River Ecological Reserve in Yountville, (lower right image).

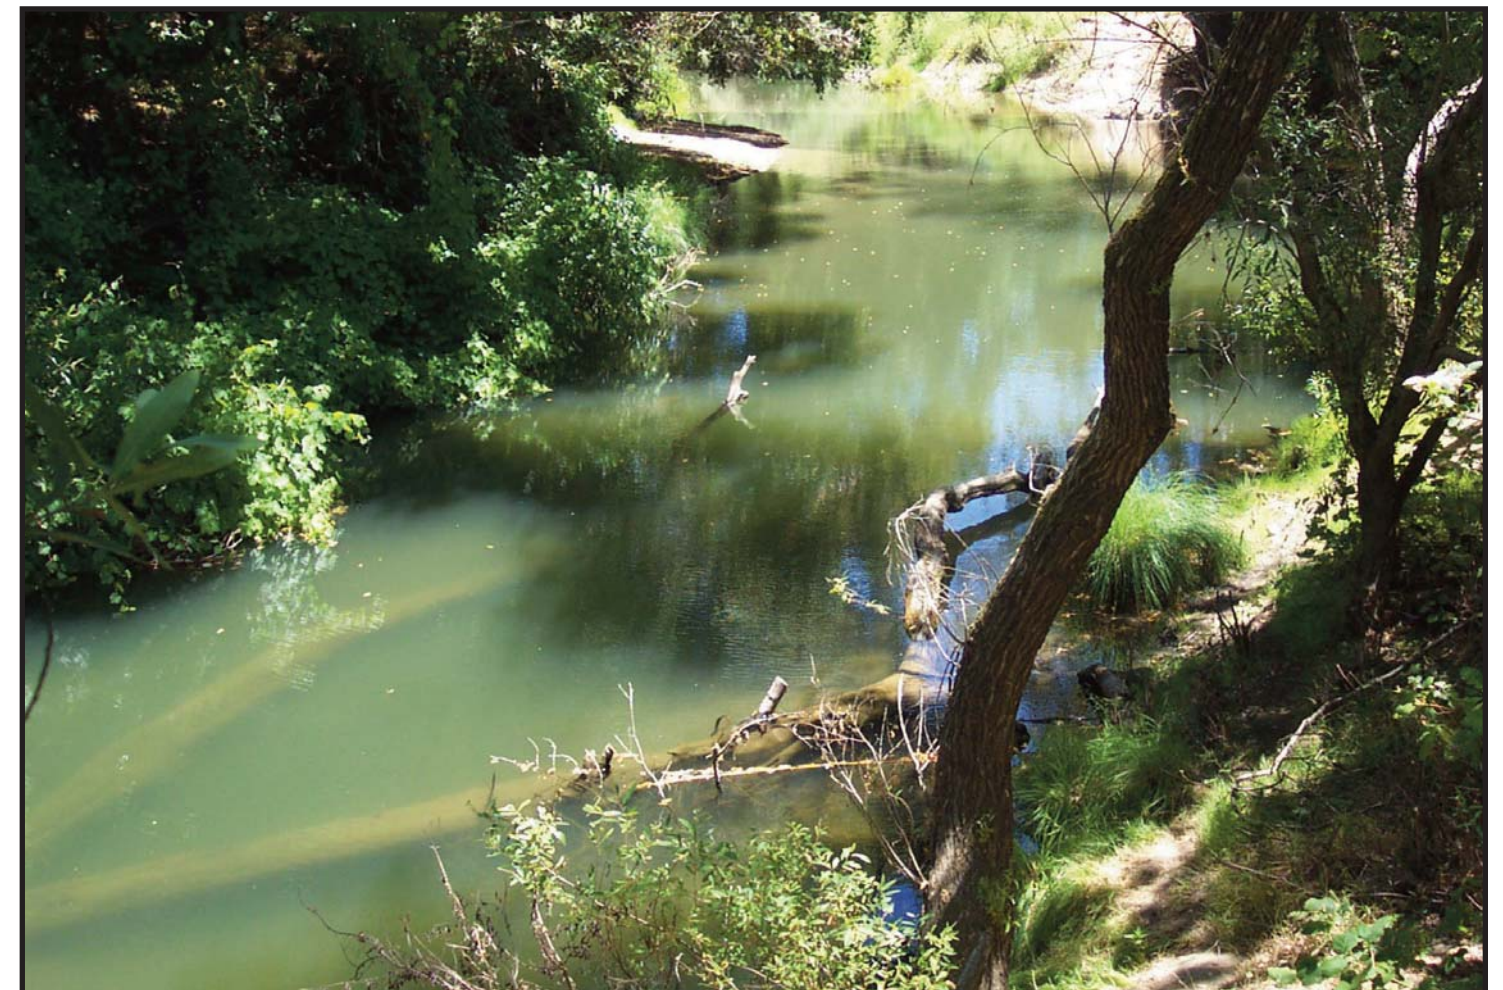
A LONG DEEP POOL UPSTREAM OF THE NAPA RIVER ECOLOGICAL RESERVE. THIS AREA HAS A LOW HABITAT VALUE FOR SALMON.

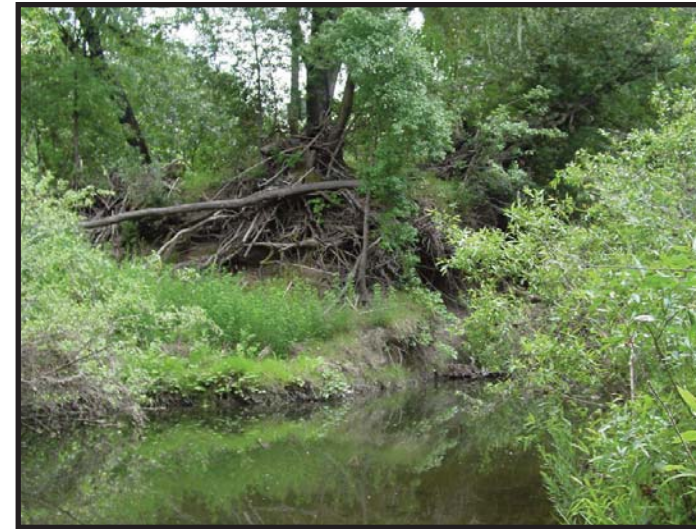
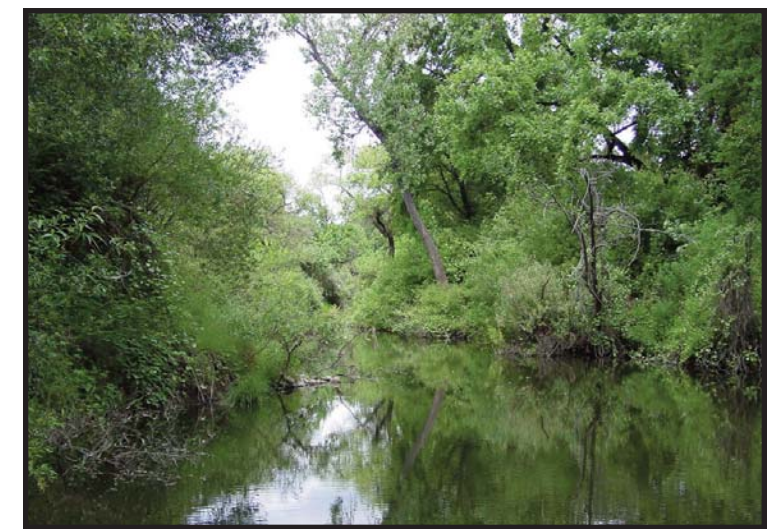
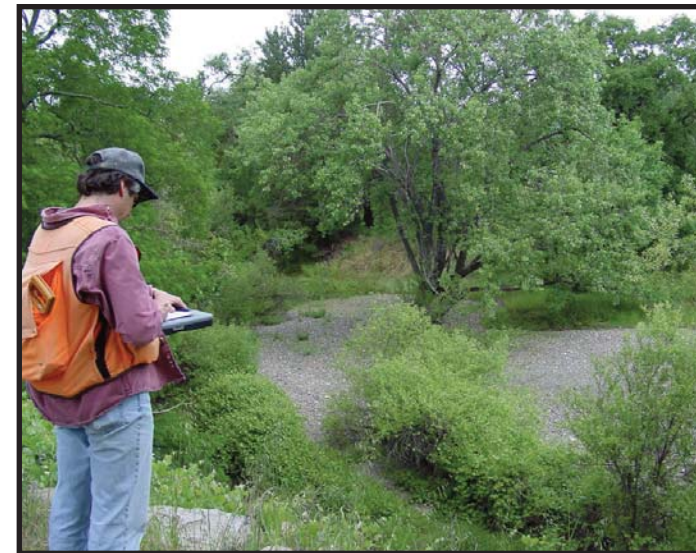
The Shield's stress analysis shows areas with selective scour where a thin layer of spawning gravel or weaker unvegetated bank material may be eroded. Shallow redds may experience some scour, but occasional turnover of material can also be beneficial to promote cleaning of fines from the redds. Partial scour areas are the most common where the upper few inches of spawning gravel are eroded, and medium strength unvegetated bank material may start to erode. This level of erosion will cause some

Reach 7 is characterized by confined upper sections with deep glides and eroding banks, with pockets of gravel and floodplain increasing downstream. Many of the banks are armored with riprap.

erosion of redds, and some loss of eggs. One area has full scour where gravel beds will fully mobilize, destroying all redds. Moderate to resistant unvegetated banks will experience erosion. After these flows gravel may reform bed features.

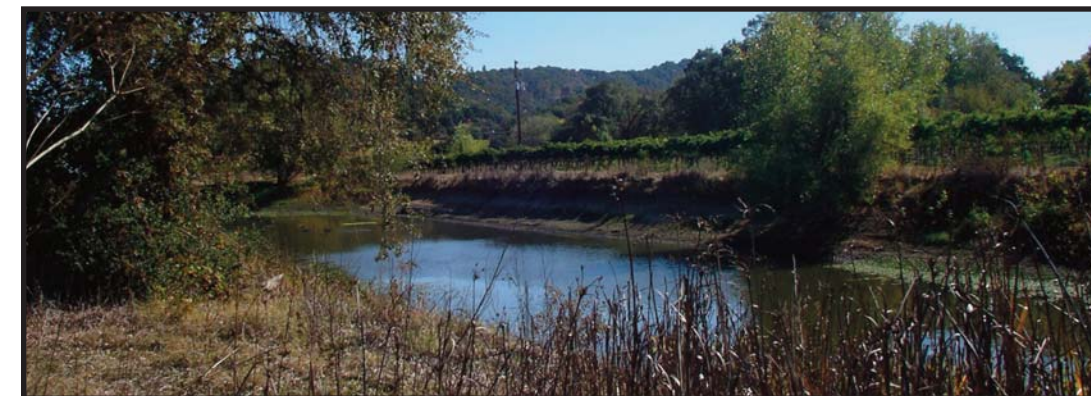
THE OLD RIVER CHANNEL THAT PARALLELS REACH 7 WAS CHANGED INTO A SERIES OF RESERVOIRS IN ITS DOWNSTREAM AREA.

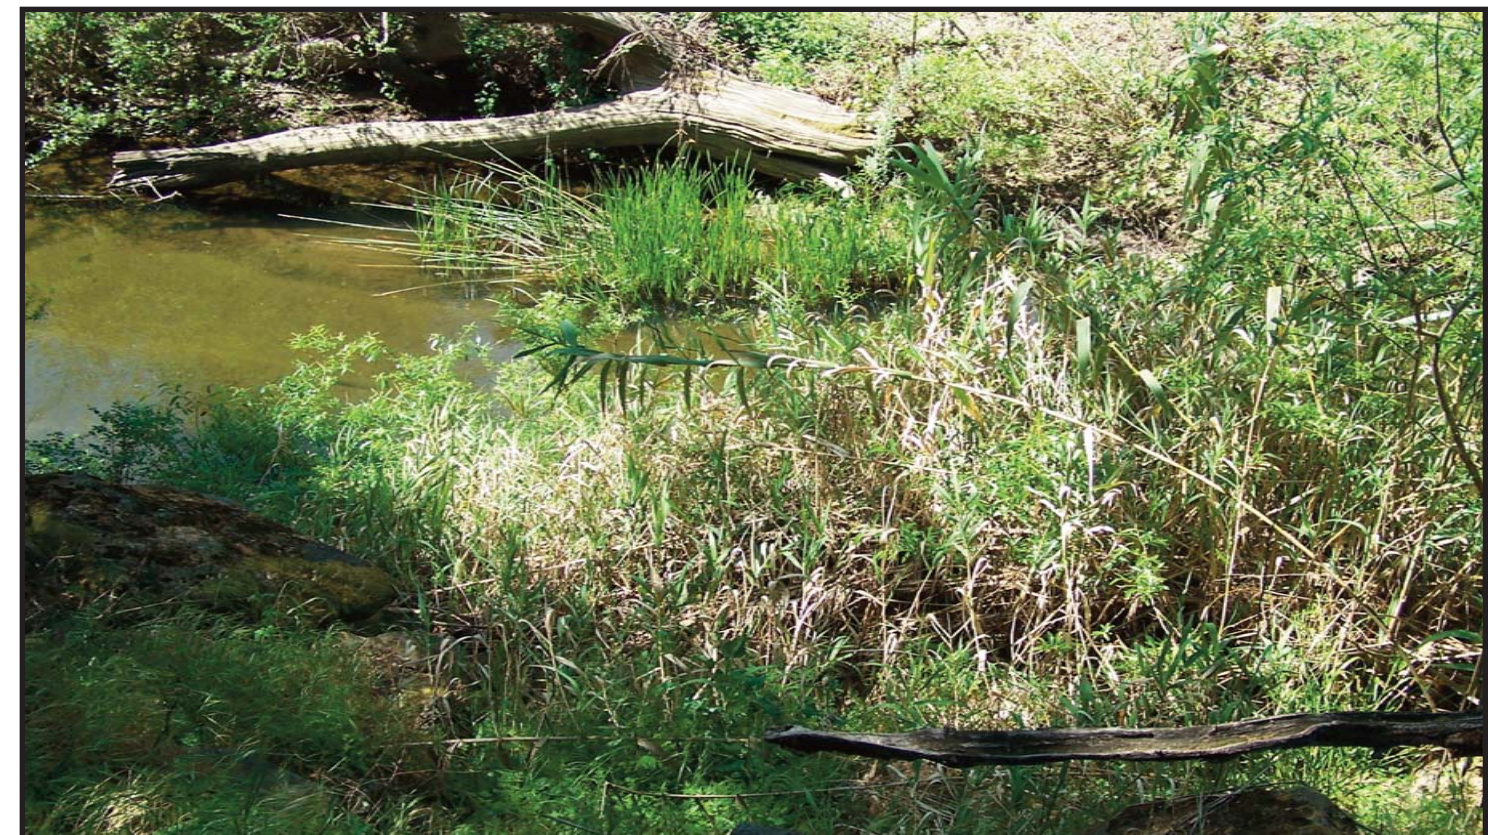
ARUNDO DONAX IN REACH 7

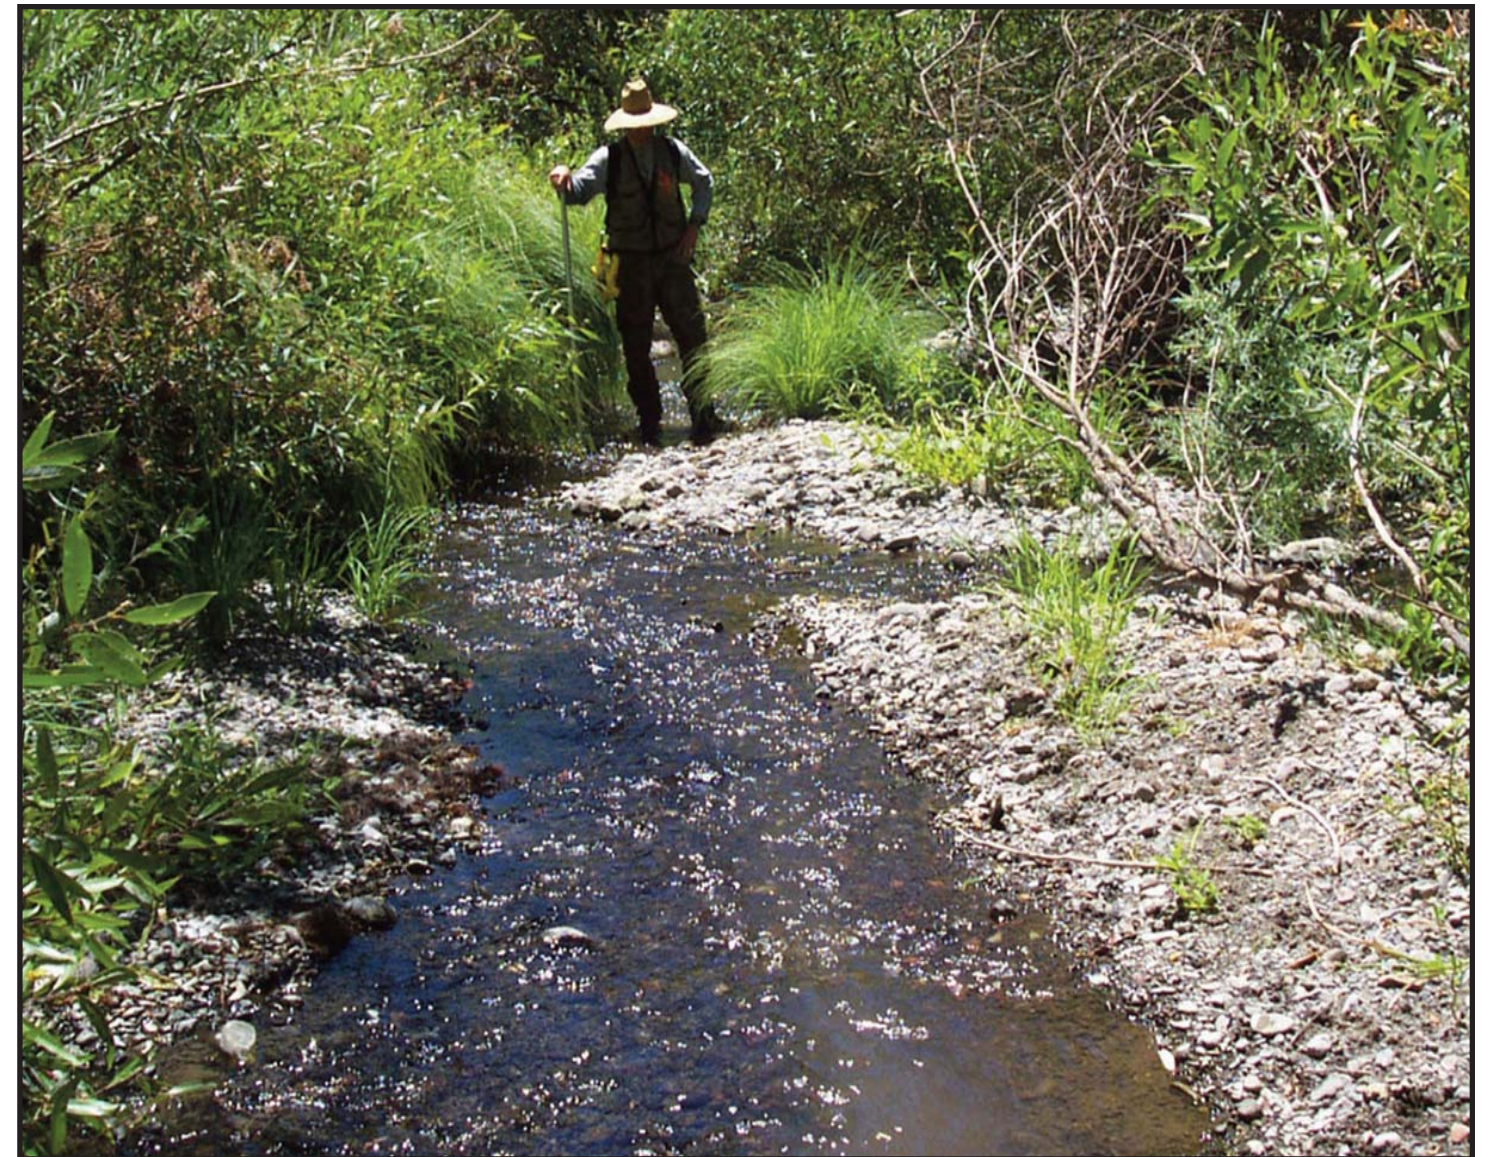
HIGH QUALITY SPAWNING RIFFLE IN REACH 7.

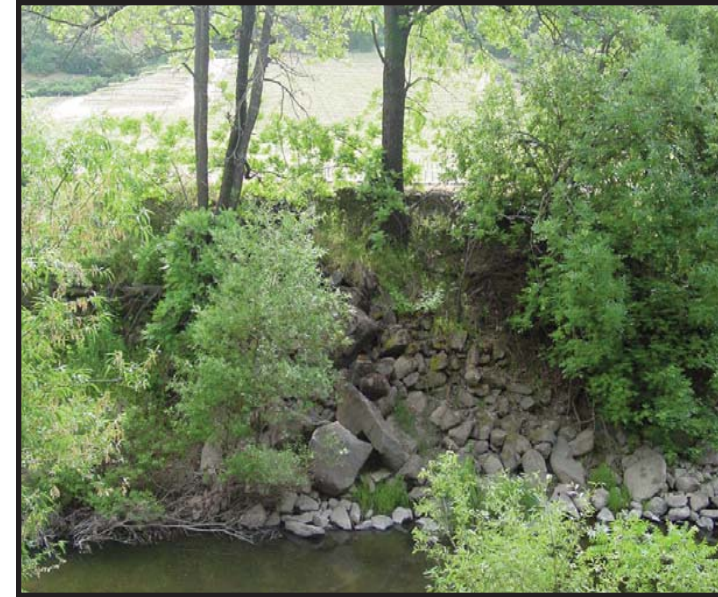
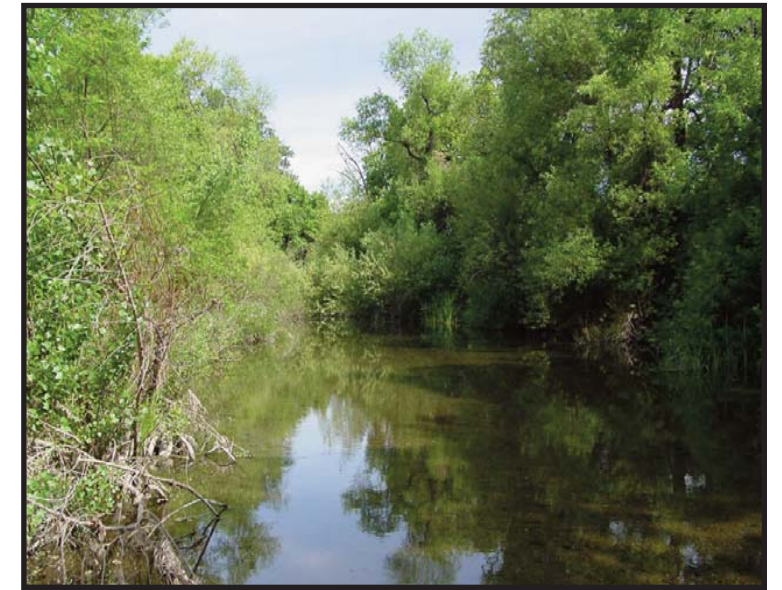
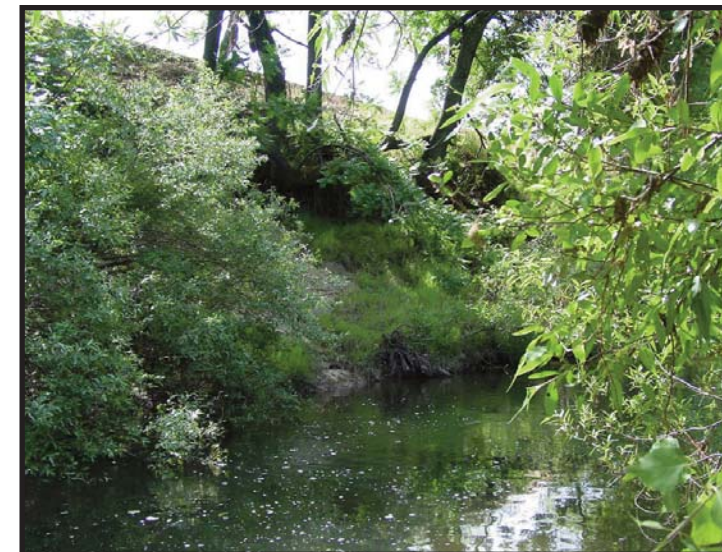
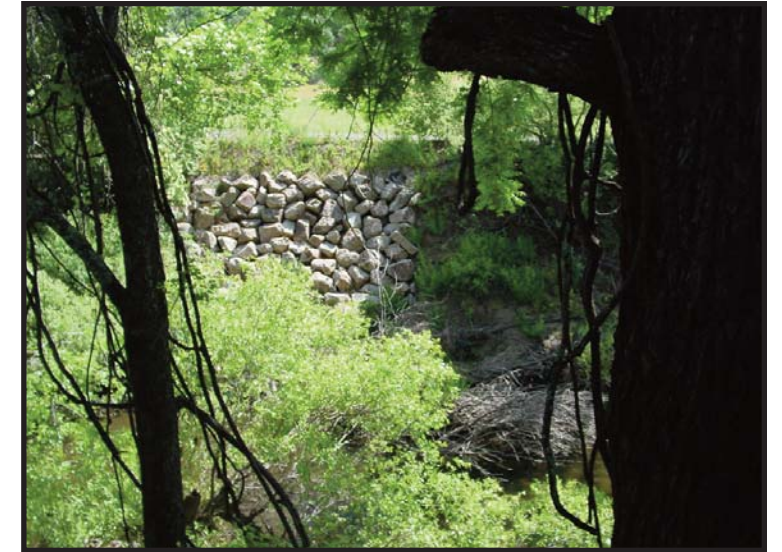
Continuous glides, steep eroding banks and hard bank protection are common in Reach 6.

Reach 6 is one of the most confined reaches in the project area, with relatively homogeneous conditions and few geomorphic features that support good salmonid habitat (e.g. gravel bars, secondary channels, floodplain sections). The reach is bounded on the east bank and parts of the west bank by a levee at the top of a steep bank. The bank is actively eroding in many areas, and has been protected by rip rap in others. Most of the reach is a series of long pools with little riffle-pool habitat. In several areas the channel has eroded down to a layer of resistant cohesive substrate.

The Shields stress analysis shows partial scour for most of this reach where the upper few inches of spawning gravel are eroded, and medium strength unvegetated bank material may start to erode. This level of erosion will cause some erosion of redds, and some loss of eggs.

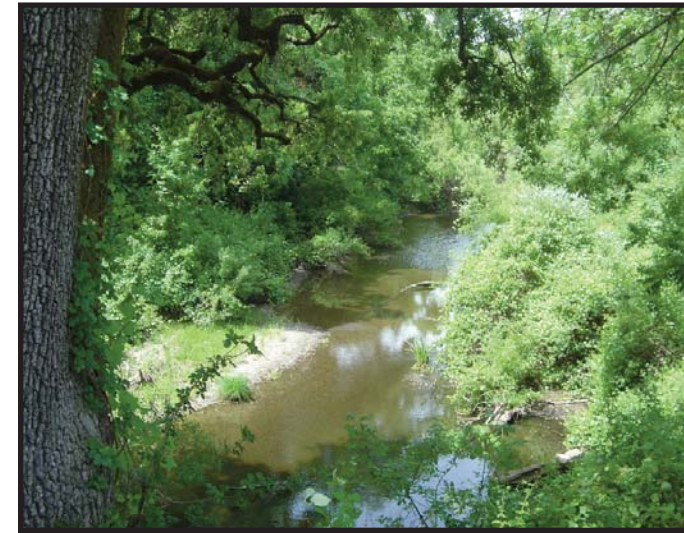
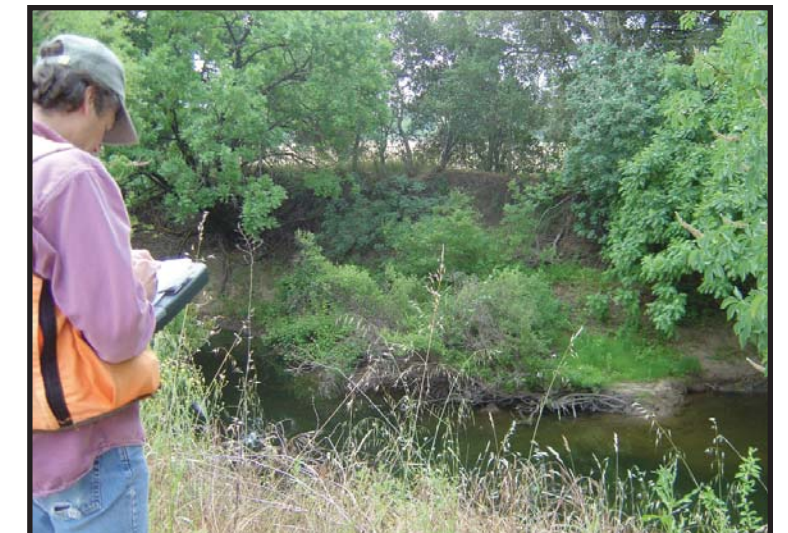
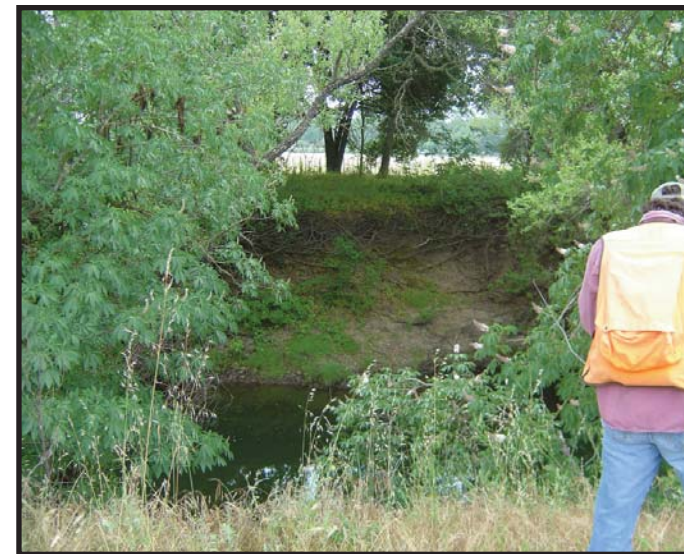
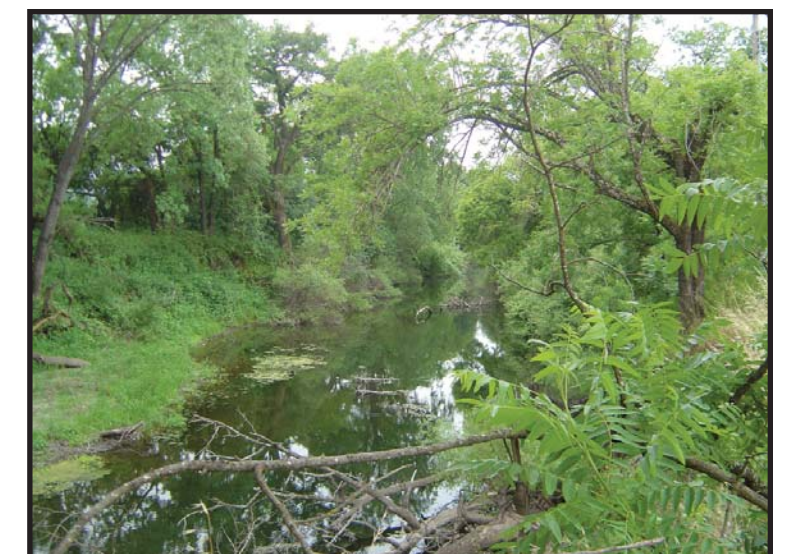
Images show wider conditions at the upper and lower ends of the reach, with upper right and lower left images typical of the more entrenched and eroding middle section.

Reach 4 is the most entrenched reach in the project area with an average w:d of 4.9. Most of the reach is one single pool, though there is a small area of riffle-pool habitat at the upstream end. Incision has exposed a resistant, cohesive substrate in many sections.

The Shields stress analysis shows full scour for much of the reach where gravel beds will fully mobilize, destroying all redds. Moderate to resistant unvegetated banks will experience erosion. After these flows gravel may reform bed features. One area has partial scour where the upper few inches of spawning gravel are eroded, and medium strength unvegetated bank material may start to erode. This level of erosion will cause some erosion of redds, and some loss of eggs.

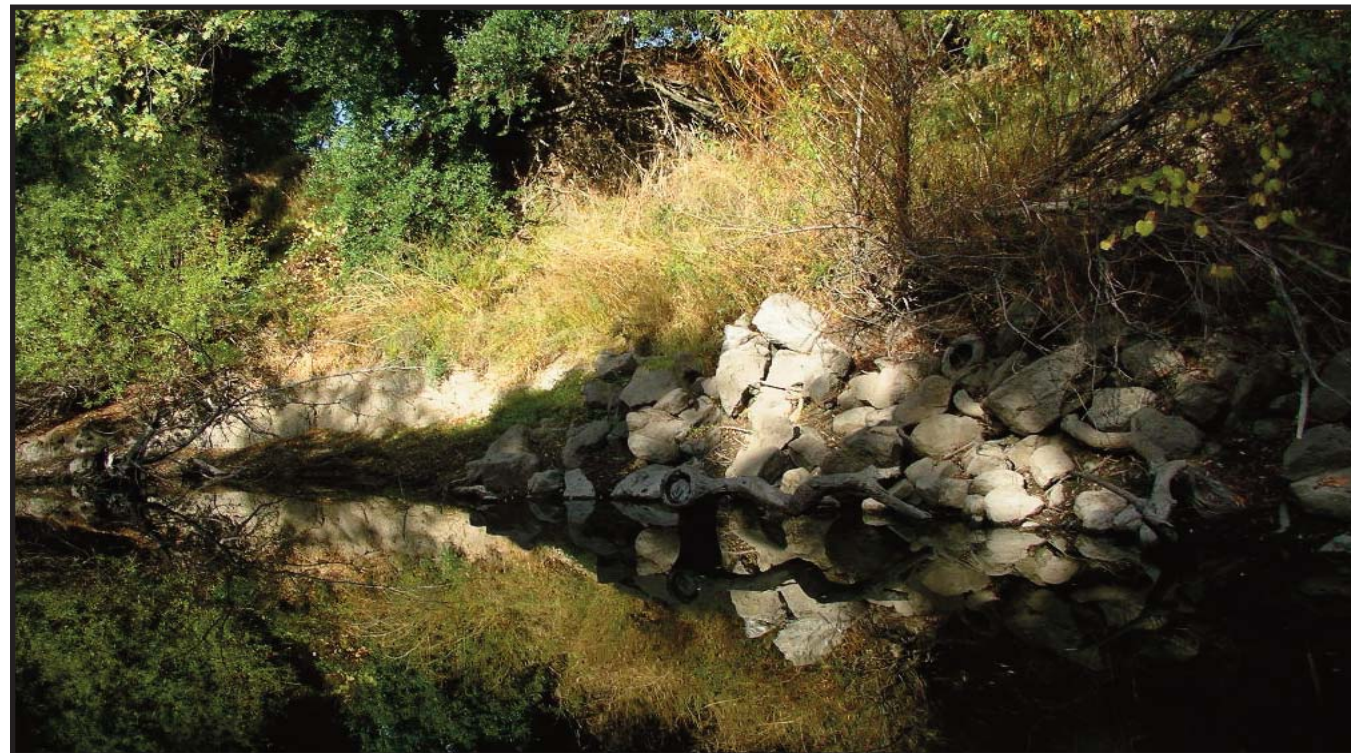
MOST OF REACH 4 IS A LONG POOL/GLIDE SEQUENCE OF LIMITED VALUE TO SALMON.

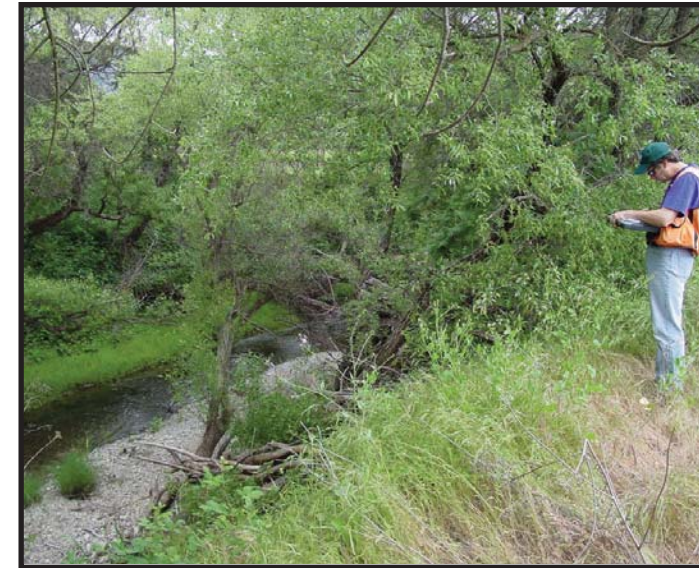
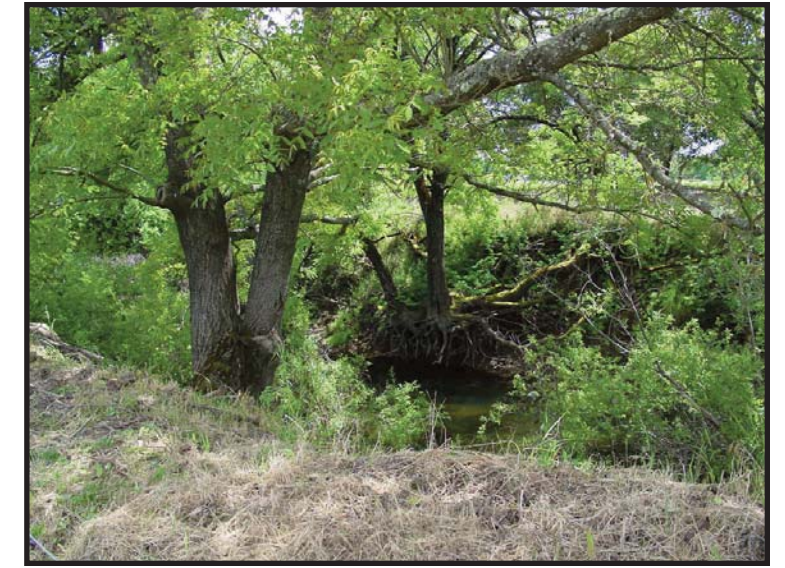
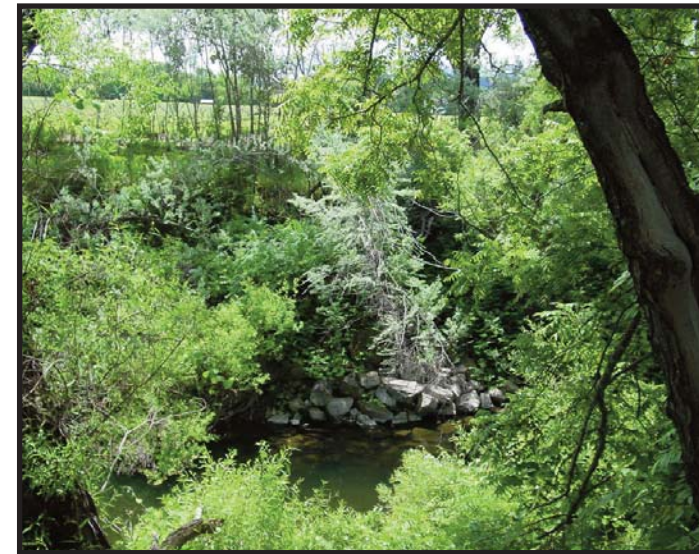
These images show the combination of steep, eroding banks with relatively good in-channel gravel and vegetation cover that is typical of Reach 3

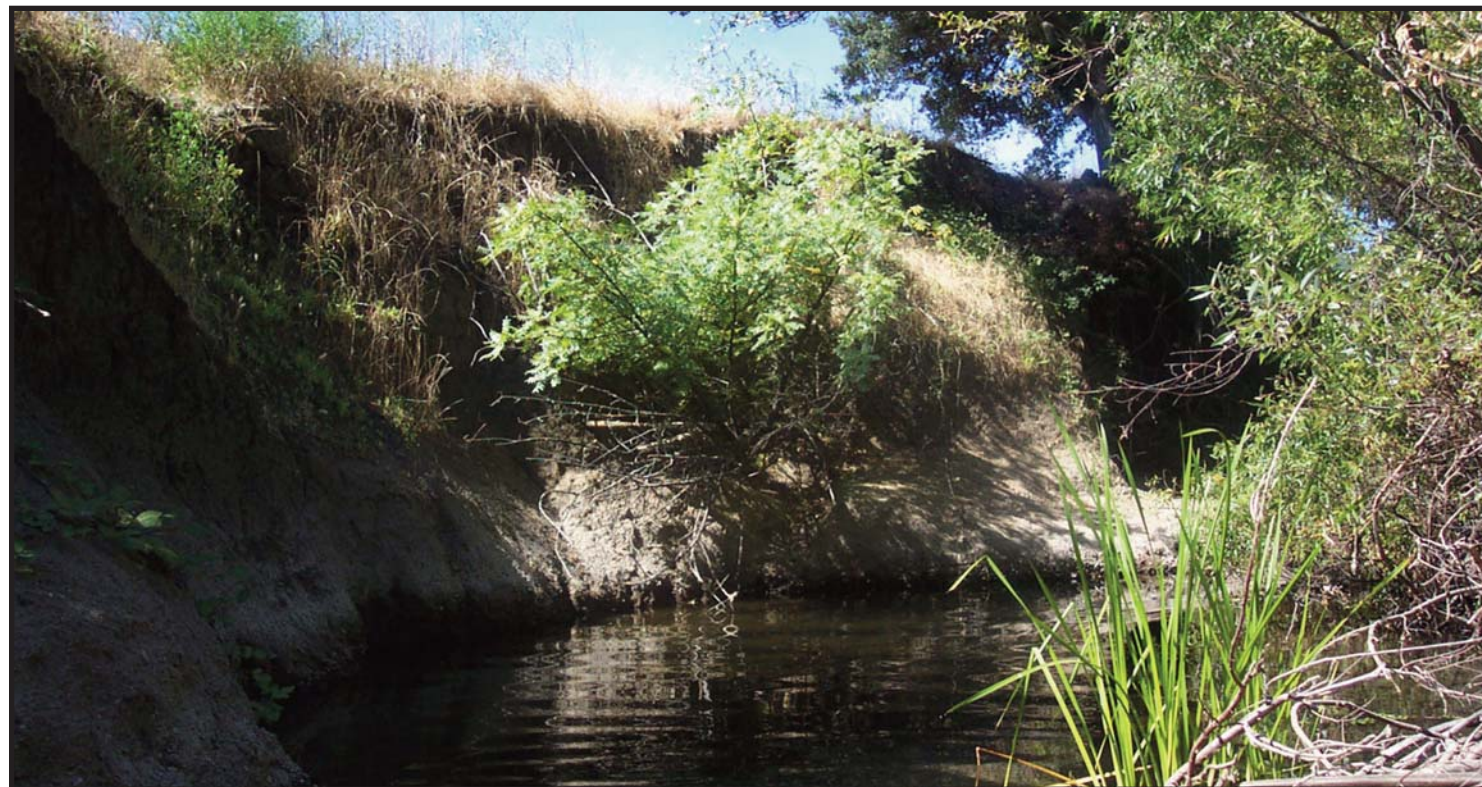
HIGH QUALITY SPAWNING RIFFLES WERE MORE ABUNDANT IN REACH 3A THAN OTHER REACHES. 71

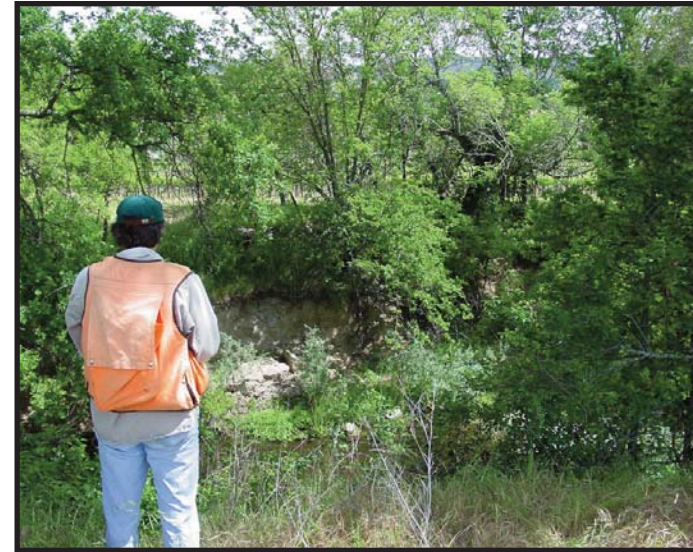
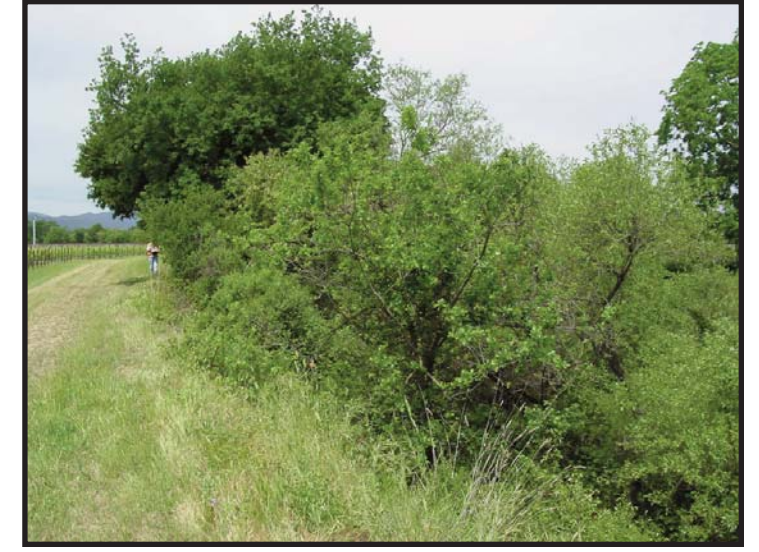
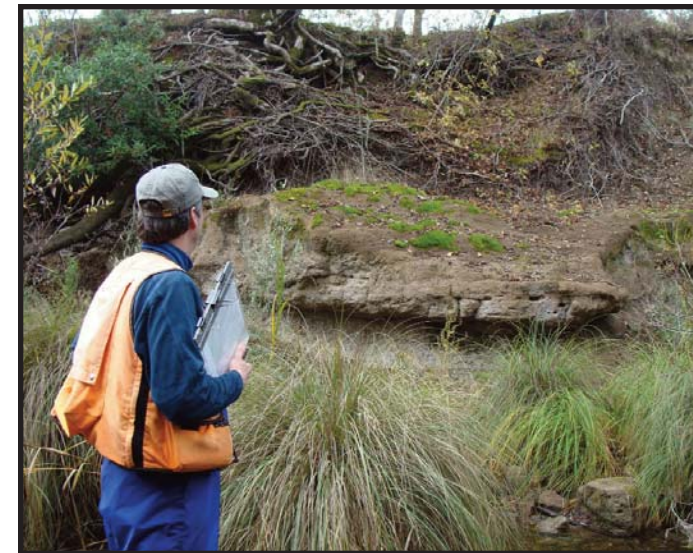
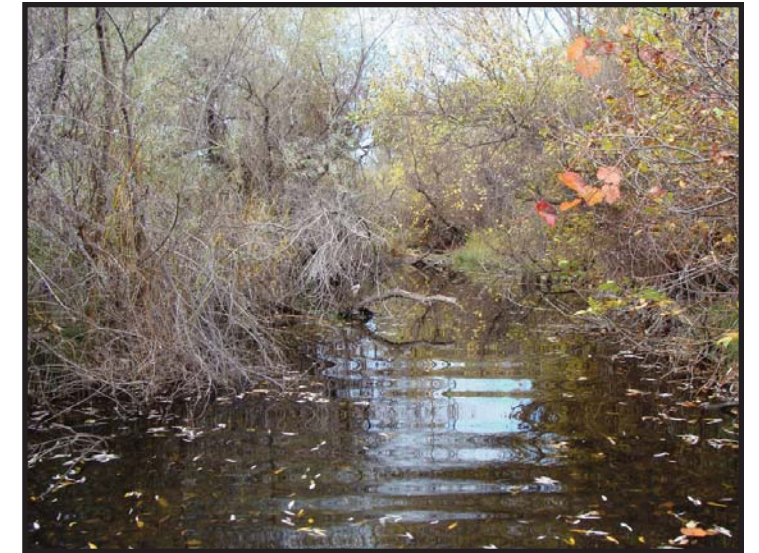
These images show the steep banks and relatively sparse riparian corridor typical of Reach 2.

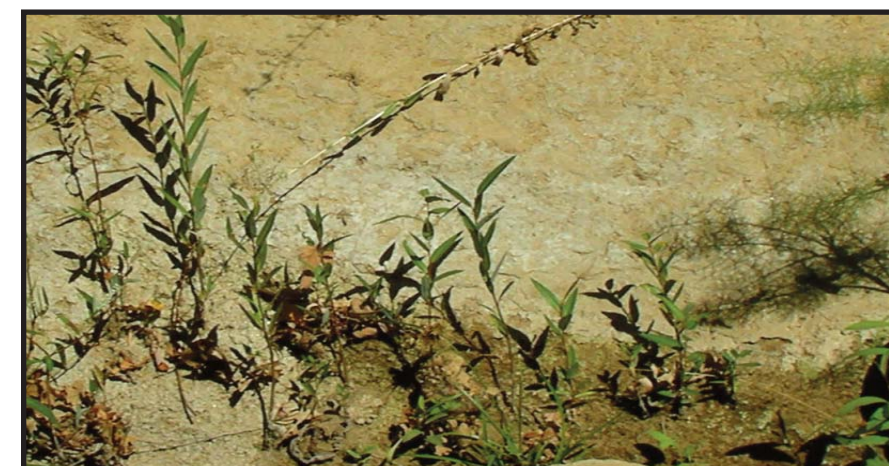
SEEDLING WILLOWS HAVE LIMITED GROWTH IN RESISTANT CLAY LAYER.
