Napa River Sediment Reduction and Habitat Enhancement Plan: Oakville to Oak Knoll

April 2011

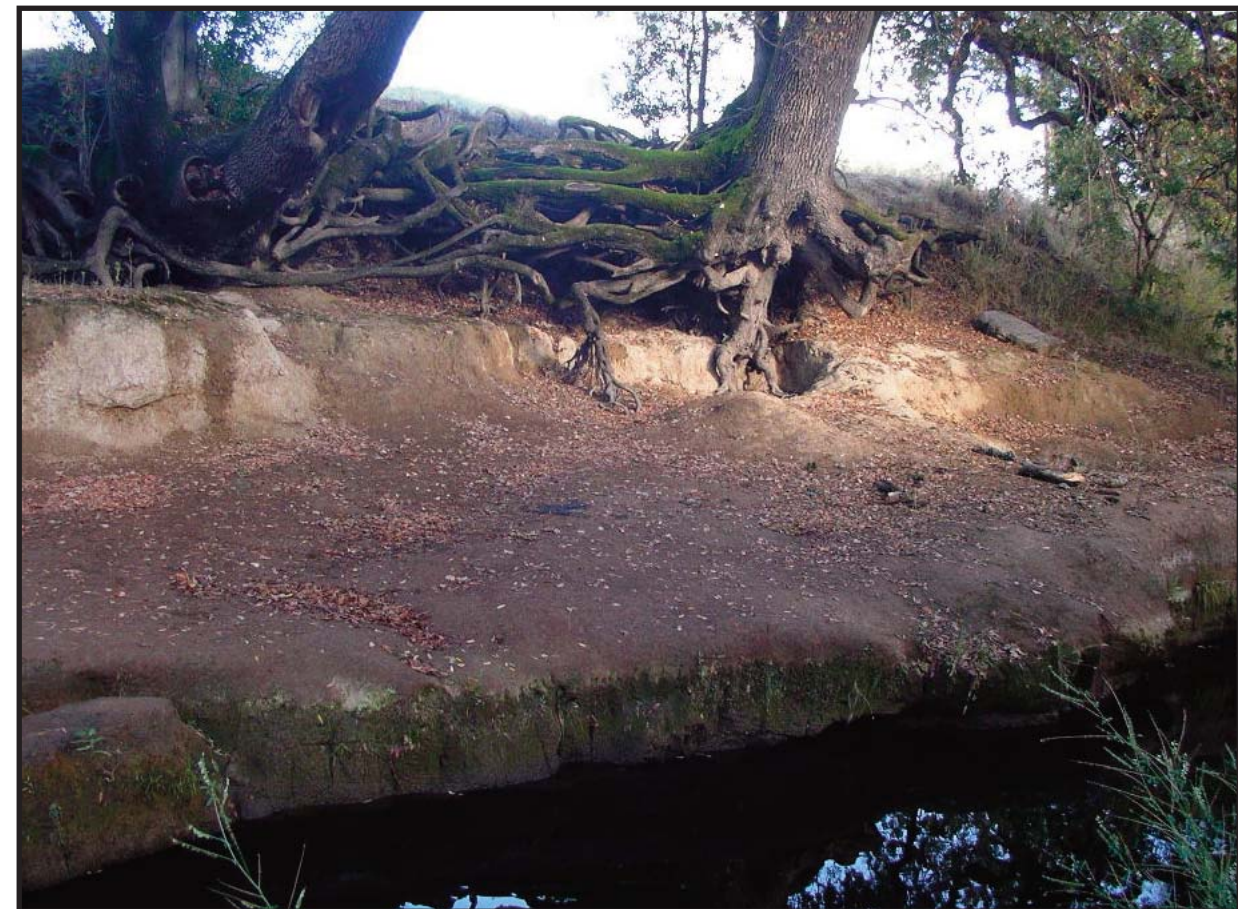
A RESISTANT CLAY LAYER DOMINATES THE CHANNEL IN REACH 2 AND ELIMINATES SEEDLING GERMINATION.

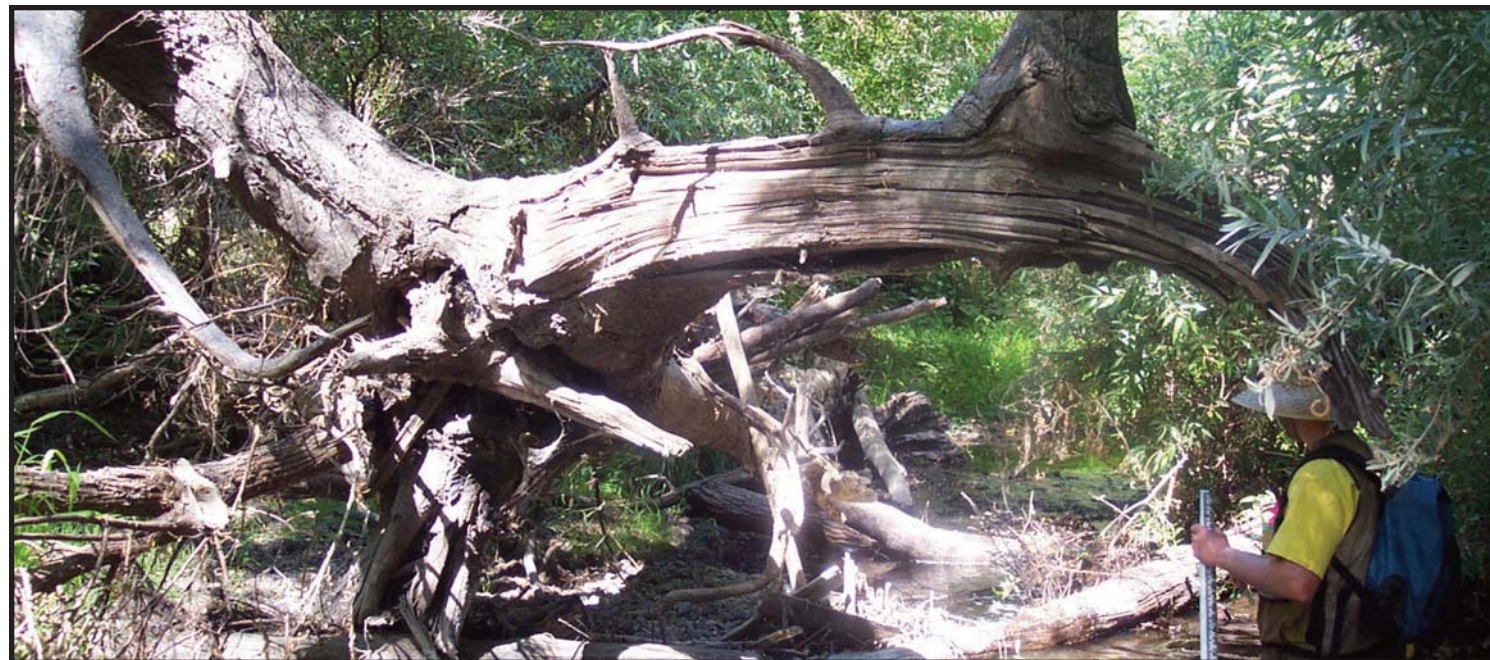
REACH 2 IS DOMINATED BY A RESISTANT CLAY ON THE CHANNEL AND BANKS REDUCING SPAWNING AREAS.

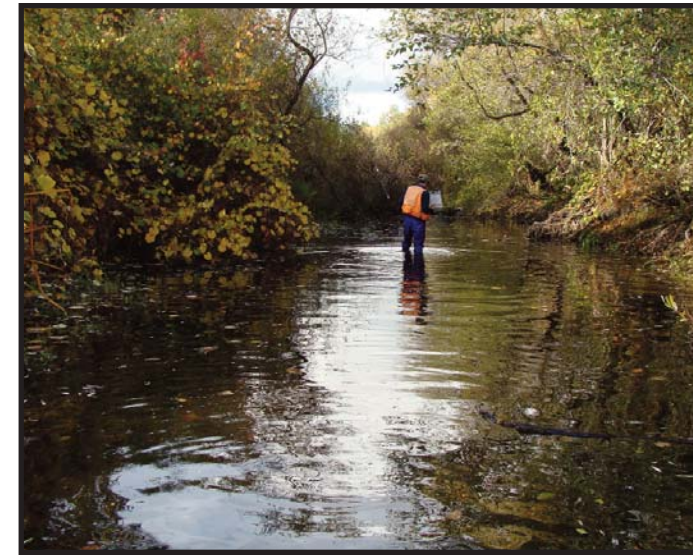
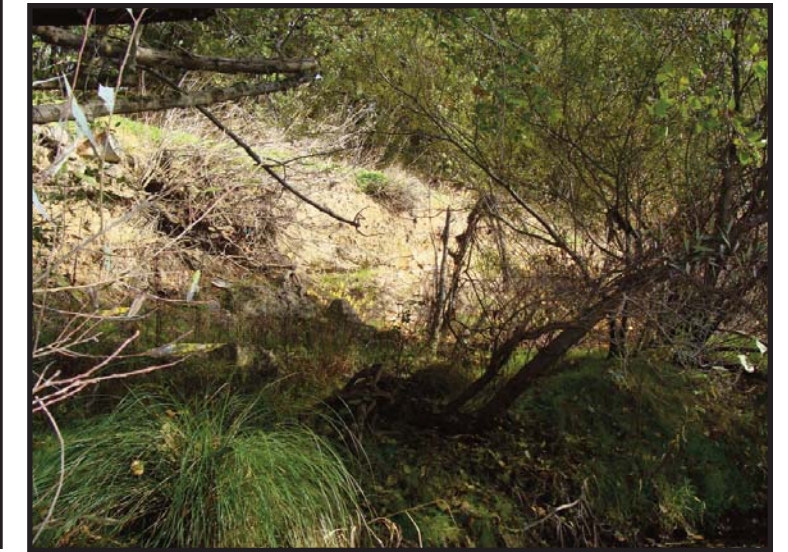
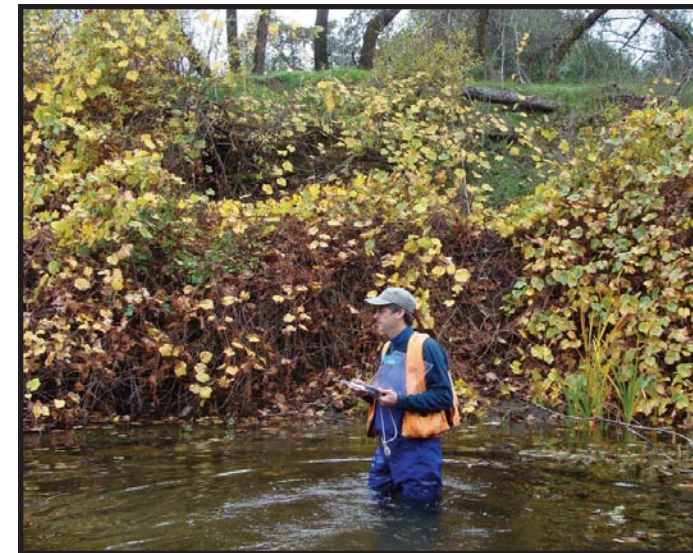
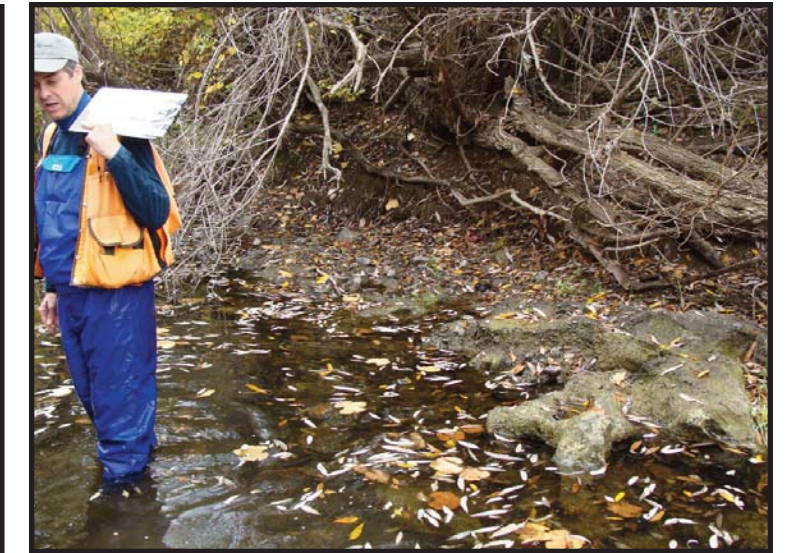
These images convey the relatively 'trench-like' character of Reach 1, with straight glides and steep banks.

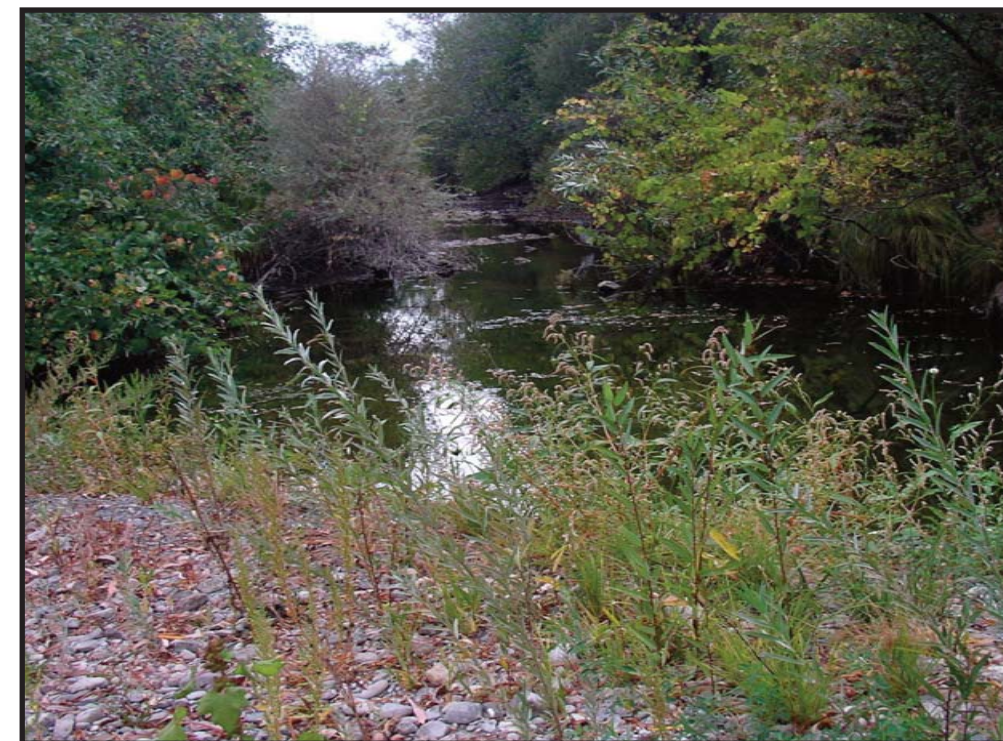
IN LOCATIONS WHERE GRAVEL BARS OCCUR IN REACH 1 SEEDLINGS OF RIPARIAN TREES ARE ABUNDANT.

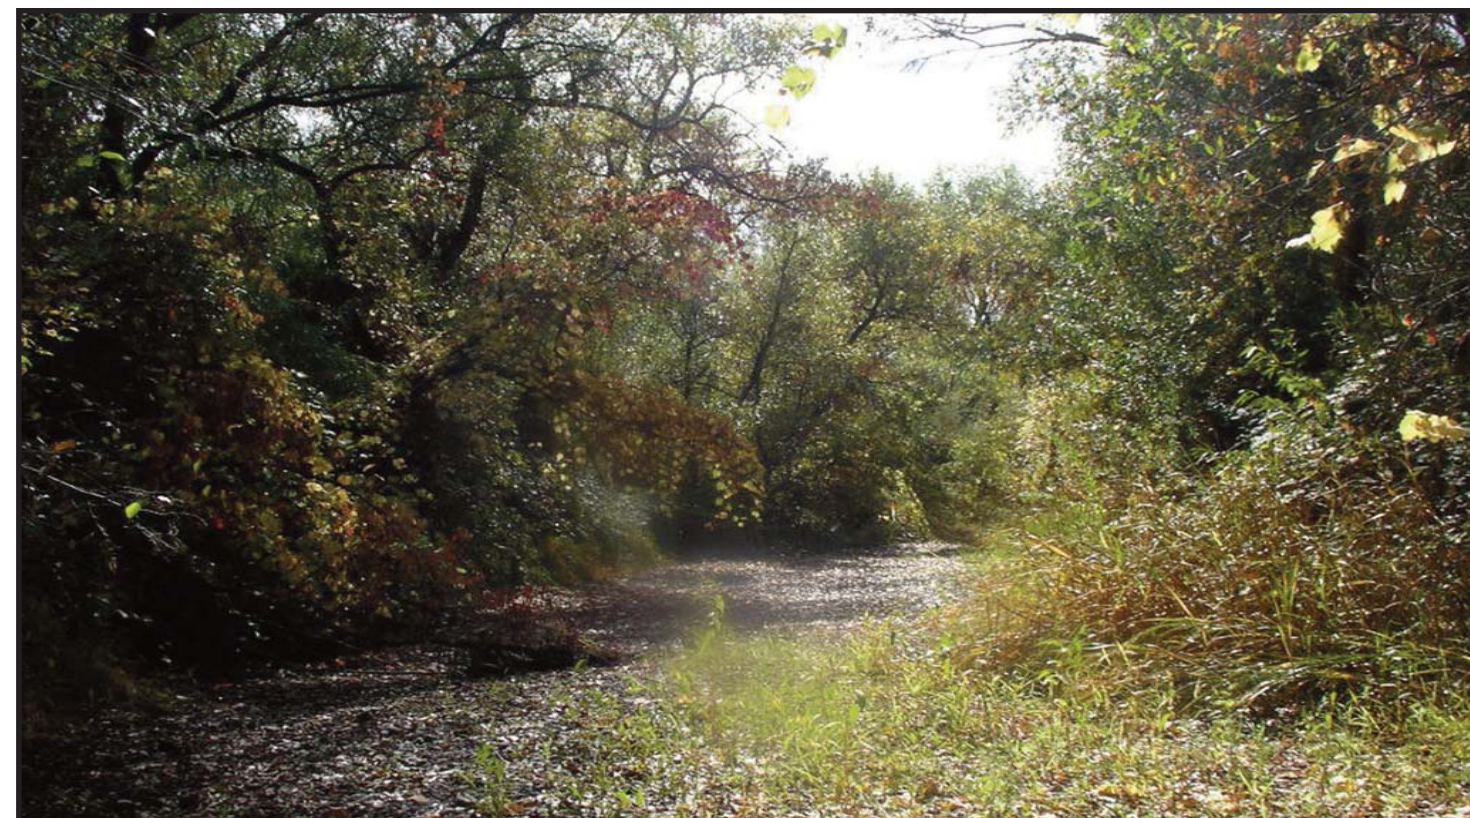
REACH 10 REPRESENTS AN EVOLUTION OF THE RIPARIAN SYSTEM IN RESPONSE TO CHANNEL WIDENING IN AN AREA DOMINATED BY ALLUVIAL SUBSTRATE.

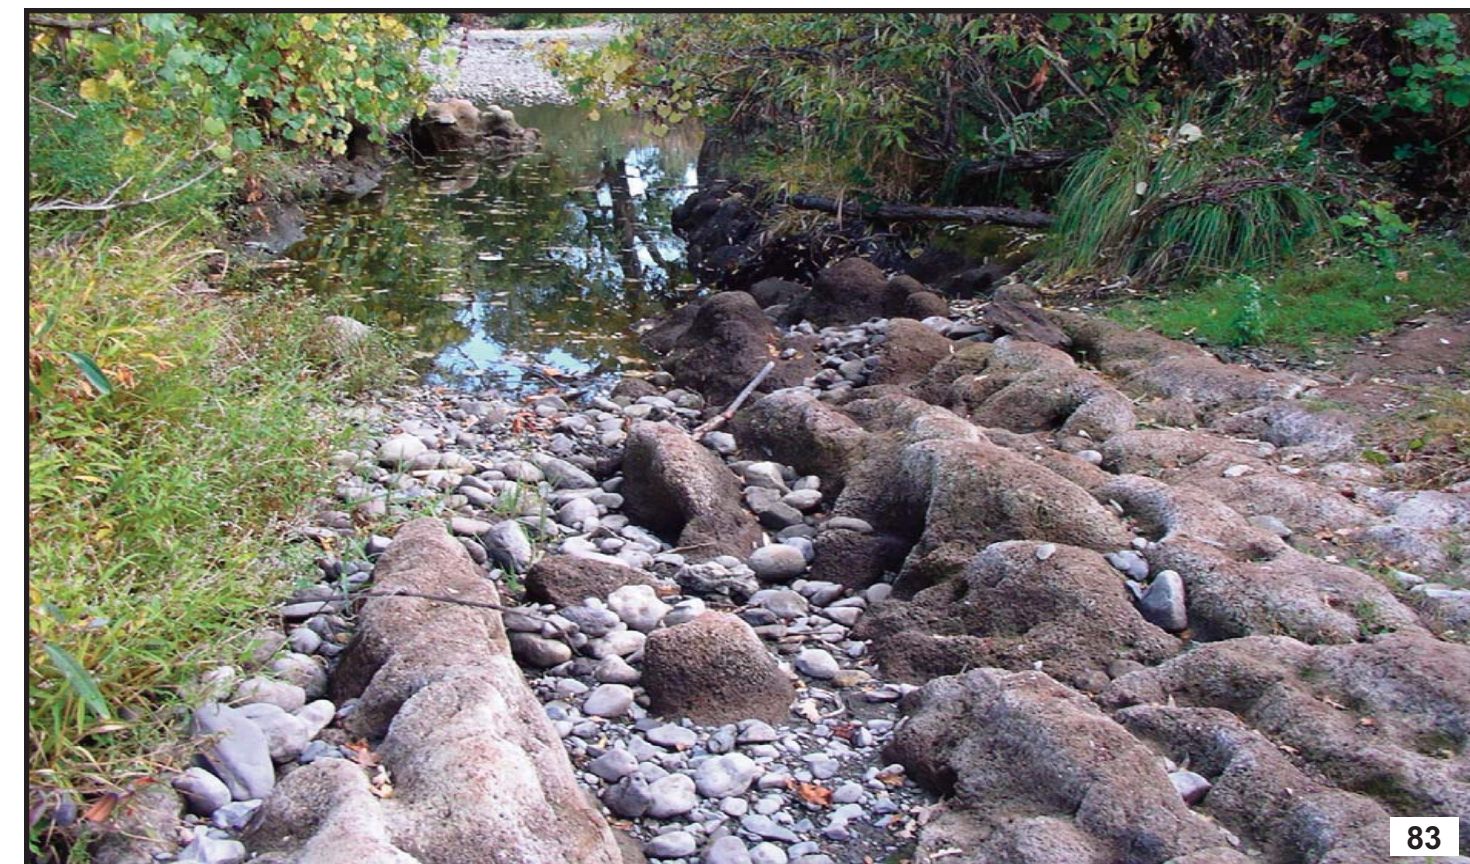
IN REACH 1, PLANT GROWTH AND REGENERATION ARE LIMITED BY A LAYER OF HIGHLY RESISTANT CLAY WHICH DOMINATES THE BED AND BANKS.

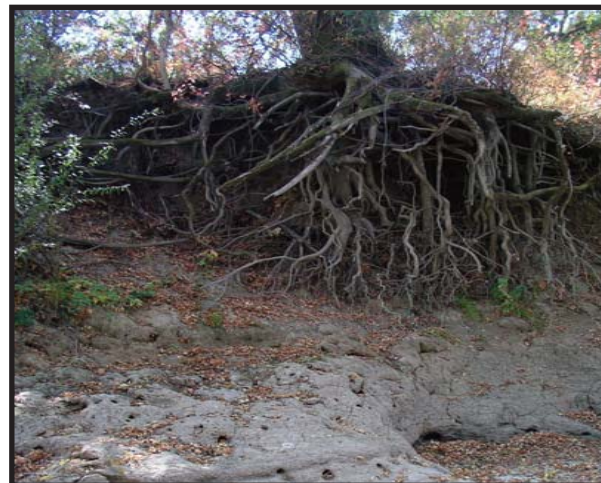
THE NARROWEST REACHES ARE 4, 6 AND 7.

REACH 4 (LEFT AND RIGHT) HAS NO TREE REGENERATION AND MOST OF THE TREES ON THE BANKS ARE BEING ERODED OUT.

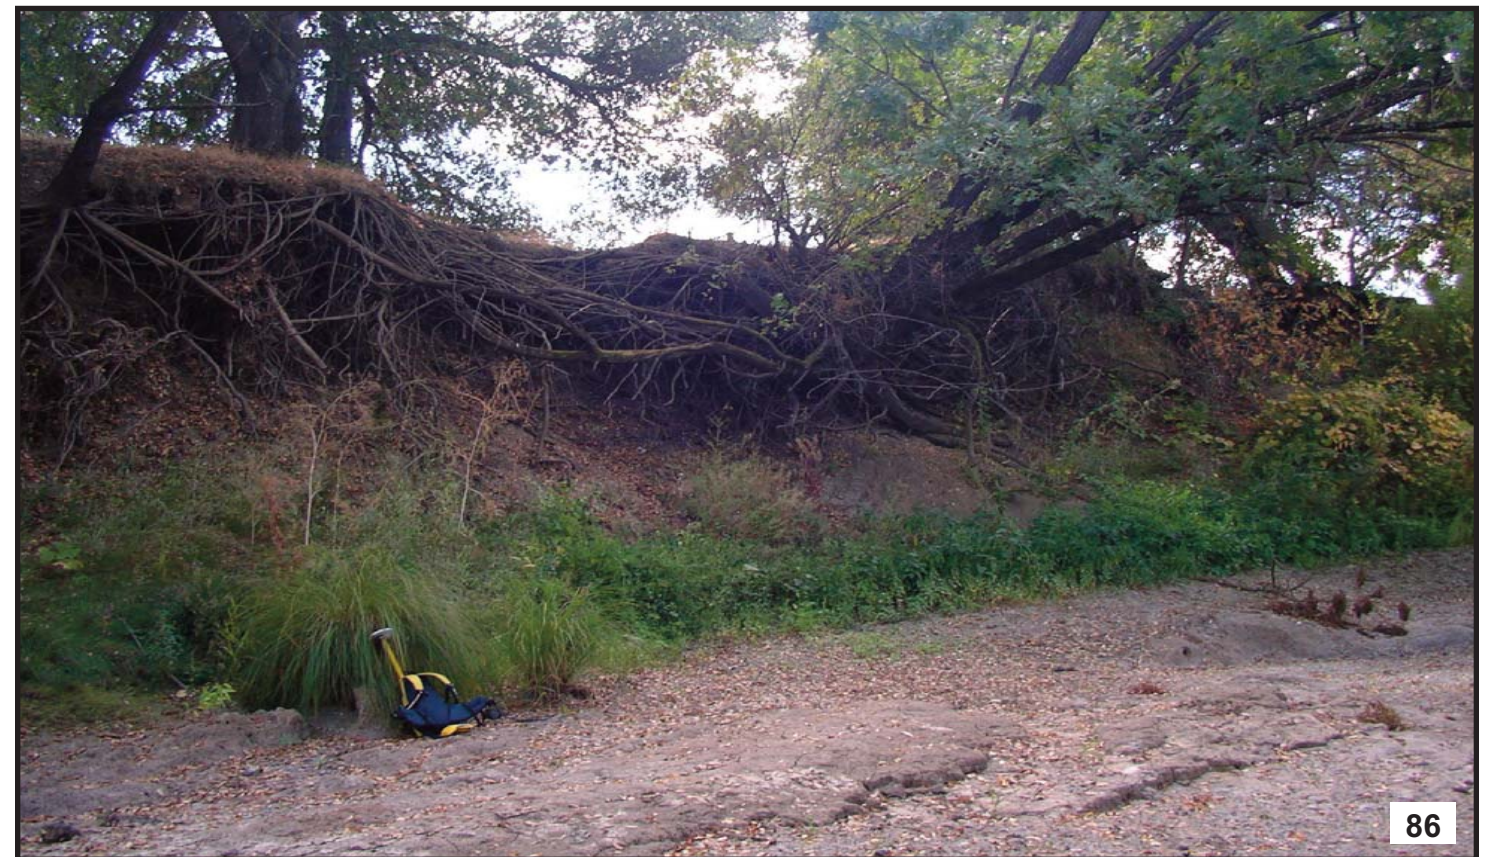
ABOVE: REACH 1 IS WIDE BUT VEGETATIVE GROWTH IS RESTRICTED BY A HIGHLY RESISTANT CLAY LAYER ON THE CHANNEL AND BANKS.

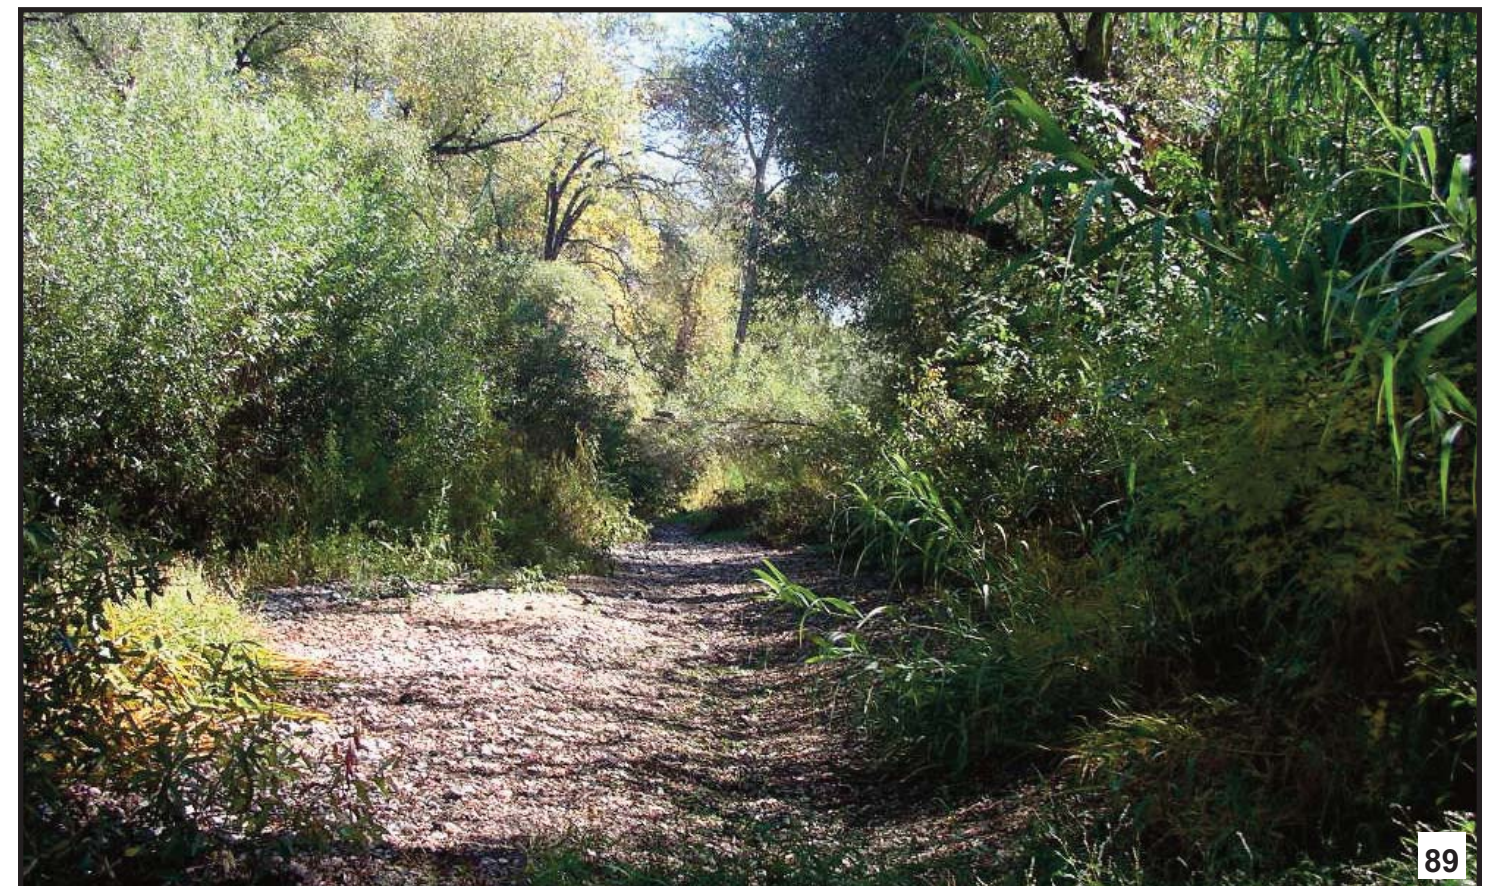
REACH 7 HAS LITTLE TO NO REGENERATION AND A HIGH LEVEL OF BOTH SPIDER TREES AND RIPRAP.

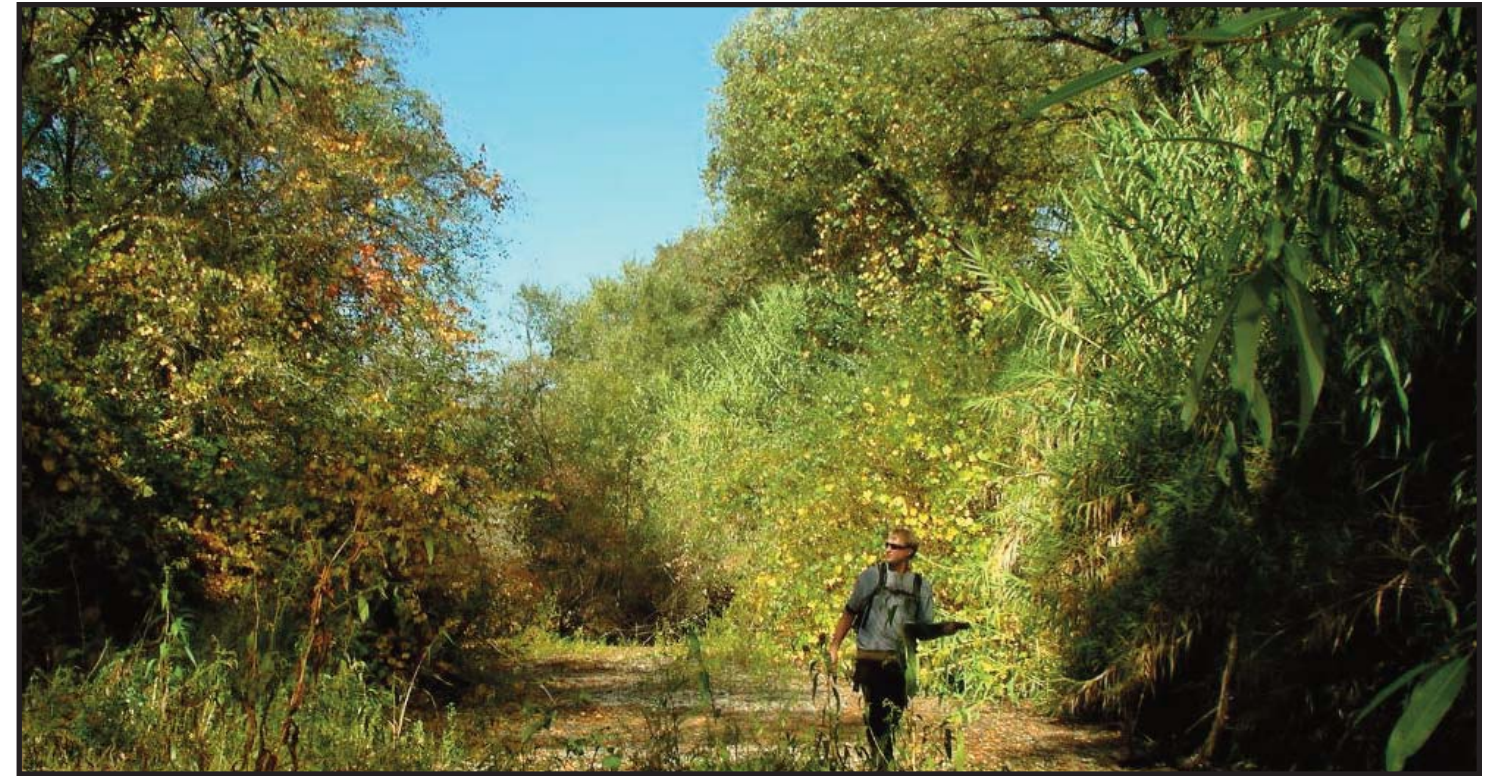
THE REACHES WITH A MEDIUM WIDTH ARE 2 , 8 AND 9. ABOVE: REACH 8 HAS MEDIUM DENSITY VEGETATION IN ALL OF ITS MORPHOLOGICAL AREAS.

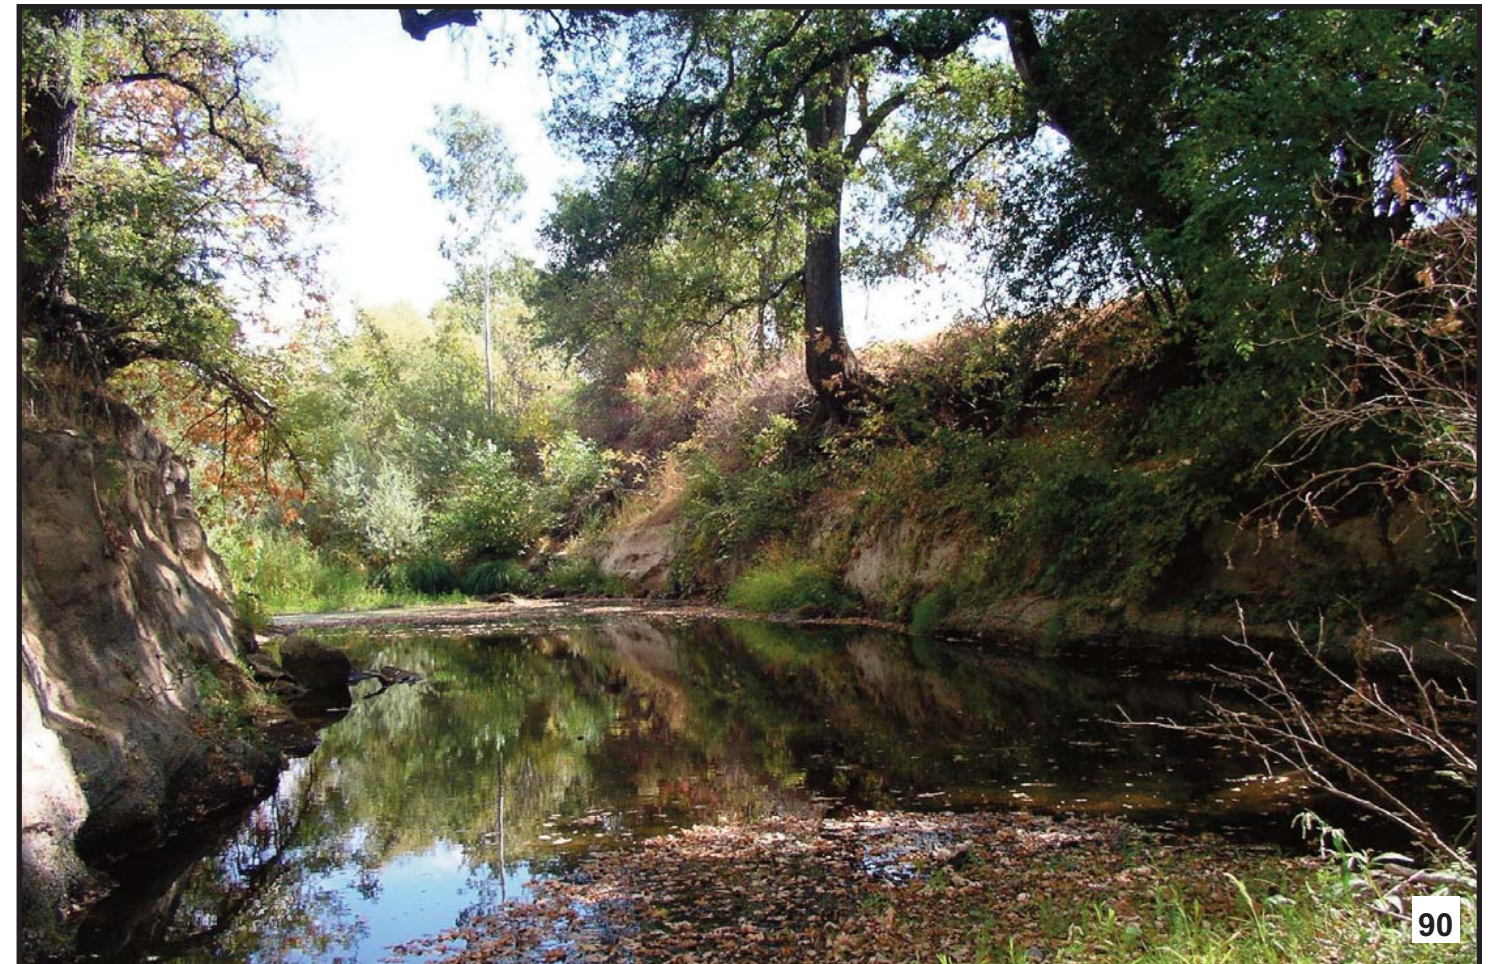
REACH 9 HAS A HIGH TO MEDIUM DENSITY OF TREES AND A GOOD LEVEL OF REGENERATION BUT ALSO HAS A HIGH ABUNDANCE OF ARUNDO DONAX.

Reach 10 is the widest reach in the project area and has a complex of morphological areas and high biodiversity. Reach 9 also has a high level of biodiversity. Both of these reaches have high levels of *Arundo donax* which should be removed to increase native plant regeneration.

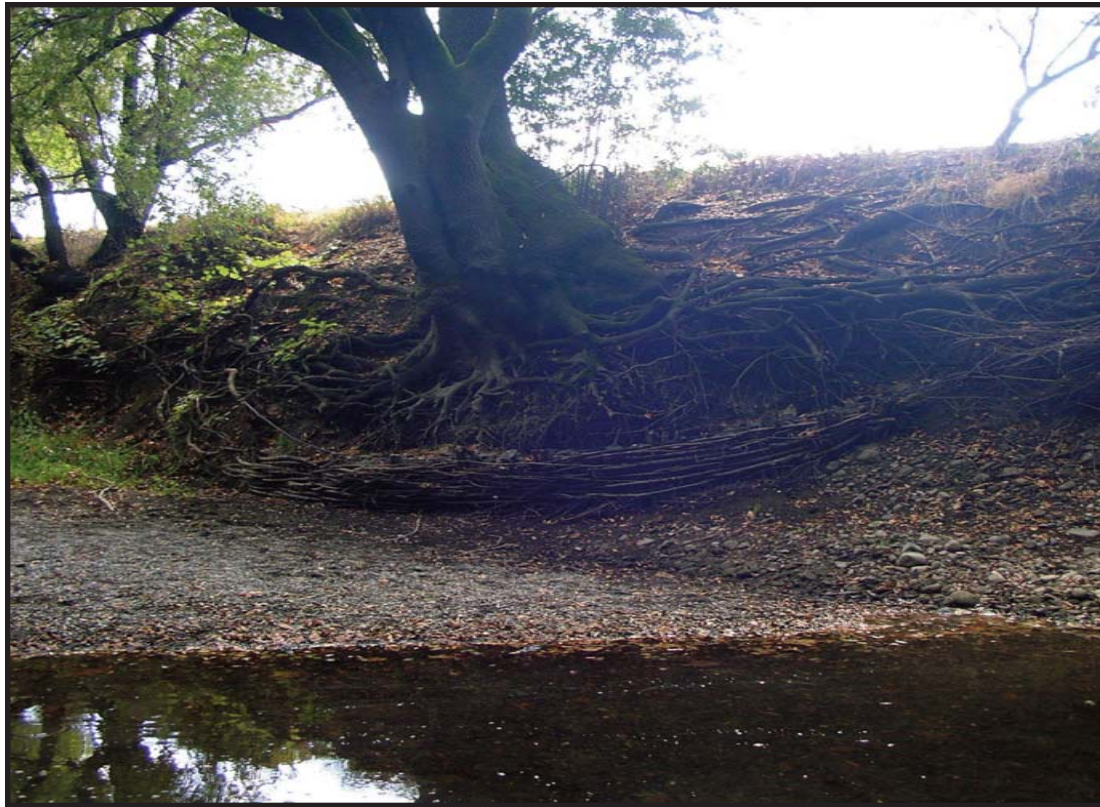
**LARGE UNDERCUT TREE IN NAPA RIVER ECOLOGICAL RESERVE.
WILLOW BASKET WAS INSTALLED TO REDUCE BANK EROSION**

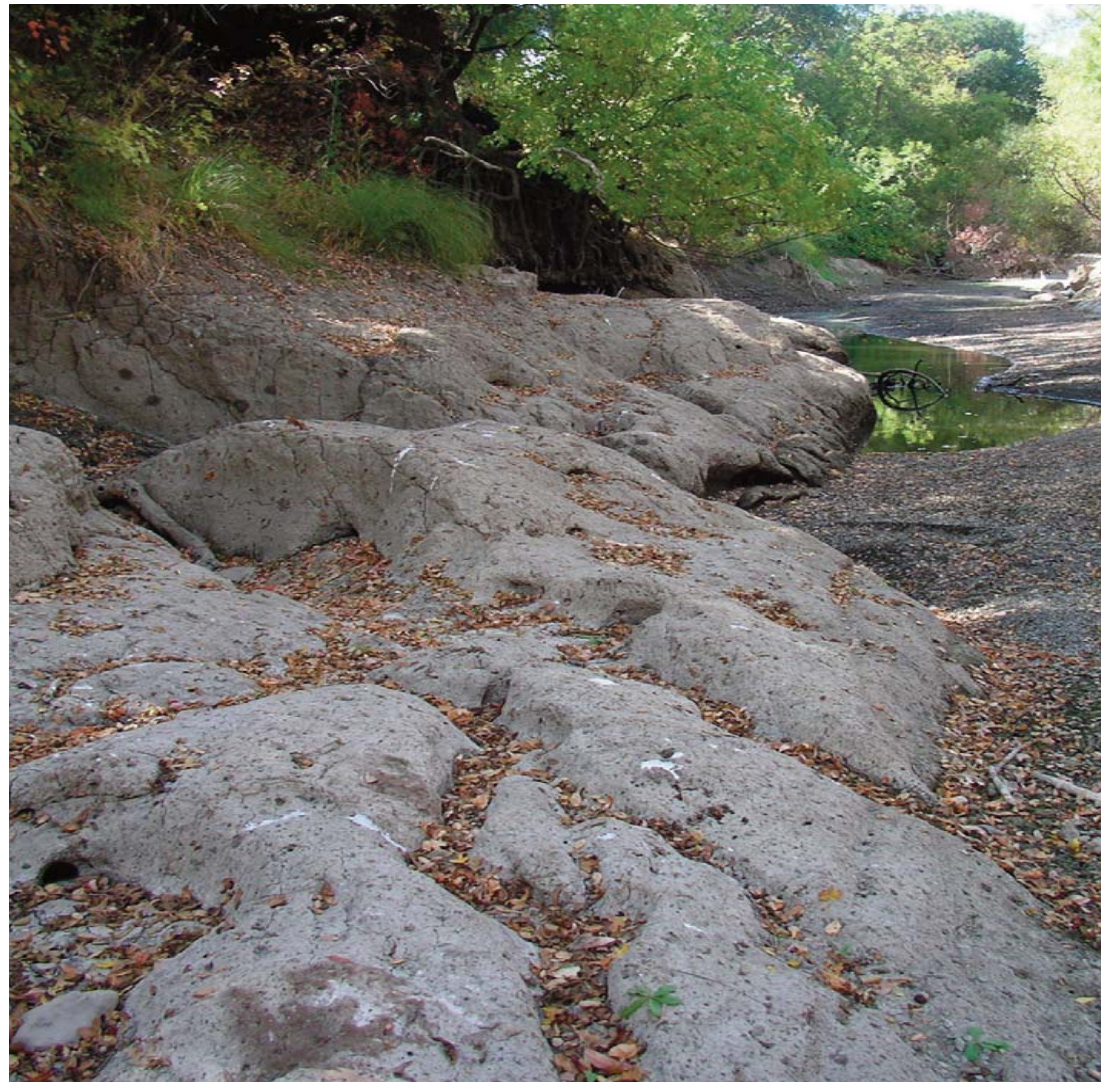
HARD PAN CLAY DOMINATED THE RIVER BOTTOM IN AREAS 13-8

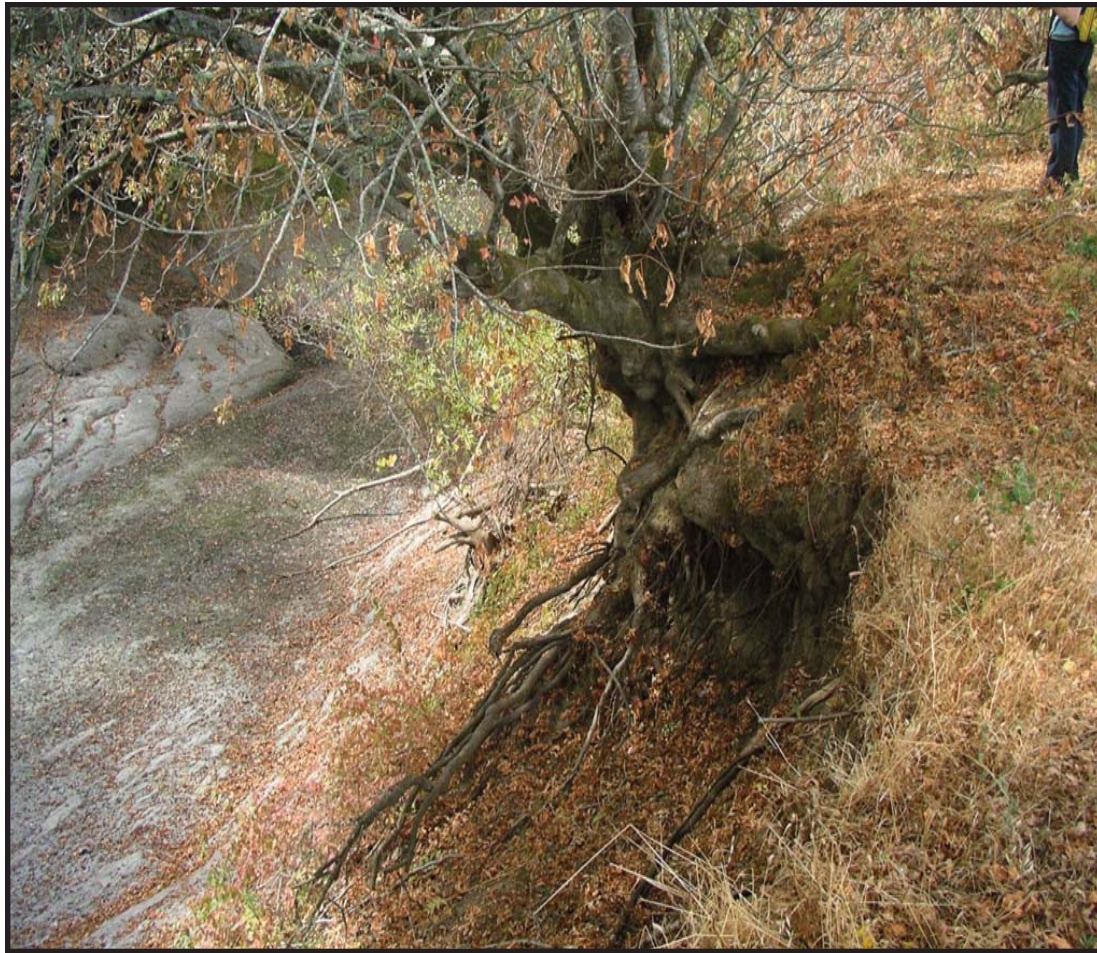
**HARD PAN CLAY DOMINATES THE RIVER BOTTOM AND BANKS
EROSION IS REMOVING THE LARGE TREES ALONG
REACH 4 OF THE NAPA RIVER**

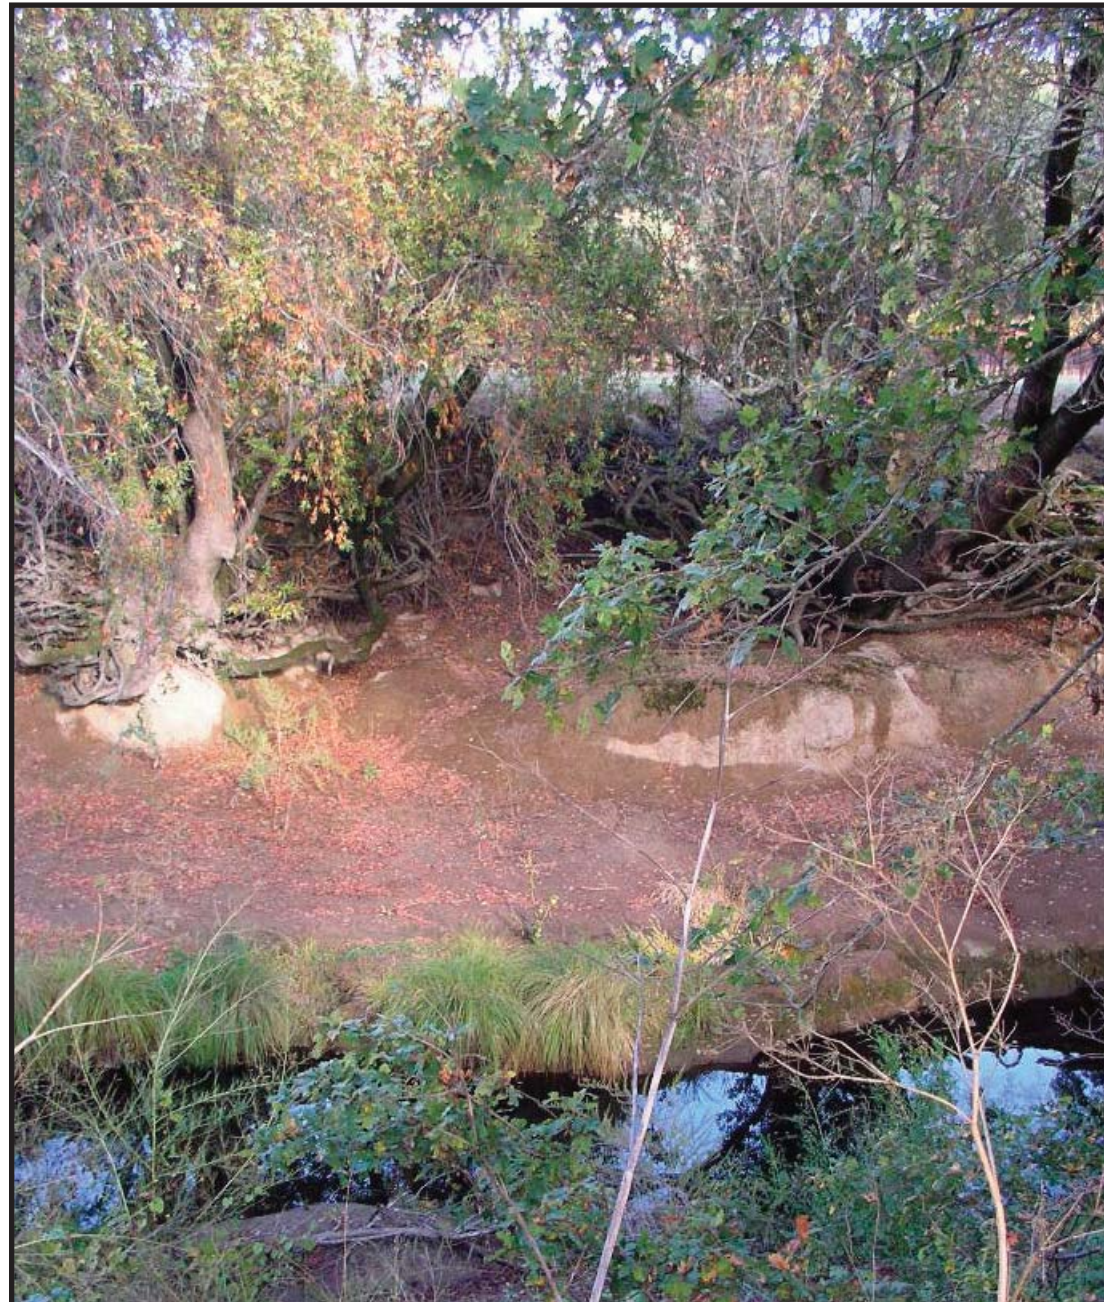
RIVER LOW FLOW CHANNEL IS IN A DEEP NARROW TRENCH IN THE CLAY WHILE THE LEFT BANK SUPPORTS LITTLE TO NO VEGETATION. LARGE TREES ARE GROWING ON SOIL ABOVE THE CLAY

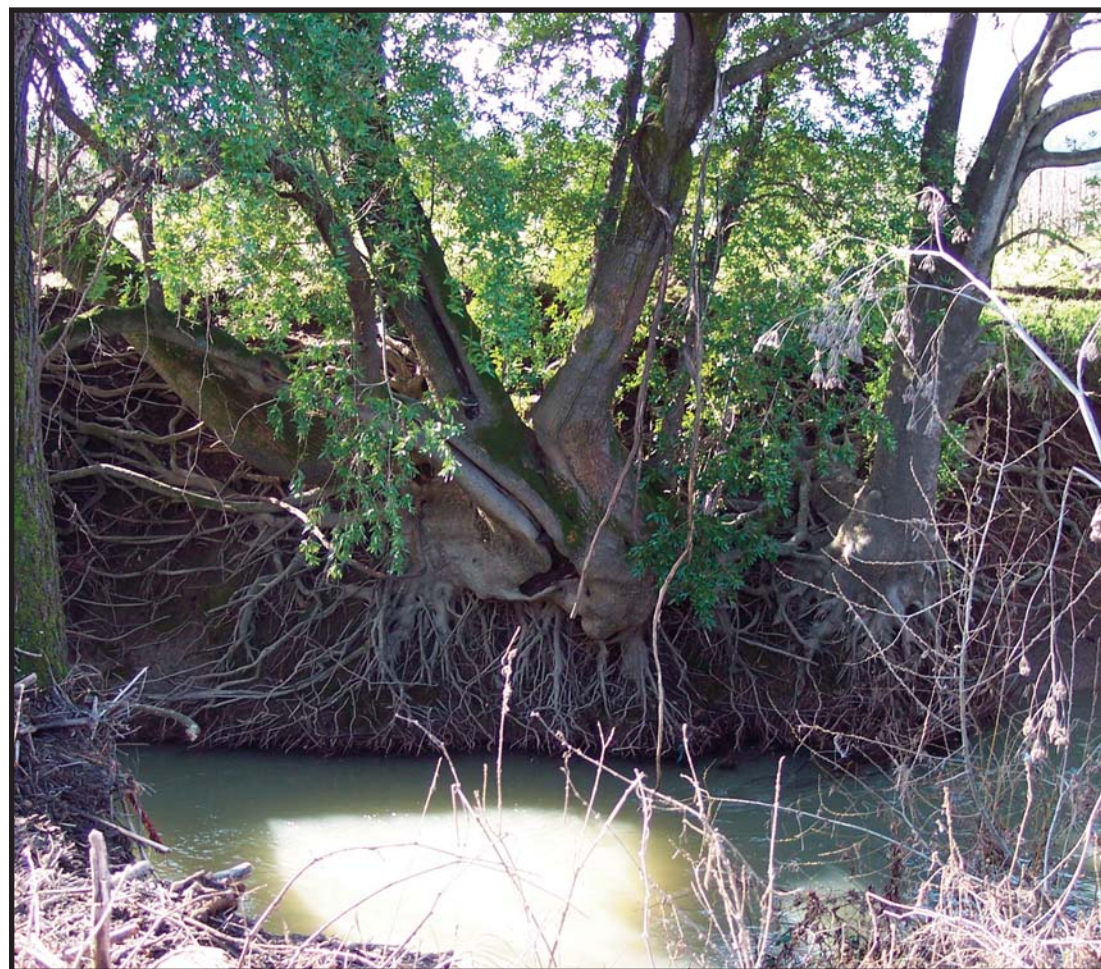
FAR LEFT: ENTRENCHMENT FROM THE NAPA RIVER HAS MOVED UP INTO DRY CREEK ERODING THE CHANNEL AND UNDERCUTTING TREES.
